Profile/Photo Observation Report

Date:	03/28/2018	Weather:		Coding:	PACP 6.0
Pipe Length (ft):	299.6	Owner:	NA	Pre Clean:	No Pre-Cleaning
P.O.#:		Surveyor:	Selasie Honu	PSR:	P-507-029-020
Customer:		Clean Date:	01/01/1900	Shape:	C

Street:	OFF S DEKALB ST	Flow Control:	Not Controlled
City:	Hobart, IN	Year Renewed:	
Location:	Woods	Tape/Media #:	
Purpose:	Routine Assessment	Dia/Height:	12"
Use:	Sanitary	Material:	VCP
Drain Area:	NA	Lining:	
Category:	NA

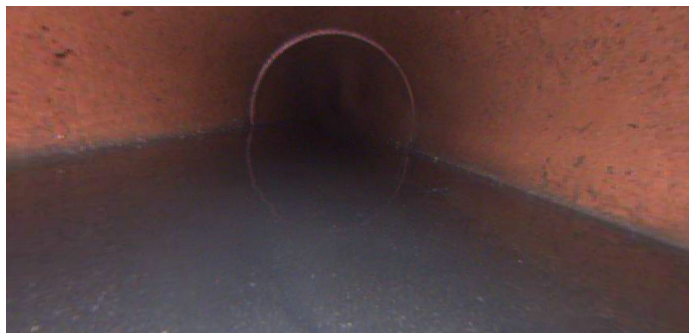
Code: **AMH**
Description: **Manhole**

Distance (ft): **.0**
Structural Grade: **0**
O&M Grade: **0**
Clock Start/From:
Clock To:
1st Value:
2nd Value:
Value Percent:
Continuous Index:
Within 8" of Joint: **NO**
Remarks: **M-507-020**

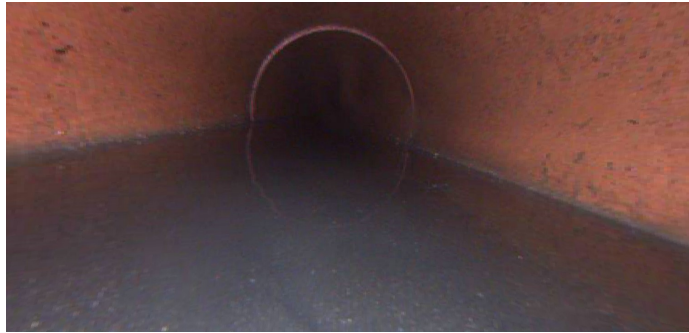
Code: **MWL**
Description: **Water Level**

Distance (ft): **.0**
Structural Grade: **0**
O&M Grade: **0**
Clock Start/From:
Clock To:
1st Value:
2nd Value:
Value Percent: **5.000**
Continuous Index:
Within 8" of Joint: **NO**
Remarks:

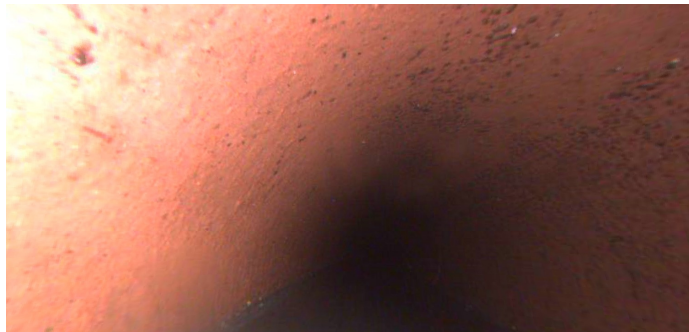
Comment: **F_S_R_M at 5 ft build up of grit and rocks in the pipe. \nFlow direction wrong**

Code: **MSA**
Description: **Abandoned Survey**

Distance (ft): **6.4**
Structural Grade: **0**
O&M Grade: **0**
Clock Start/From:
Clock To:
1st Value:
2nd Value:
Value Percent:
Continuous Index:
Within 8" of Joint: **NO**
Remarks: **OVERTURNED**
