Profile/Photo Observation Report

Street:	FOXCROFT STREET	Flow Control:	Not Controlled
City:	Hobart, IN	Year Renewed:	
Location:	Woods	Tape/Media #:	
Purpose:	Routine Assessment	Dia/Height:	12"
Use:	Sanitary	Material:	VCP
Drain Area:	NA	Lining:	
Category:	NA

US MH: **M-507-020** DS MH: **M-507-029** Total Length Surveyed (ft): **6.4**

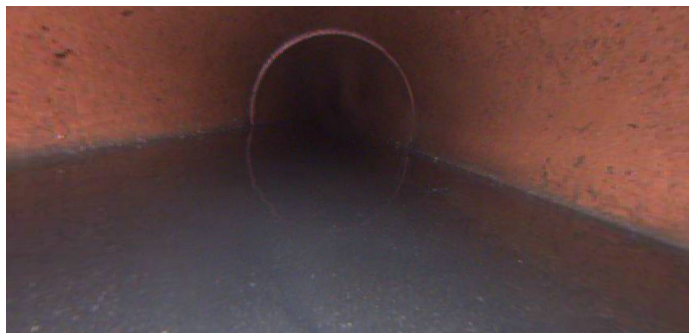
Code: **AMH**
 Description: **Manhole**
 Distance (ft): **.0**
 Structural Grade: **0**
 O&M Grade: **0**
 Clock Start/From:
 Clock To:
 1st Value:
 2nd Value:
 Value Percent:
 Continuous Index:
 Within 8" of Joint: **NO**
 Remarks: **M-507-020**

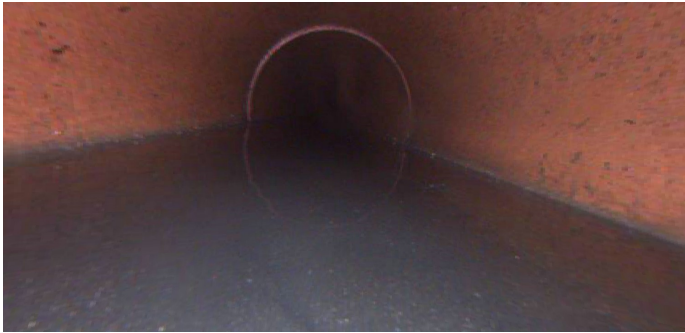
Code:	MWL
Description:	Water Level

Distance (ft):	.0
Structural Grade:	0
O&M Grade:	0
Clock Start/From:	
Clock To:	
1st Value:	
2nd Value:	
Value Percent:	5.000
Continuous Index:	
Within 8" of Joint:	NO
Remarks:

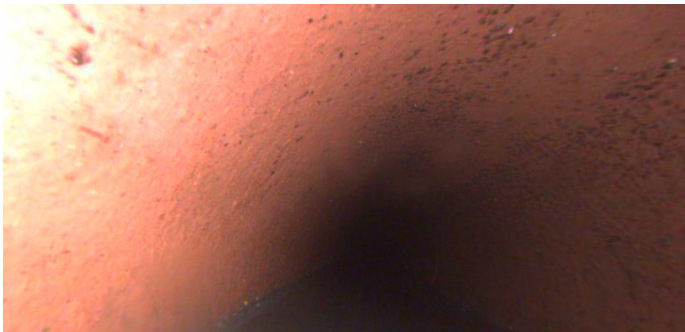
Code:	MSA
Description:	Abandoned Survey

Comment: **F_S_R_M at 5 ft build up of grit and rocks in the pipe. \nFlow direction wrong**

Distance (ft):	6.4
Structural Grade:	0
O&M Grade:	0
Clock Start/From:	
Clock To:	
1st Value:	
2nd Value:	
Value Percent:	
Continuous Index:	
Within 8" of Joint:	NO
Remarks:	OVERTURNED
