Profile/Photo Observation Report

Date:	10/09/2018	Weather:		Coding:	PACP 6.0
Pipe Length (ft):	299.6	Owner:	NA	Pre Clean:	Not Known
P.O.#:		Surveyor:	Selasie Honu	PSR:	P-507-029-020
Customer:		Clean Date:	01/01/1900	Shape:	C

Street:	Dekalb St.	Flow Control:	Not Controlled
City:	Hobart, IN	Year Renewed:	
Location:	Light Highway	Tape/Media #:	
Purpose:	Routine Assessment	Dia/Height:	12"
Use:	Sanitary	Material:	VCP
Drain Area:	NA	Lining:	
Category:	NA		
Comment:

Location Details:		Direction of Survey:	Upstream
US MH:	M-507-020	DS MH:	M-507-029
		Total Length Surveyed (ft):	252.8

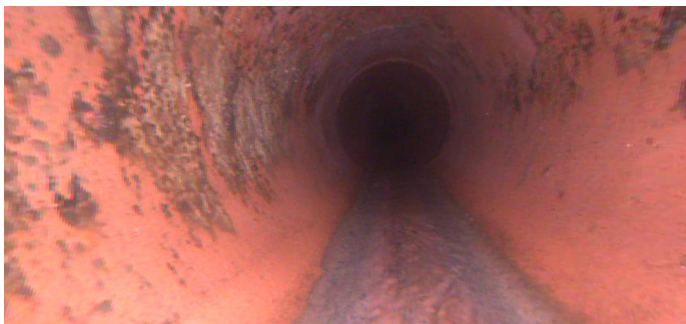
Code: **AMH**
Description: **Manhole**

Distance (ft): **.0**
Structural Grade: **0**
O&M Grade: **0**
Clock Start/From:
Clock To:
1st Value:
2nd Value:
Value Percent:
Continuous Index:
Within 8" of Joint: **NO**
Remarks: **M-507-029**

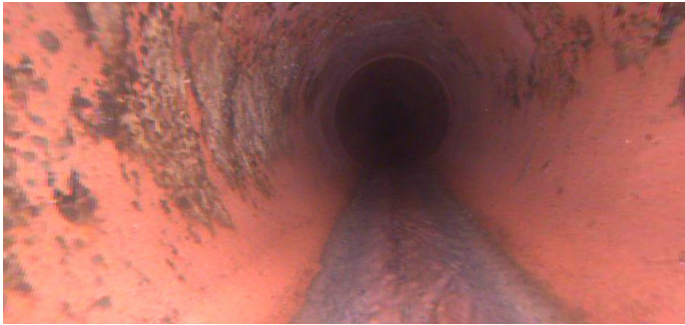
Code:	MWL
Description:	Water Level

Distance (ft):	.0
Structural Grade:	0
O&M Grade:	0
Clock Start/From:	
Clock To:	
1st Value:	
2nd Value:	
Value Percent:	5.000
Continuous Index:	
Within 8" of Joint:	NO
Remarks:

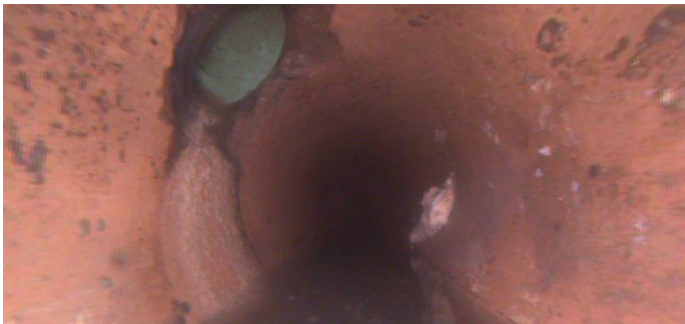
Code:	TF
Description:	Tap Factory

Distance (ft):	62.9
Structural Grade:	0
O&M Grade:	0
Clock Start/From:	10
Clock To:	
1st Value:	4.000
2nd Value:	
Value Percent:	
Continuous Index:	
Within 8" of Joint:	
Remarks:

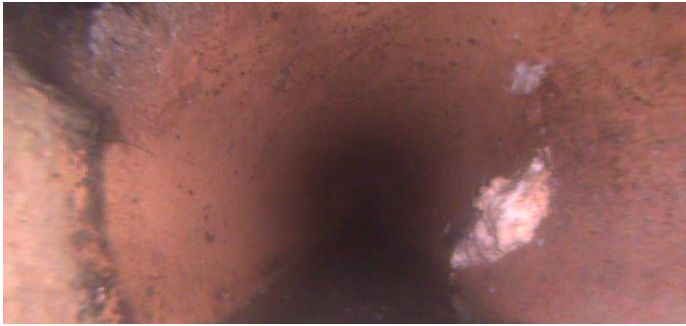
Code: **DAGS**
Description: **Deposits Attached Grease**

Distance (ft): **63.6**
Structural Grade: **0**
O&M Grade: **2**
Clock Start/From: **3**
Clock To: **4**
1st Value:
2nd Value:
Value Percent: **5.000**
Continuous Index:
Within 8" of Joint: **NO**
Remarks:

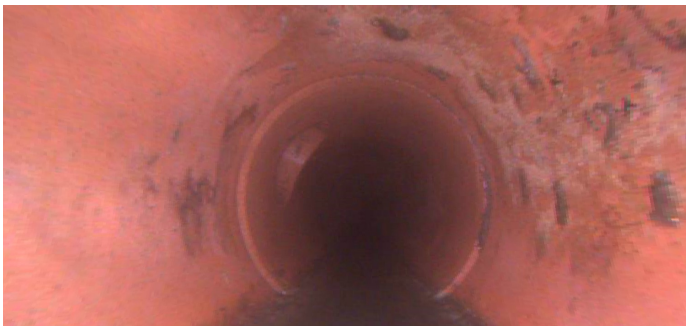
Code: **TF**
Description: **Tap Factory**

Distance (ft): **73.0**
Structural Grade: **0**
O&M Grade: **0**
Clock Start/From: **10**
Clock To:
1st Value: **4.000**
2nd Value:
Value Percent:
Continuous Index:
Within 8" of Joint:
Remarks:

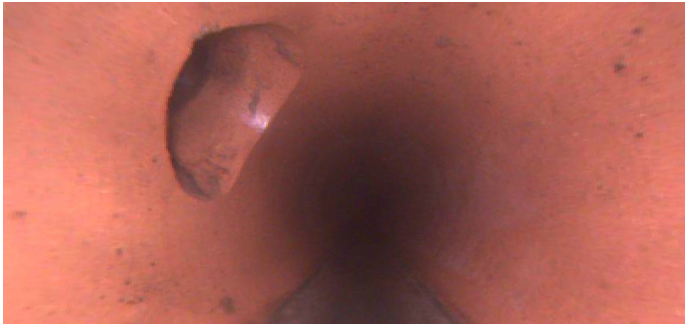
Code: **TF**
Description: **Tap Factory**

Distance (ft): **73.8**
Structural Grade: **0**
O&M Grade: **0**
Clock Start/From: **10**
Clock To:
1st Value: **4.000**
2nd Value:
Value Percent:
Continuous Index:
Within 8" of Joint:
Remarks:

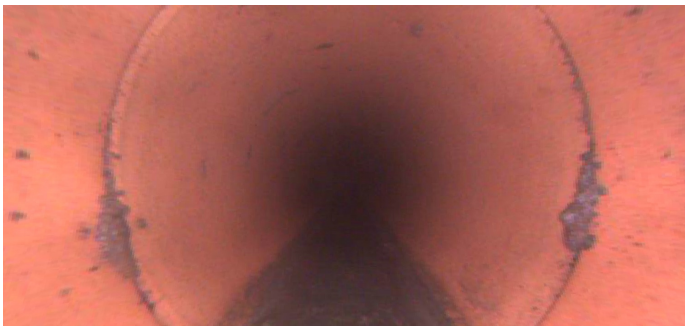
Code: **RFJ**
Description: **Roots Fine Joint**

Distance (ft): **81.9**
Structural Grade: **0**
O&M Grade: **1**
Clock Start/From: **8**
Clock To: **4**
1st Value:
2nd Value:
Value Percent:
Continuous Index:
Within 8" of Joint: **YES**
Remarks:

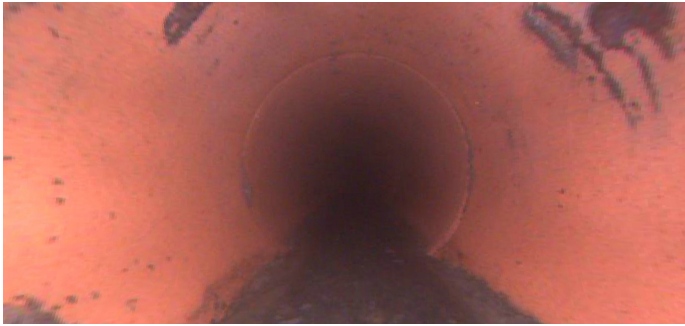
Code: **RFJ**
Description: **Roots Fine Joint**

Distance (ft): **93.6**
Structural Grade: **0**
O&M Grade: **1**
Clock Start/From: **8**
Clock To: **4**
1st Value:
2nd Value:
Value Percent:
Continuous Index:
Within 8" of Joint: **YES**
Remarks:

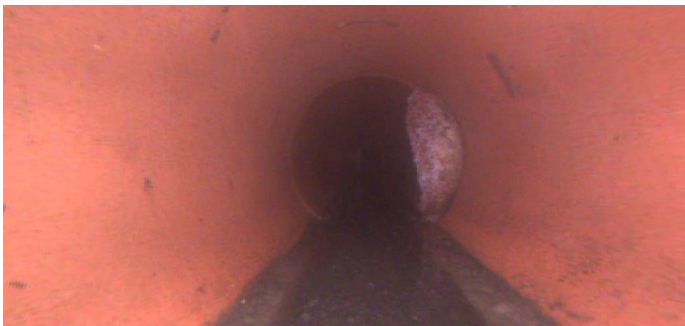
Code: **DAE**
Description: **Deposits Attached Encrustation**

Distance (ft): **118.0**
Structural Grade: **0**
O&M Grade: **3**
Clock Start/From: **1**
Clock To: **4**
1st Value:
2nd Value:
Value Percent: **20.000**
Continuous Index:
Within 8" of Joint: **YES**
Remarks:

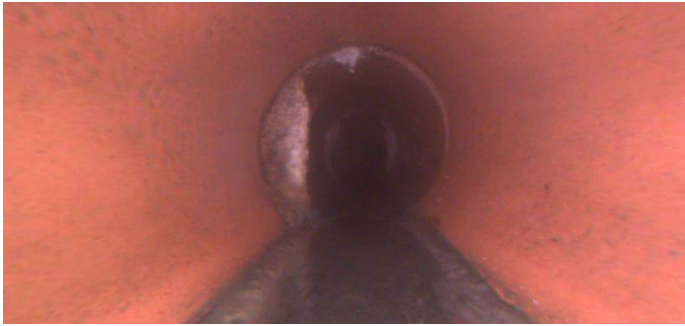
Code: **DAE**
Description: **Deposits Attached Encrustation**

Distance (ft): **124.3**
Structural Grade: **0**
O&M Grade: **4**
Clock Start/From: **7**
Clock To: **12**
1st Value:
2nd Value:
Value Percent: **30.000**
Continuous Index:
Within 8" of Joint: **YES**
Remarks:

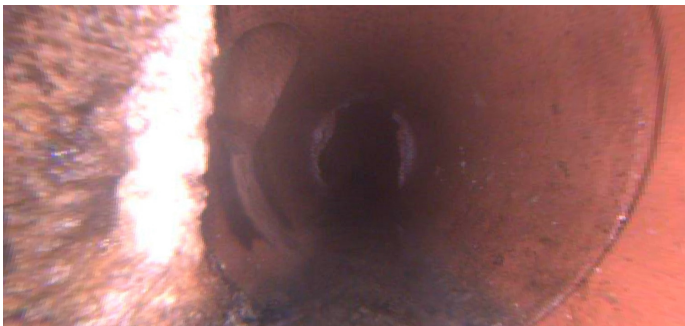
Code: **TF**
Description: **Tap Factory**

Distance (ft): **125.5**
Structural Grade: **0**
O&M Grade: **0**
Clock Start/From: **9**
Clock To:
1st Value: **4.000**
2nd Value:
Value Percent:
Continuous Index:
Within 8" of Joint:
Remarks:

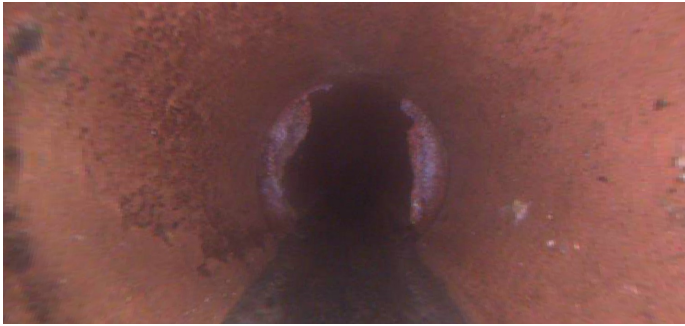
Code: **DAE**
Description: **Deposits Attached Encrustation**

Distance (ft): **126.4**
Structural Grade: **0**
O&M Grade: **4**
Clock Start/From: **8**
Clock To: **4**
1st Value:
2nd Value:
Value Percent: **30.000**
Continuous Index:
Within 8" of Joint: **YES**
Remarks:

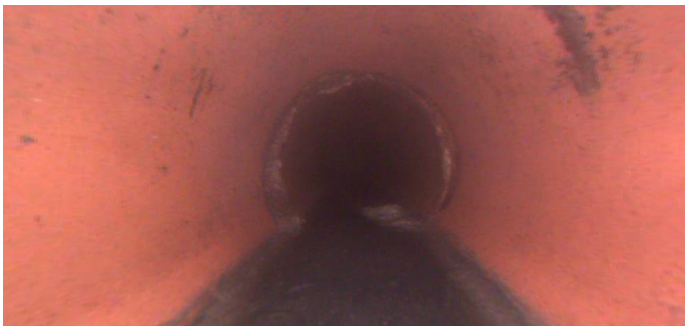
Code: **DAE**
Description: **Deposits Attached Encrustation**

Distance (ft): **132.0**
Structural Grade: **0**
O&M Grade: **2**
Clock Start/From: **8**
Clock To: **4**
1st Value:
2nd Value:
Value Percent: **10.000**
Continuous Index:
Within 8" of Joint: **YES**
Remarks:

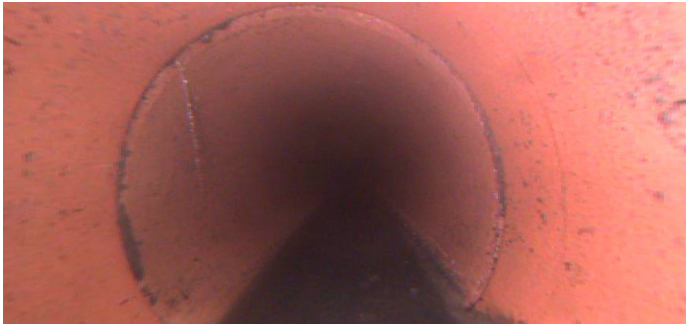
Code: **DAE**
Description: **Deposits Attached Encrustation**

Distance (ft): **145.3**
Structural Grade: **0**
O&M Grade: **2**
Clock Start/From: **8**
Clock To: **4**
1st Value:
2nd Value:
Value Percent: **5.000**
Continuous Index:
Within 8" of Joint: **YES**
Remarks:

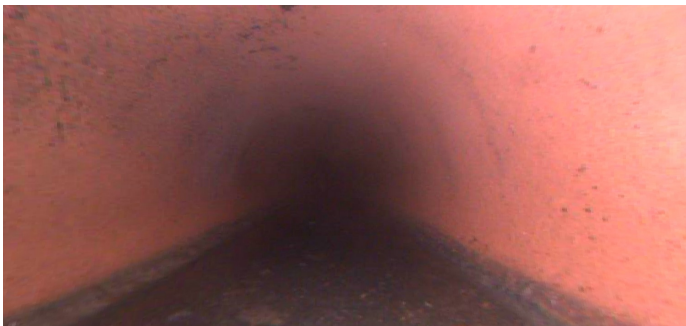
Code: **MSA**
Description: **Abandoned Survey**

Distance (ft): **252.8**
Structural Grade: **0**
O&M Grade: **0**
Clock Start/From:
Clock To:
1st Value:
2nd Value:
Value Percent:
Continuous Index:
Within 8" of Joint: **NO**
Remarks: **M-507-020**
