Profile/Photo Observation Report

Date:	03/29/2018	Weather:		Coding:	PACP 6.0
Pipe Length (ft):	193.1	Owner:	NA	Pre Clean:	No Pre-Cleaning
P.O.#:		Surveyor:	Jen Costello	PSR:	P-507-022-021
Customer:		Clean Date:	01/01/1900	Shape:	C

Street:	OFF CSOKASY LN	Flow Control:	Not Controlled
City:	Hobart, IN	Year Renewed:	
Location:	Yard	Tape/Media #:	
Purpose:	Routine Assessment	Dia/Height:	8"
Use:	Sanitary	Material:	VCP
Drain Area:	NA	Lining:	
Category:	NA		
Comment:	Flow direction wrong

Location Details:		Direction of Survey:	Upstream
US MH:	M-507-021	DS MH:	M-507-022
		Total Length Surveyed (ft):	185.7

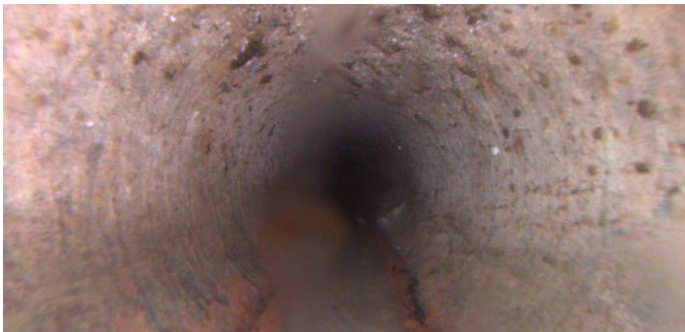
Code:	DAE
Description:	Deposits Attached Encrustation

Distance (ft):	.0
Structural Grade:	0
O&M Grade:	2
Clock Start/From:	7
Clock To:	5
1st Value:	
2nd Value:	
Value Percent:	5.000
Continuous Index:	S01
Within 8" of Joint:	NO
Remarks:

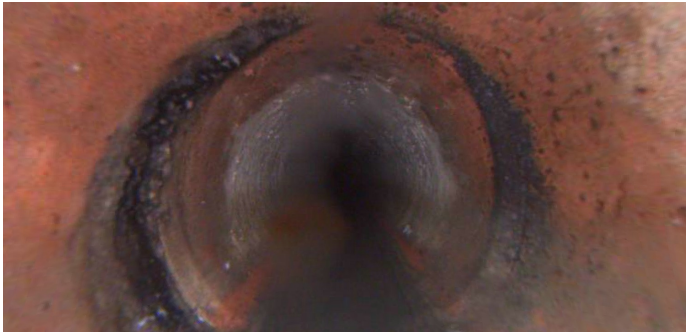
Code: **IW**
Description: **Infil Weeper**

Distance (ft): **37.3**
Structural Grade: **0**
O&M Grade: **2**
Clock Start/From: **8**
Clock To: **4**
1st Value:
2nd Value:
Value Percent:
Continuous Index:
Within 8" of Joint: **YES**
Remarks:

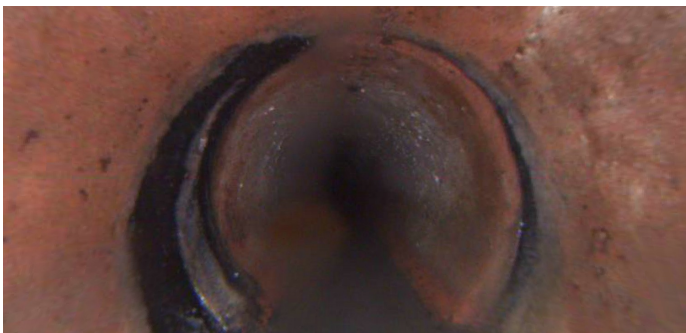
Code: **IW**
Description: **Infil Weeper**

Distance (ft): **42.3**
Structural Grade: **0**
O&M Grade: **2**
Clock Start/From: **8**
Clock To: **4**
1st Value:
2nd Value:
Value Percent:
Continuous Index:
Within 8" of Joint: **YES**
Remarks:

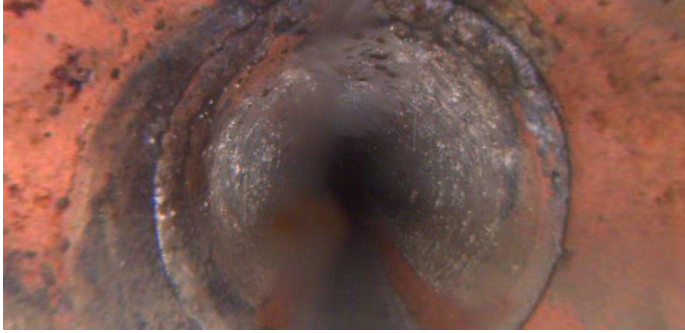
Code: **IW**
Description: **Infil Weeper**

Distance (ft): **62.1**
Structural Grade: **0**
O&M Grade: **2**
Clock Start/From: **8**
Clock To: **4**
1st Value:
2nd Value:
Value Percent:
Continuous Index:
Within 8" of Joint: **YES**
Remarks:

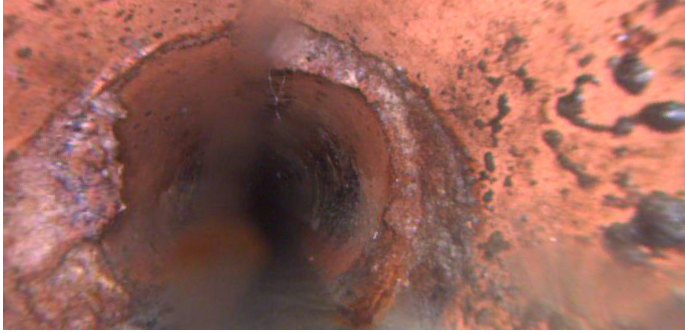
Code: **DAE**
Description: **Deposits Attached Encrustation**

Distance (ft): **69.0**
Structural Grade: **0**
O&M Grade: **2**
Clock Start/From: **8**
Clock To: **4**
1st Value:
2nd Value:
Value Percent: **10.000**
Continuous Index: **S02**
Within 8" of Joint: **YES**
Remarks:

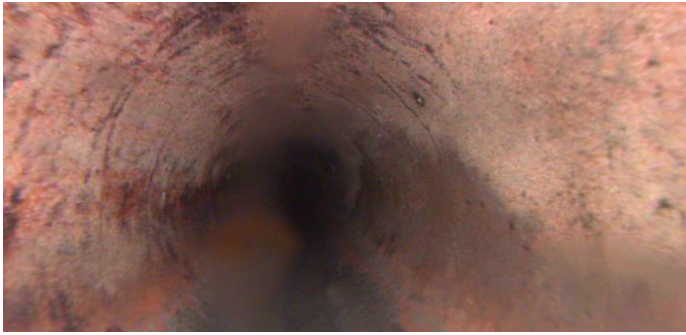
Code: **DAE**
Description: **Deposits Attached Encrustation**

Distance (ft): **108.5**
Structural Grade: **0**
O&M Grade: **2**
Clock Start/From: **7**
Clock To: **5**
1st Value:
2nd Value:
Value Percent: **5.000**
Continuous Index: **F01**
Within 8" of Joint: **NO**
Remarks:

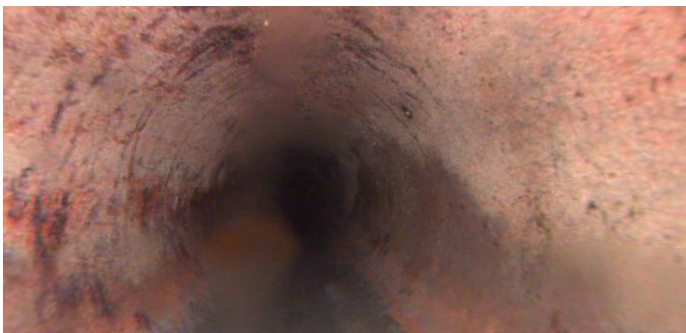
Code: **DAE**
Description: **Deposits Attached Encrustation**

Distance (ft): **108.5**
Structural Grade: **0**
O&M Grade: **2**
Clock Start/From: **8**
Clock To: **4**
1st Value:
2nd Value:
Value Percent: **10.000**
Continuous Index: **F03**
Within 8" of Joint: **NO**
Remarks:

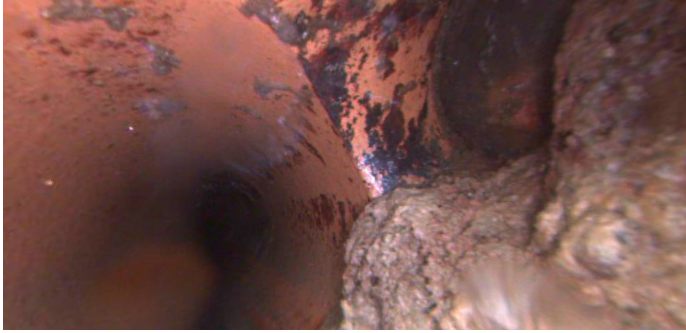
Code: **TFD**
Description: **Tap Factory Defective**

Distance (ft): **116.4**
Structural Grade: **0**
O&M Grade: **2**
Clock Start/From: **2**
Clock To:
1st Value: **4.000**
2nd Value:
Value Percent:
Continuous Index:
Within 8" of Joint:
Remarks: **dae**

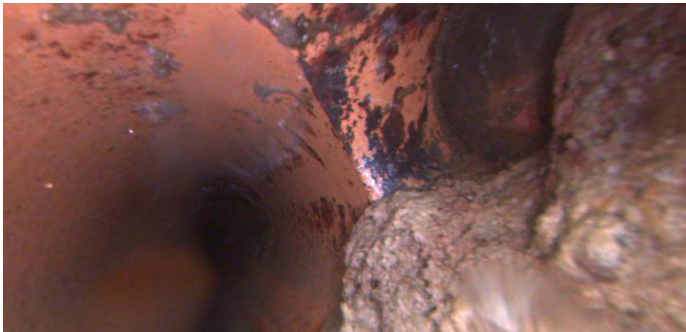
Code: **DAE**
Description: **Deposits Attached Encrustation**

Distance (ft): **116.4**
Structural Grade: **0**
O&M Grade: **2**
Clock Start/From: **2**
Clock To: **4**
1st Value:
2nd Value:
Value Percent: **10.000**
Continuous Index:
Within 8" of Joint: **NO**
Remarks:

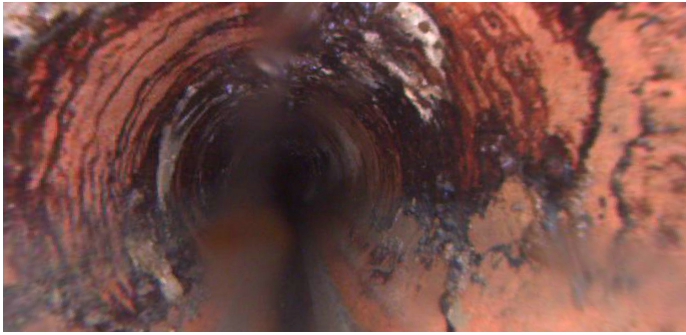
Code: **DAE**
Description: **Deposits Attached Encrustation**

Distance (ft): **118.2**
Structural Grade: **0**
O&M Grade: **2**
Clock Start/From: **8**
Clock To: **4**
1st Value:
2nd Value:
Value Percent: **5.000**
Continuous Index: **S03**
Within 8" of Joint: **NO**
Remarks:

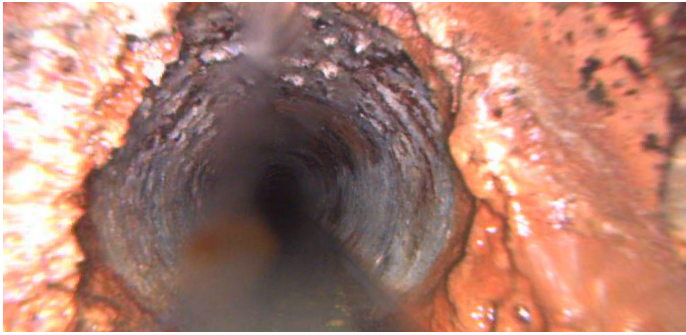
Code: **DAE**
Description: **Deposits Attached Encrustation**

Distance (ft): **154.4**
Structural Grade: **0**
O&M Grade: **3**
Clock Start/From: **8**
Clock To: **4**
1st Value:
2nd Value:
Value Percent: **15.000**
Continuous Index:
Within 8" of Joint: **YES**
Remarks:

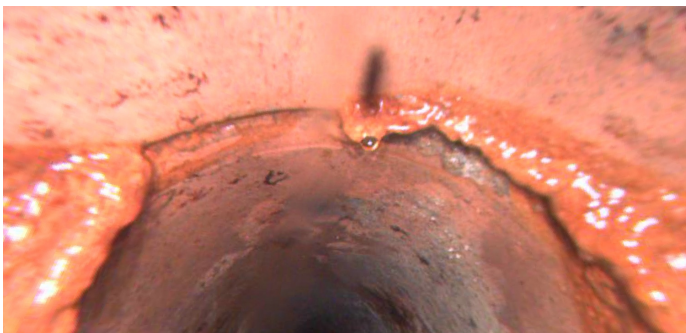
Code: **ID**
Description: **Infil Dripper**

Distance (ft): **164.6**
Structural Grade: **0**
O&M Grade: **3**
Clock Start/From: **12**
Clock To:
1st Value:
2nd Value:
Value Percent:
Continuous Index:
Within 8" of Joint: **YES**
Remarks:

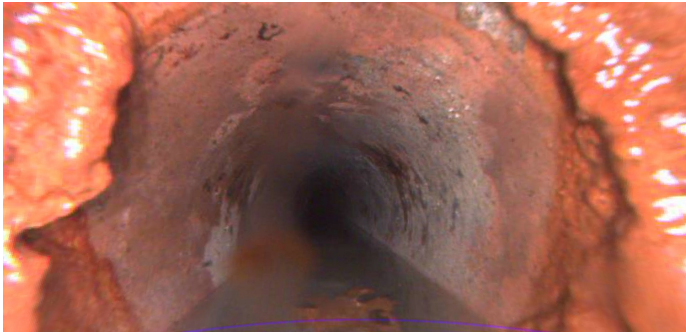
Code: **DAE**
Description: **Deposits Attached Encrustation**

Distance (ft): **164.6**
Structural Grade: **0**
O&M Grade: **3**
Clock Start/From: **8**
Clock To: **4**
1st Value:
2nd Value:
Value Percent: **15.000**
Continuous Index:
Within 8" of Joint: **YES**
Remarks:

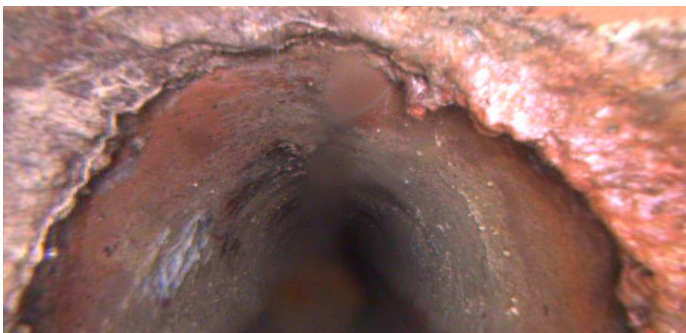
Code: **DAE**
Description: **Deposits Attached Encrustation**

Distance (ft): **169.4**
Structural Grade: **0**
O&M Grade: **2**
Clock Start/From: **8**
Clock To: **4**
1st Value:
2nd Value:
Value Percent: **10.000**
Continuous Index:
Within 8" of Joint: **YES**
Remarks:

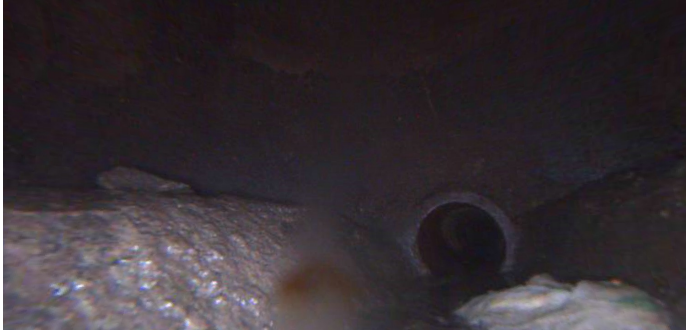
Code: **DAE**
Description: **Deposits Attached Encrustation**

Distance (ft): **185.7**
Structural Grade: **0**
O&M Grade: **2**
Clock Start/From: **8**
Clock To: **4**
1st Value:
2nd Value:
Value Percent: **10.000**
Continuous Index: **F02**
Within 8" of Joint: **YES**
Remarks:
