Profile/Photo Observation Report

Date:	03/29/2018	Weather:		Coding:	PACP 6.0
Pipe Length (ft):	235.0	Owner:	NA	Pre Clean:	No Pre-Cleaning
P.O.#:		Surveyor:	Jen Costello	PSR:	P-507-024-023
Customer:		Clean Date:	01/01/1900	Shape:	C

Street:	CSOKASY LN	Flow Control:	Not Controlled
City:	Hobart, IN	Year Renewed:	
Location:	Yard	Tape/Media #:	
Purpose:	Routine Assessment	Dia/Height:	12"
Use:	Sanitary	Material:	VCP
Drain Area:	NA	Lining:	
Category:	NA		
Comment:	F_S_P_C at 0 ft debris .Flow direction wrong		
Location Details:		Direction of Survey:	Upstream
US MH:	M-507-023	DS MH:	M-507-024
		Total Length Surveyed (ft):	1.5

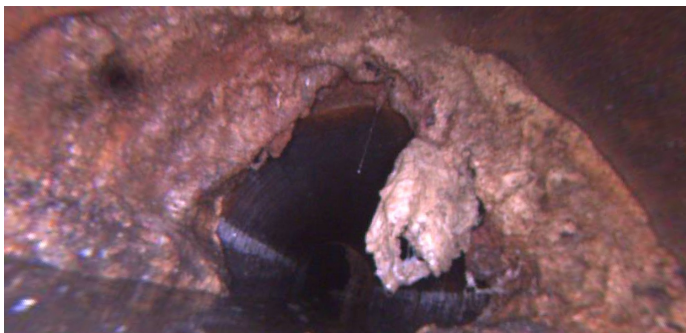
Code: **AMH**
Description: **Manhole**

Distance (ft): **.0**
Structural Grade: **0**
O&M Grade: **0**
Clock Start/From:
Clock To:
1st Value:
2nd Value:
Value Percent:
Continuous Index:
Within 8" of Joint: **NO**
Remarks: **M-507-024**

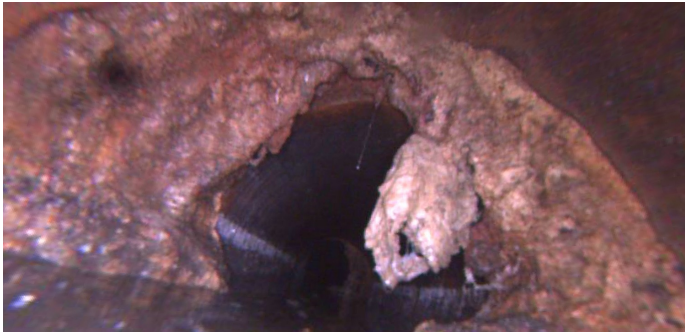
Code:	MWL
Description:	Water Level

Distance (ft):	.0
Structural Grade:	0
O&M Grade:	0
Clock Start/From:	
Clock To:	
1st Value:	
2nd Value:	
Value Percent:	30.000
Continuous Index:	
Within 8" of Joint:	NO
Remarks:

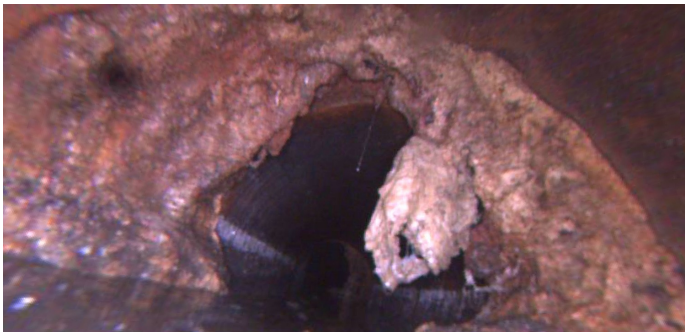
Code:	DAE
Description:	Deposits Attached Encrustation

Distance (ft):	.0
Structural Grade:	0
O&M Grade:	4
Clock Start/From:	8
Clock To:	4
1st Value:	
2nd Value:	
Value Percent:	30.000
Continuous Index:	
Within 8" of Joint:	YES
Remarks:

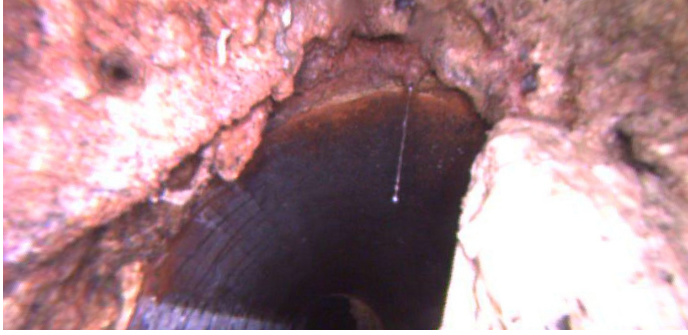
Code:	MSA
Description:	Abandoned Survey
Distance (ft):	1.5
Structural Grade:	0
O&M Grade:	0
Clock Start/From:	
Clock To:	
1st Value:	
2nd Value:	
Value Percent:	
Continuous Index:	
Within 8" of Joint:	NO
Remarks:	dae
