Profile/Photo Observation Report

Date:	03/29/2018	Weather:		Coding:	PACP 6.0
Pipe Length (ft):	235.0	Owner:	NA	Pre Clean:	No Pre-Cleaning
P.O.#:		Surveyor:	Jen Costello	PSR:	P-507-024-023
Customer:		Clean Date:	01/01/1900	Shape:	C

Street:	FOXCROFT STREET	Flow Control:	Not Controlled
City:	Hobart, IN	Year Renewed:	
Location:	Yard	Tape/Media #:	
Purpose:	Routine Assessment	Dia/Height:	12"
Use:	Sanitary	Material:	VCP
Drain Area:	NA	Lining:	
Category:	NA		
Comment:	F_S_P_C at 0 ft debris .Flow direction wrong		
Location Details:		Direction of Survey:	Upstream
US MH:	M-507-023	DS MH:	M-507-024
		Total Length Surveyed (ft):	1.5

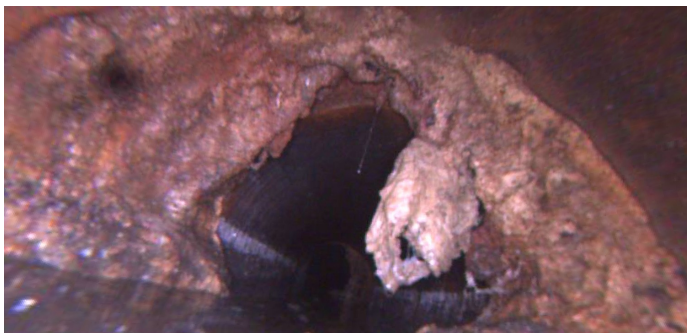
Code: **AMH**
 Description: **Manhole**

Distance (ft): **.0**
 Structural Grade: **0**
 O&M Grade: **0**
 Clock Start/From:
 Clock To:
 1st Value:
 2nd Value:
 Value Percent:
 Continuous Index:
 Within 8" of Joint: **NO**
 Remarks: **M-507-024**

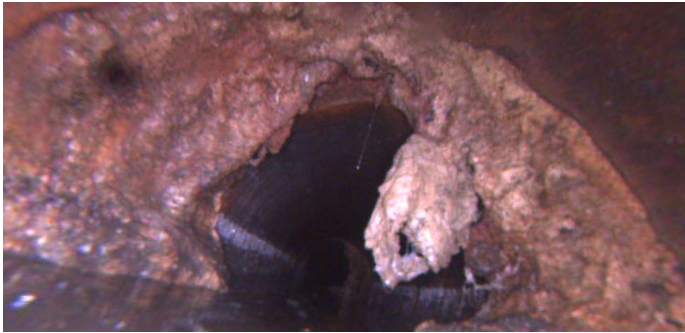
Code:	MWL
Description:	Water Level

Distance (ft):	.0
Structural Grade:	0
O&M Grade:	0
Clock Start/From:	
Clock To:	
1st Value:	
2nd Value:	
Value Percent:	30.000
Continuous Index:	
Within 8" of Joint:	NO
Remarks:

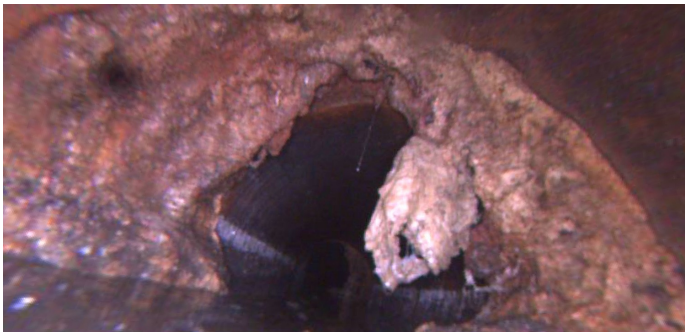
Code:	DAE
Description:	Deposits Attached Encrustation

Distance (ft):	.0
Structural Grade:	0
O&M Grade:	4
Clock Start/From:	8
Clock To:	4
1st Value:	
2nd Value:	
Value Percent:	30.000
Continuous Index:	
Within 8" of Joint:	YES
Remarks:

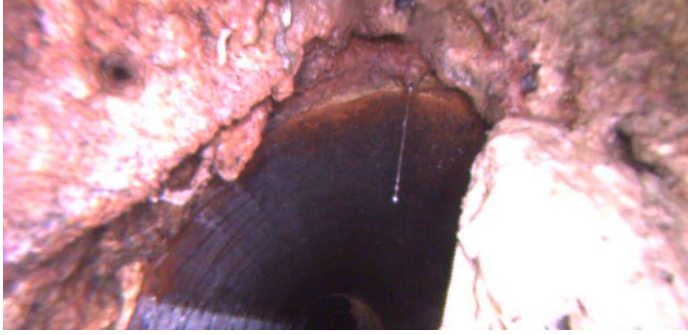
Code:	MSA
Description:	Abandoned Survey
Distance (ft):	1.5
Structural Grade:	0
O&M Grade:	0
Clock Start/From:	
Clock To:	
1st Value:	
2nd Value:	
Value Percent:	
Continuous Index:	
Within 8" of Joint:	NO
Remarks:	dae
