## Profile/Photo Observation Report

Street:	<b>CSOKASY LN</b>	Flow Control:	<b>Not Controlled</b>
City:	<b>Hobart, IN</b>	Year Renewed:	
Location:	<b>Yard</b>	Tape/Media #:	
Purpose:	<b>Routine Assessment</b>	Dia/Height:	<b>12"</b>
Use:	<b>Sanitary</b>	Material:	<b>VCP</b>
Drain Area:	<b>NA</b>	Lining:	
Category:	<b>NA</b>		
Comment:	<b>R_M at 10 ft debris . Flow direction wrong .</b>		
Location Details:		Direction of Survey:	<b>Downstream</b>
US MH:	<b>M-507-023</b>	DS MH:	<b>M-507-024</b>
		Total Length Surveyed (ft):	<b>11.6</b>

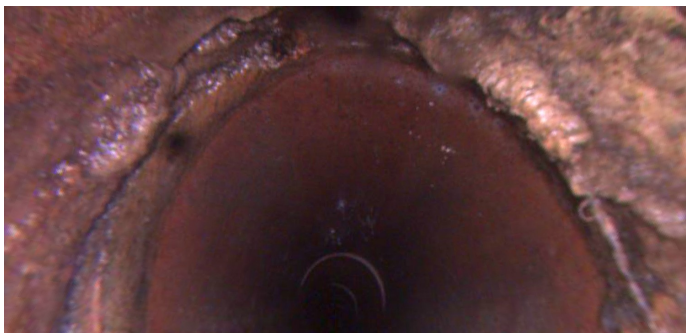
Code: **AMH**  
Description: **Manhole**

Distance (ft): **.0**  
Structural Grade: **0**  
O&M Grade: **0**  
Clock Start/From:  
Clock To:  
1st Value:  
2nd Value:  
Value Percent:  
Continuous Index:  
Within 8" of Joint: **NO**  
Remarks: **M-507-023**

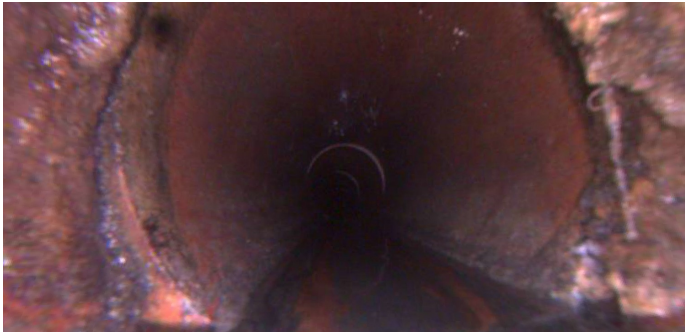
Code:	<b>MWL</b>
Description:	<b>Water Level</b>

Distance (ft):	<b>.0</b>
Structural Grade:	<b>0</b>
O&M Grade:	<b>0</b>
Clock Start/From:	
Clock To:	
1st Value:	
2nd Value:	
Value Percent:	<b>5.000</b>
Continuous Index:	
Within 8" of Joint:	<b>NO</b>
Remarks:

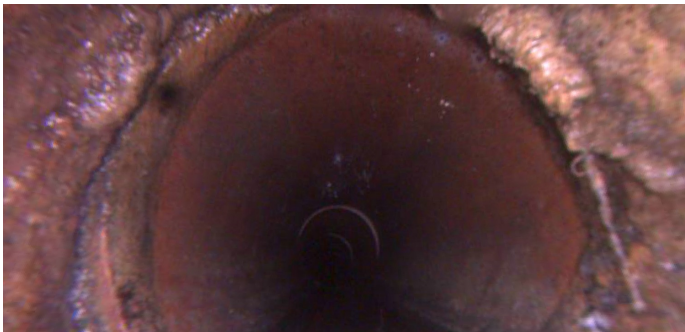
Code:	<b>DAE</b>
Description:	<b>Deposits Attached Encrustation</b>

Distance (ft):	<b>.0</b>
Structural Grade:	<b>0</b>
O&M Grade:	<b>2</b>
Clock Start/From:	<b>8</b>
Clock To:	<b>4</b>
1st Value:	
2nd Value:	
Value Percent:	<b>5.000</b>
Continuous Index:	
Within 8" of Joint:	<b>YES</b>
Remarks:

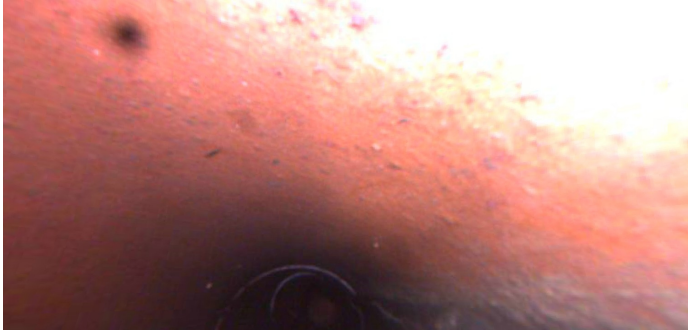
Code:	<b>MSA</b>
Description:	<b>Abandoned Survey</b>
Distance (ft):	<b>11.6</b>
Structural Grade:	<b>0</b>
O&M Grade:	<b>0</b>
Clock Start/From:	
Clock To:	
1st Value:	
2nd Value:	
Value Percent:	
Continuous Index:	
Within 8" of Joint:	<b>NO</b>
Remarks:	<b>DEBRIS UNDER WATER</b>
