Profile/Photo Observation Report

Date:	03/29/2018	Weather:		Coding:	PACP 6.0
Pipe Length (ft):	235.0	Owner:	NA	Pre Clean:	No Pre-Cleaning
P.O.#:		Surveyor:	Jen Costello	PSR:	P-507-024-023
Customer:		Clean Date:	01/01/1900	Shape:	C

Street:	FOXCROFT STREET	Flow Control:	Not Controlled
City:	Hobart, IN	Year Renewed:	
Location:	Yard	Tape/Media #:	
Purpose:	Routine Assessment	Dia/Height:	12"
Use:	Sanitary	Material:	VCP
Drain Area:	NA	Lining:	
Category:	NA		
Comment:	R_M at 10 ft debris . Flow direction wrong .		
Location Details:		Direction of Survey:	Downstream
US MH:	M-507-023	DS MH:	M-507-024
		Total Length Surveyed (ft):	11.6

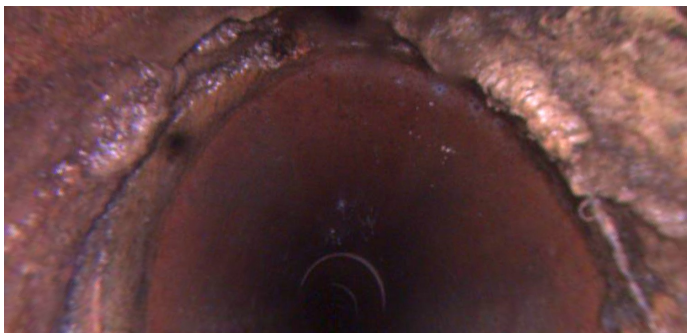
Code: **AMH**
Description: **Manhole**

Distance (ft): **.0**
Structural Grade: **0**
O&M Grade: **0**
Clock Start/From:
Clock To:
1st Value:
2nd Value:
Value Percent:
Continuous Index:
Within 8" of Joint: **NO**
Remarks: **M-507-023**

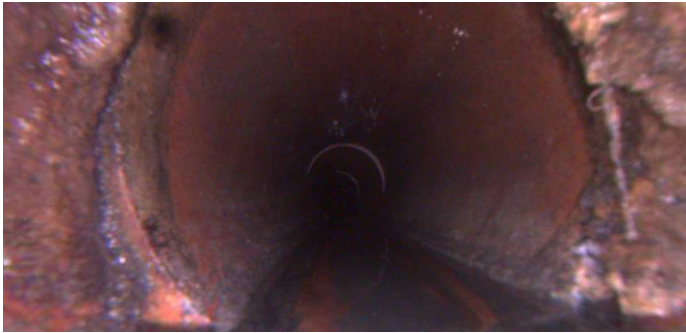
Code:	MWL
Description:	Water Level

Distance (ft):	.0
Structural Grade:	0
O&M Grade:	0
Clock Start/From:	
Clock To:	
1st Value:	
2nd Value:	
Value Percent:	5.000
Continuous Index:	
Within 8" of Joint:	NO
Remarks:

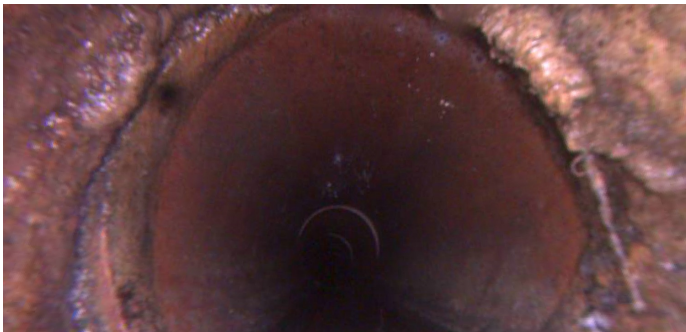
Code:	DAE
Description:	Deposits Attached Encrustation

Distance (ft):	.0
Structural Grade:	0
O&M Grade:	2
Clock Start/From:	8
Clock To:	4
1st Value:	
2nd Value:	
Value Percent:	5.000
Continuous Index:	
Within 8" of Joint:	YES
Remarks:

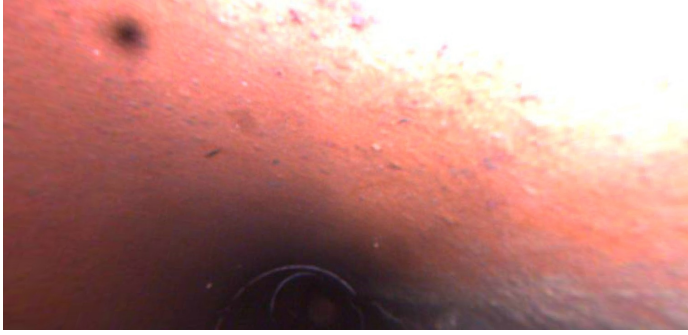
Code:	MSA
Description:	Abandoned Survey
Distance (ft):	11.6
Structural Grade:	0
O&M Grade:	0
Clock Start/From:	
Clock To:	
1st Value:	
2nd Value:	
Value Percent:	
Continuous Index:	
Within 8" of Joint:	NO
Remarks:	DEBRIS UNDER WATER
