Profile/Photo Observation Report

| Street: | CSOKASY LN | Flow Control: | Not Controlled |
| City: | Hobart, IN | Year Renewed: | |
| US MH: | M-507-023 | DS MH: | M-507-024 |

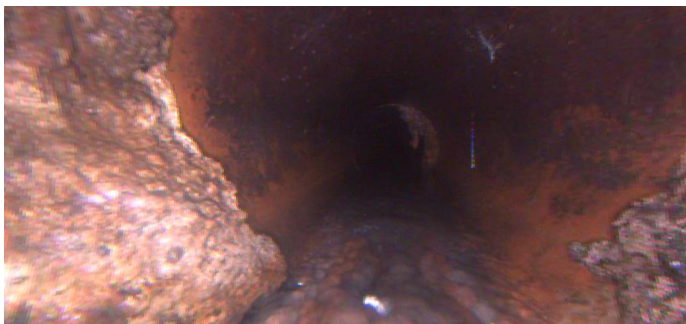
Code: **AMH**
Description: **Manhole**

Distance (ft): **.0**
Structural Grade: **0**
O&M Grade: **0**
Clock Start/From:
Clock To:
1st Value:
2nd Value:
Value Percent:
Continuous Index:
Within 8" of Joint: **NO**
Remarks: **M-507-024**

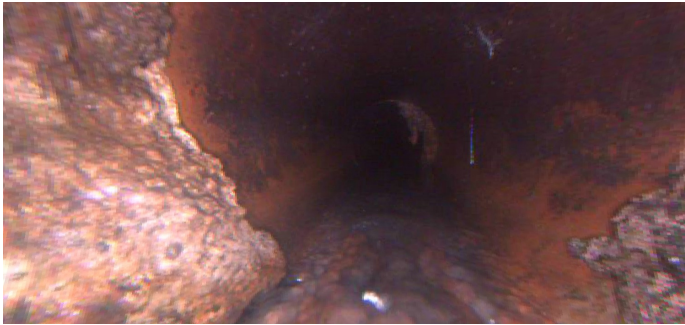
| Code: | MWL |
| Description: | Water Level |

| Distance (ft): | .0 |
| Value Percent: | 5.000 |

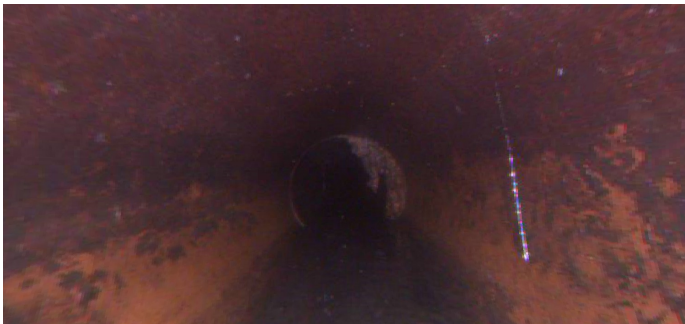
| Code: | MSA |
| Description: | Abandoned Survey |

| Distance (ft): | 2.7 |
| Remarks: | camera stoppe |
