## Profile/Photo Observation Report

Date:	<b>03/29/2018</b>	Weather:		Coding:	<b>PACP 6.0</b>
Pipe Length (ft):	<b>164.1</b>	Owner:	<b>NA</b>	Pre Clean:	<b>No Pre-Cleaning</b>
P.O.#:		Surveyor:	<b>Jen Costello</b>	PSR:	<b>P-507-036-023</b>
Customer:		Clean Date:	<b>01/01/1900</b>	Shape:	<b>C</b>

Street:	<b>CSOKASY LN &amp; S DEKALB ST</b>	Flow Control:	<b>Not Controlled</b>
City:	<b>Hobart, IN</b>	Year Renewed:	
Location:	<b>Yard</b>	Tape/Media #:	
Purpose:	<b>Routine Assessment</b>	Dia/Height:	<b>8"</b>
Use:	<b>Sanitary</b>	Material:	<b>VCP</b>
Drain Area:	<b>NA</b>	Lining:	
Category:	<b>NA</b>		
Comment:	<b>P_C at 132 ft nothing visible . Flow direction wrong</b>		
Location Details:		Direction of Survey:	<b>Upstream</b>
US MH:	<b>M-507-023</b>	DS MH:	<b>M-507-036</b>
		Total Length Surveyed (ft):	<b>134.0</b>

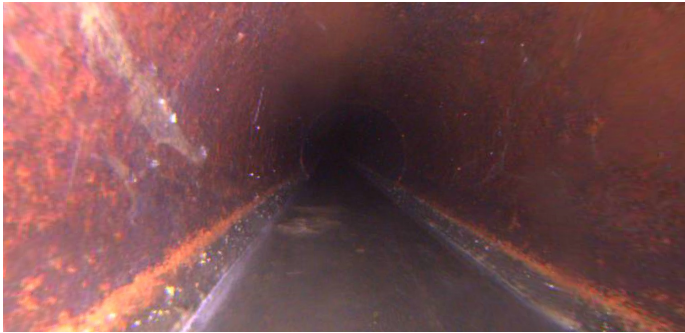
Code:	<b>MWL</b>
Description:	<b>Water Level</b>

Distance (ft):	<b>.0</b>
Structural Grade:	<b>0</b>
O&M Grade:	<b>0</b>
Clock Start/From:	
Clock To:	
1st Value:	
2nd Value:	
Value Percent:	<b>10.000</b>
Continuous Index:	
Within 8" of Joint:	<b>NO</b>
Remarks:

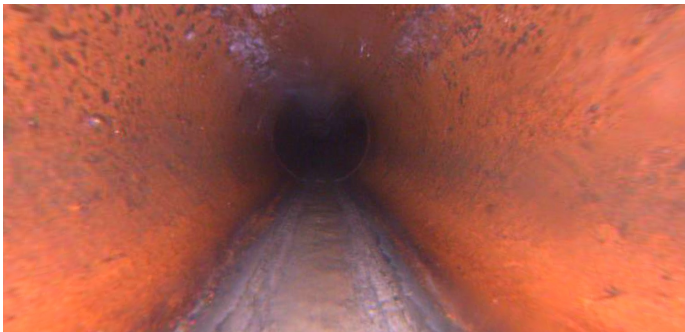
Code:	<b>MWL</b>
Description:	<b>Water Level</b>

Distance (ft):	<b>46.4</b>
Structural Grade:	<b>0</b>
O&M Grade:	<b>0</b>
Clock Start/From:	
Clock To:	
1st Value:	
2nd Value:	
Value Percent:	<b>5.000</b>
Continuous Index:	
Within 8" of Joint:	<b>NO</b>
Remarks:

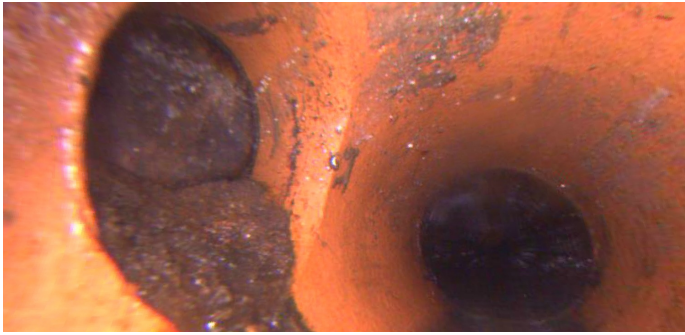
Code: **TFC**  
Description: **Tap Factory Capped**

Distance (ft): **84.6**  
Structural Grade: **0**  
O&M Grade: **0**  
Clock Start/From: **9**  
Clock To:  
1st Value: **4.000**  
2nd Value:  
Value Percent:  
Continuous Index:  
Within 8" of Joint:  
Remarks:

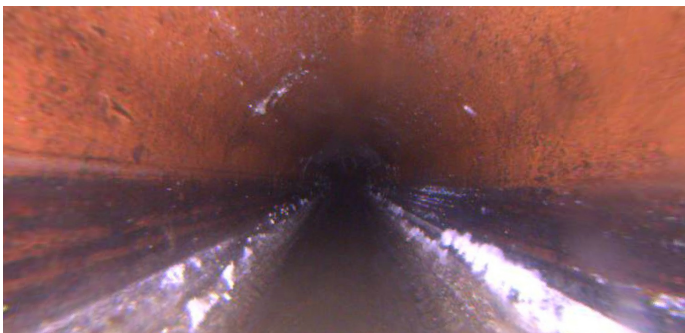
Code: **DAGS**  
Description: **Deposits Attached Grease**

Distance (ft): **91.9**  
Structural Grade: **0**  
O&M Grade: **2**  
Clock Start/From: **7**  
Clock To: **5**  
1st Value:  
2nd Value:  
Value Percent: **5.000**  
Continuous Index: **S01**  
Within 8" of Joint: **NO**  
Remarks:

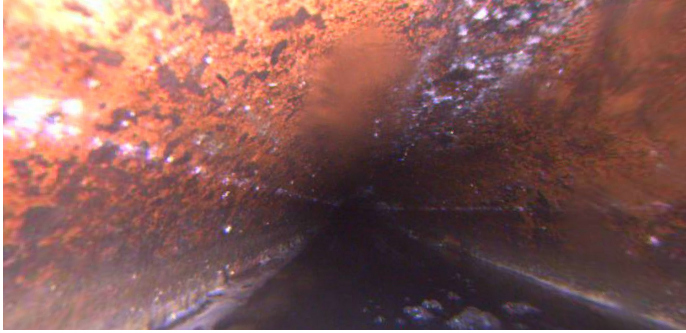
Code: **MSA**  
Description: **Abandoned Survey**

Distance (ft): **134.0**  
Structural Grade: **0**  
O&M Grade: **0**  
Clock Start/From:  
Clock To:  
1st Value:  
2nd Value:  
Value Percent:  
Continuous Index:  
Within 8" of Joint: **NO**  
Remarks: **debris under water**

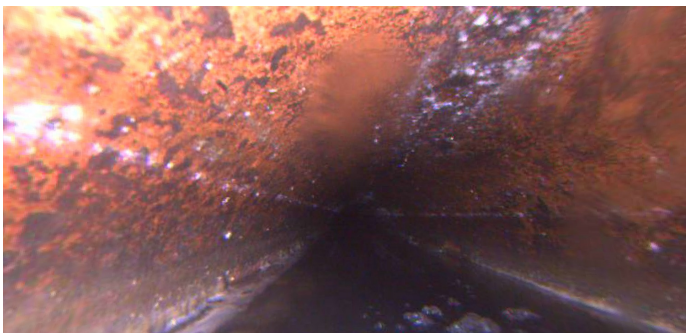
Code: **DAGS**  
Description: **Deposits Attached Grease**

Distance (ft): **134.0**  
Structural Grade: **0**  
O&M Grade: **2**  
Clock Start/From: **7**  
Clock To: **5**  
1st Value:  
2nd Value:  
Value Percent: **5.000**  
Continuous Index: **F01**  
Within 8" of Joint: **NO**  
Remarks:
