Profile/Photo Observation Report

Date:	03/29/2018	Weather:		Coding:	PACP 6.0
Pipe Length (ft):	164.1	Owner:	NA	Pre Clean:	No Pre-Cleaning
P.O.#:		Surveyor:	Jen Costello	PSR:	P-507-036-023
Customer:		Clean Date:	01/01/1900	Shape:	C

Street:	FOXCROFT STREET	Flow Control:	Not Controlled
City:	Hobart, IN	Year Renewed:	
Location:	Yard	Tape/Media #:	
Purpose:	Routine Assessment	Dia/Height:	8"
Use:	Sanitary	Material:	VCP
Drain Area:	NA	Lining:	
Category:	NA		
Comment:	P_C at 132 ft nothing visible . Flow direction wrong		
Location Details:		Direction of Survey:	Upstream
US MH:	M-507-023	DS MH:	M-507-036
		Total Length Surveyed (ft):	134.0

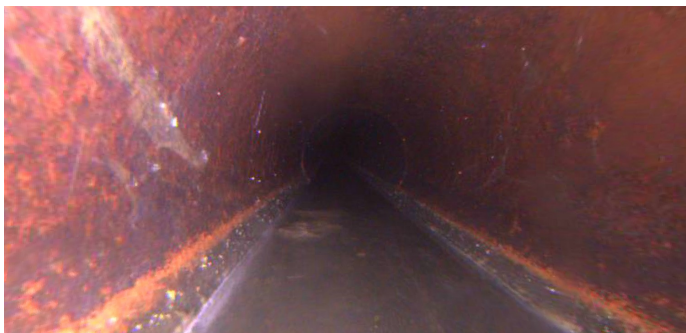
Code: **AMH**
Description: **Manhole**

Distance (ft): **.0**
Structural Grade: **0**
O&M Grade: **0**
Clock Start/From:
Clock To:
1st Value:
2nd Value:
Value Percent:
Continuous Index:
Within 8" of Joint: **NO**
Remarks: **M-507-036**

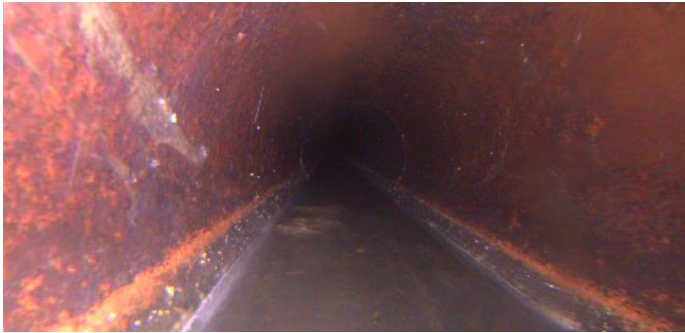
Code:	MWL
Description:	Water Level

Distance (ft):	.0
Structural Grade:	0
O&M Grade:	0
Clock Start/From:	
Clock To:	
1st Value:	
2nd Value:	
Value Percent:	10.000
Continuous Index:	
Within 8" of Joint:	NO
Remarks:

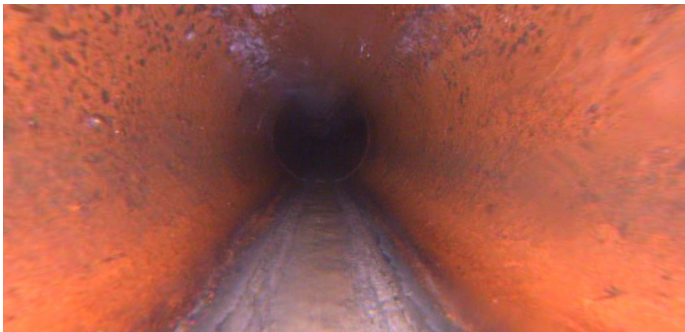
Code:	MWL
Description:	Water Level

Distance (ft):	46.4
Structural Grade:	0
O&M Grade:	0
Clock Start/From:	
Clock To:	
1st Value:	
2nd Value:	
Value Percent:	5.000
Continuous Index:	
Within 8" of Joint:	NO
Remarks:

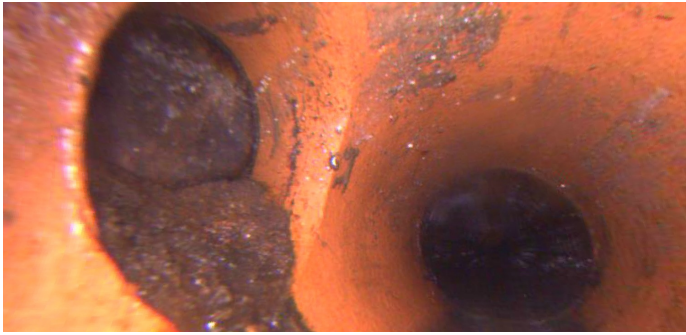
Code: **TFC**
Description: **Tap Factory Capped**

Distance (ft): **84.6**
Structural Grade: **0**
O&M Grade: **0**
Clock Start/From: **9**
Clock To:
1st Value: **4.000**
2nd Value:
Value Percent:
Continuous Index:
Within 8" of Joint:
Remarks:

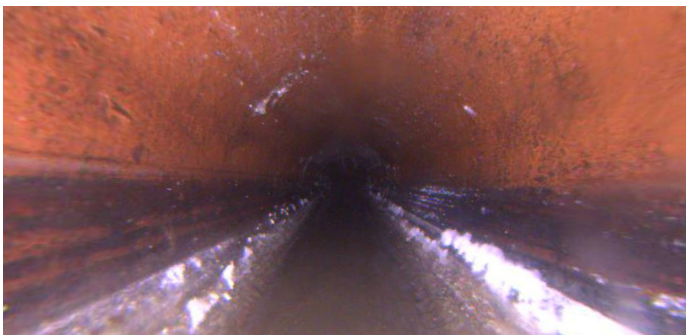
Code: **DAGS**
Description: **Deposits Attached Grease**

Distance (ft): **91.9**
Structural Grade: **0**
O&M Grade: **2**
Clock Start/From: **7**
Clock To: **5**
1st Value:
2nd Value:
Value Percent: **5.000**
Continuous Index: **S01**
Within 8" of Joint: **NO**
Remarks:

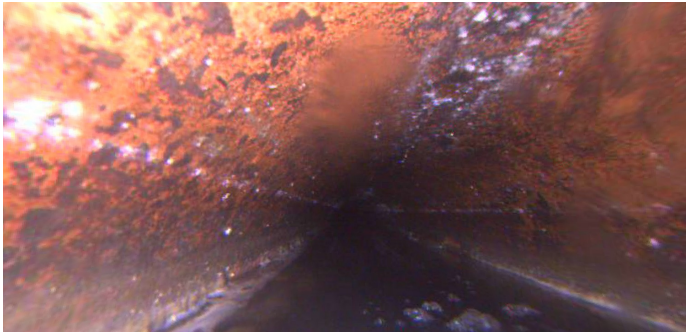
Code: **MSA**
Description: **Abandoned Survey**

Distance (ft): **134.0**
Structural Grade: **0**
O&M Grade: **0**
Clock Start/From:
Clock To:
1st Value:
2nd Value:
Value Percent:
Continuous Index:
Within 8" of Joint: **NO**
Remarks: **debris under water**

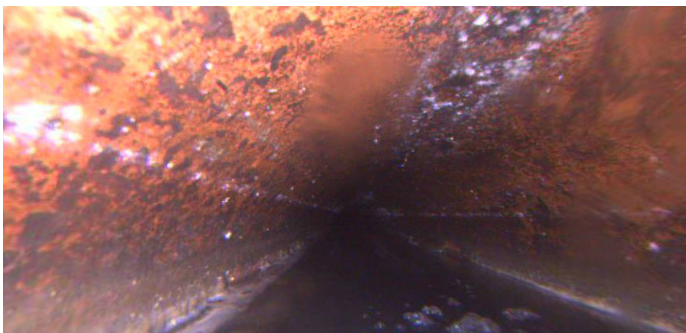
Code: **DAGS**
Description: **Deposits Attached Grease**

Distance (ft): **134.0**
Structural Grade: **0**
O&M Grade: **2**
Clock Start/From: **7**
Clock To: **5**
1st Value:
2nd Value:
Value Percent: **5.000**
Continuous Index: **F01**
Within 8" of Joint: **NO**
Remarks:
