## Profile/Photo Observation Report

Street:	<b>CSOKASY LN &amp; S DEKALB ST</b>	Flow Control:	<b>Not Controlled</b>
City:	<b>Hobart, IN</b>	Year Renewed:	
Location:	<b>Light Highway</b>	Tape/Media #:	
Purpose:	<b>Routine Assessment</b>	Dia/Height:	<b>10"</b>
Use:	<b>Sanitary</b>	Material:	<b>VCP</b>
Drain Area:	<b>NA</b>	Lining:	
Category:	<b>NA</b>		
Comment:

Location Details:		Direction of Survey:	<b>Downstream</b>
US MH:	<b>M-507-023</b>	DS MH:	<b>M-507-036</b>
		Total Length Surveyed (ft):	<b>2.6</b>

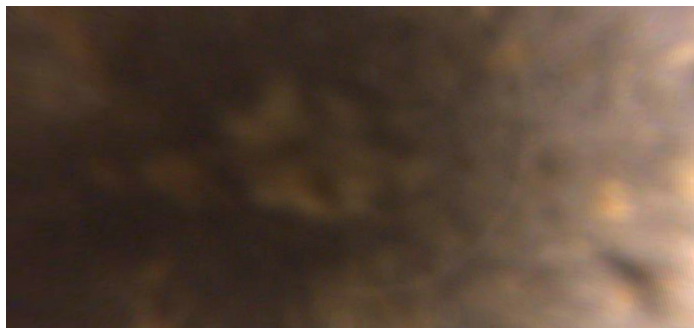
Code: **AMH**  
Description: **Manhole**

Distance (ft): **.0**  
Structural Grade: **0**  
O&M Grade: **0**  
Clock Start/From:  
Clock To:  
1st Value:  
2nd Value:  
Value Percent:  
Continuous Index:  
Within 8" of Joint: **NO**  
Remarks: **M-507-023**

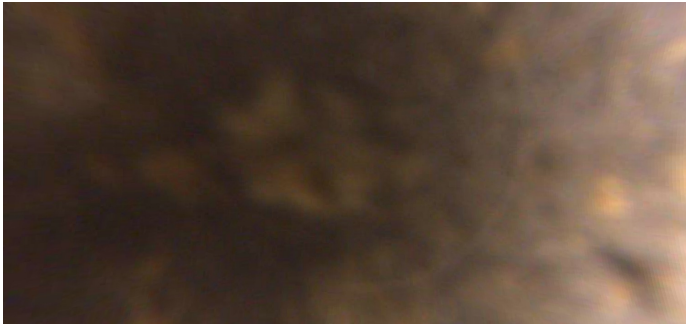
Code:	<b>MWL</b>
Description:	<b>Water Level</b>

Distance (ft):	<b>.0</b>
Structural Grade:	<b>0</b>
O&M Grade:	<b>0</b>
Clock Start/From:	
Clock To:	
1st Value:	
2nd Value:	
Value Percent:	<b>5.000</b>
Continuous Index:	
Within 8" of Joint:	<b>NO</b>
Remarks:
