## Profile/Photo Observation Report

Date:	<b>10/09/2018</b>	Weather:		Coding:	<b>PACP 6.0</b>
Pipe Length (ft):	<b>164.1</b>	Owner:	<b>NA</b>	Pre Clean:	<b>Not Known</b>
P.O.#:		Surveyor:	<b>Selasie Honu</b>	PSR:	<b>P-507-036-023</b>
Customer:		Clean Date:	<b>01/01/1900</b>	Shape:	<b>C</b>

Street:	<b>Csokasy Ln.</b>	Flow Control:	<b>Not Controlled</b>
City:	<b>Hobart, IN</b>	Year Renewed:	
Location:	<b>Light Highway</b>	Tape/Media #:	
Purpose:	<b>Routine Assessment</b>	Dia/Height:	<b>10"</b>
Use:	<b>Sanitary</b>	Material:	<b>VCP</b>
Drain Area:	<b>NA</b>	Lining:	
Category:	<b>NA</b>		
Comment:

Location Details:		Direction of Survey:	<b>Downstream</b>
US MH:	<b>M-507-023</b>	DS MH:	<b>M-507-036</b>
		Total Length Surveyed (ft):	<b>2.6</b>

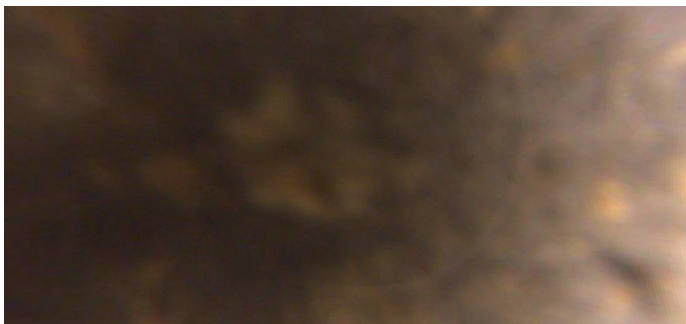
Code: **AMH**  
Description: **Manhole**

Distance (ft): **.0**  
Structural Grade: **0**  
O&M Grade: **0**  
Clock Start/From:  
Clock To:  
1st Value:  
2nd Value:  
Value Percent:  
Continuous Index:  
Within 8" of Joint: **NO**  
Remarks: **M-507-023**

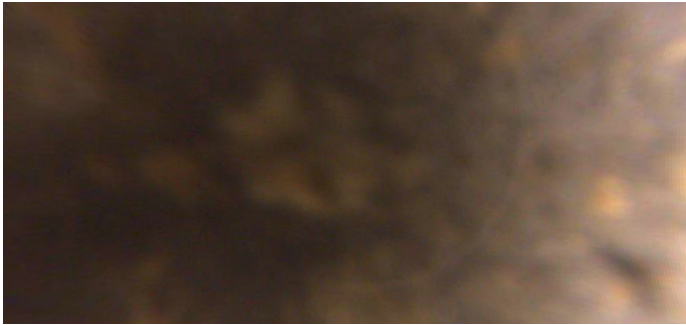
Code:	<b>MWL</b>
Description:	<b>Water Level</b>

Distance (ft):	<b>.0</b>
Structural Grade:	<b>0</b>
O&M Grade:	<b>0</b>
Clock Start/From:	
Clock To:	
1st Value:	
2nd Value:	
Value Percent:	<b>5.000</b>
Continuous Index:	
Within 8" of Joint:	<b>NO</b>
Remarks:
