## Profile/Photo Observation Report

Street:	<b>CSOKASY LN &amp; S DEKALB ST</b>	Flow Control:	<b>Not Controlled</b>
City:	<b>Hobart, IN</b>	Year Renewed:	
Location:	<b>Light Highway</b>	Tape/Media #:	
Purpose:	<b>Routine Assessment</b>	Dia/Height:	<b>10"</b>
Use:	<b>Sanitary</b>	Material:	<b>VCP</b>
Drain Area:	<b>NA</b>	Lining:	
Category:	<b>NA</b>		
Comment:

Location Details:		Direction of Survey:	<b>Upstream</b>
US MH:	<b>M-507-023</b>	DS MH:	<b>M-507-036</b>
		Total Length Surveyed (ft):	<b>136.2</b>

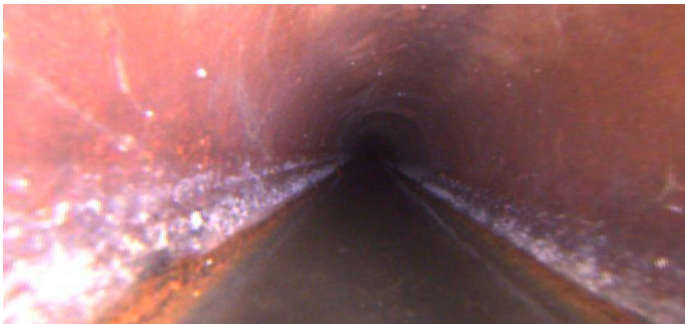
Code: **AMH**  
Description: **Manhole**

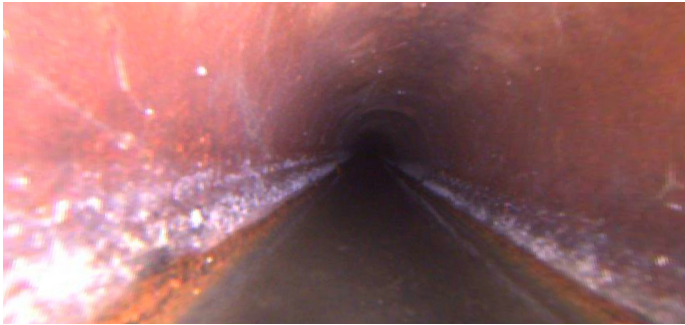
Code:	<b>MWL</b>
Description:	<b>Water Level</b>

Distance (ft):	<b>.0</b>
Structural Grade:	<b>0</b>
O&M Grade:	<b>0</b>
Clock Start/From:	
Clock To:	
1st Value:	
2nd Value:	
Value Percent:	<b>5.000</b>
Continuous Index:	
Within 8" of Joint:	<b>NO</b>
Remarks:

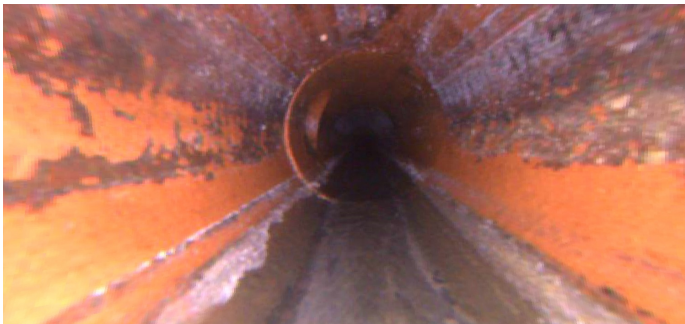
Code:	<b>TF</b>
Description:	<b>Tap Factory</b>

Distance (ft):	<b>83.2</b>
Structural Grade:	<b>0</b>
O&M Grade:	<b>0</b>
Clock Start/From:	<b>9</b>
Clock To:	
1st Value:	<b>4.000</b>
2nd Value:	
Value Percent:	
Continuous Index:	
Within 8" of Joint:	
Remarks:

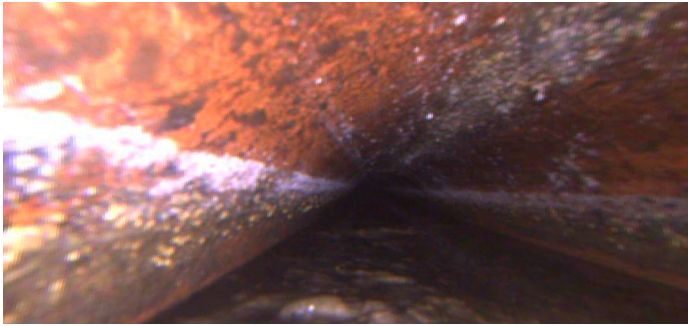
Code:	<b>MSA</b>
Description:	<b>Abandoned Survey</b>
Distance (ft):	<b>136.2</b>
Structural Grade:	<b>0</b>
O&M Grade:	<b>0</b>
Clock Start/From:	
Clock To:	
1st Value:	
2nd Value:	
Value Percent:	
Continuous Index:	
Within 8" of Joint:	<b>NO</b>
Remarks:	<b>camera stopped</b>
