## Profile/Photo Observation Report

Date:	<b>10/09/2018</b>	Weather:		Coding:	<b>PACP 6.0</b>
Pipe Length (ft):	<b>164.1</b>	Owner:	<b>NA</b>	Pre Clean:	<b>Not Known</b>
P.O.#:		Surveyor:	<b>Selasie Honu</b>	PSR:	<b>P-507-036-023</b>
Customer:		Clean Date:	<b>01/01/1900</b>	Shape:	<b>C</b>

Street:	<b>Csokasy Ln.</b>	Flow Control:	<b>Not Controlled</b>
City:	<b>Hobart, IN</b>	Year Renewed:	
Location:	<b>Light Highway</b>	Tape/Media #:	
Purpose:	<b>Routine Assessment</b>	Dia/Height:	<b>10"</b>
Use:	<b>Sanitary</b>	Material:	<b>VCP</b>
Drain Area:	<b>NA</b>	Lining:	
Category:	<b>NA</b>		
Comment:

Location Details:		Direction of Survey:	<b>Upstream</b>
US MH:	<b>M-507-023</b>	DS MH:	<b>M-507-036</b>
		Total Length Surveyed (ft):	<b>136.2</b>

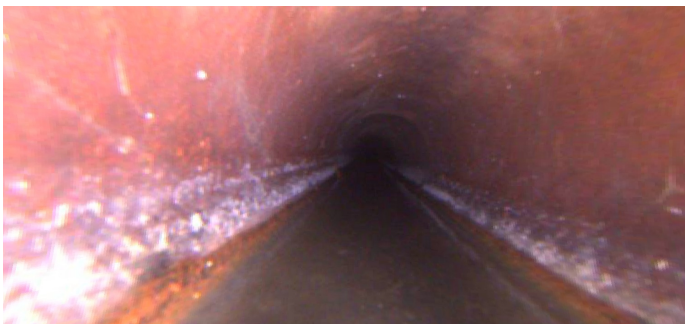
Code: **AMH**  
Description: **Manhole**

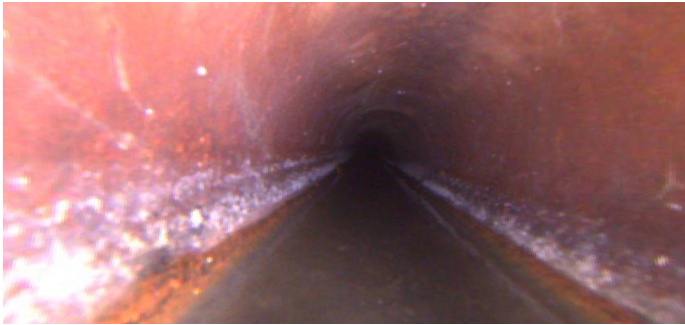
Code:	<b>MWL</b>
Description:	<b>Water Level</b>

Distance (ft):	<b>.0</b>
Structural Grade:	<b>0</b>
O&M Grade:	<b>0</b>
Clock Start/From:	
Clock To:	
1st Value:	
2nd Value:	
Value Percent:	<b>5.000</b>
Continuous Index:	
Within 8" of Joint:	<b>NO</b>
Remarks:

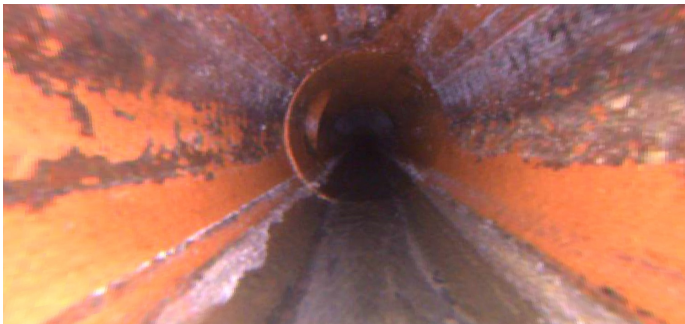
Code:	<b>TF</b>
Description:	<b>Tap Factory</b>

Distance (ft):	<b>83.2</b>
Structural Grade:	<b>0</b>
O&M Grade:	<b>0</b>
Clock Start/From:	<b>9</b>
Clock To:	
1st Value:	<b>4.000</b>
2nd Value:	
Value Percent:	
Continuous Index:	
Within 8" of Joint:	
Remarks:

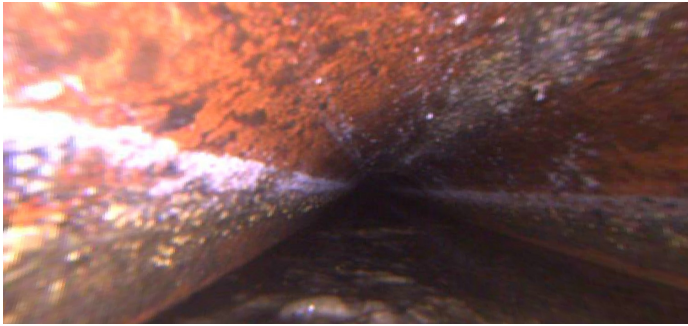
Code:	<b>MSA</b>
Description:	<b>Abandoned Survey</b>
Distance (ft):	<b>136.2</b>
Structural Grade:	<b>0</b>
O&M Grade:	<b>0</b>
Clock Start/From:	
Clock To:	
1st Value:	
2nd Value:	
Value Percent:	
Continuous Index:	
Within 8" of Joint:	<b>NO</b>
Remarks:	<b>camera stopped</b>
