Profile/Photo Observation Report

Date:	03/29/2018	Weather:		Coding:	PACP 6.0
Pipe Length (ft):	223.1	Owner:	NA	Pre Clean:	No Pre-Cleaning
P.O.#:		Surveyor:	Jen Costello	PSR:	P-507-025-024
Customer:		Clean Date:	01/01/1900	Shape:	C

Street:	FOXCROFT STREET	Flow Control:	Not Controlled
City:	Hobart, IN	Year Renewed:	
Location:	Yard	Tape/Media #:	
Purpose:	Routine Assessment	Dia/Height:	12"
Use:	Sanitary	Material:	VCP
Drain Area:	NA	Lining:	
Category:	NA		
Comment:	.P_C at 212 ft nothing visible . Flow direction wrong		
Location Details:		Direction of Survey:	Downstream
US MH:	M-507-024	DS MH:	M-507-025
		Total Length Surveyed (ft):	213.8

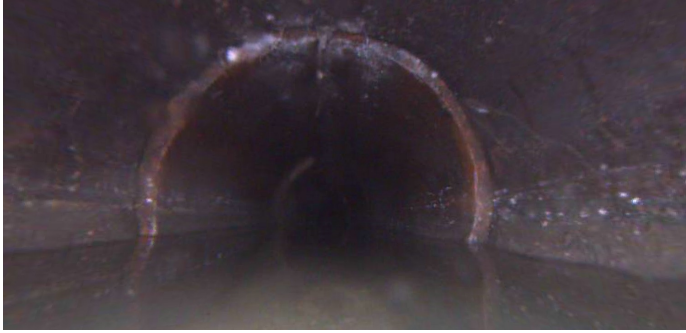
Code: **AMH**
Description: **Manhole**

Distance (ft): **.0**
Structural Grade: **0**
O&M Grade: **0**
Clock Start/From:
Clock To:
1st Value:
2nd Value:
Value Percent:
Continuous Index:
Within 8" of Joint: **NO**
Remarks: **M-507-024**

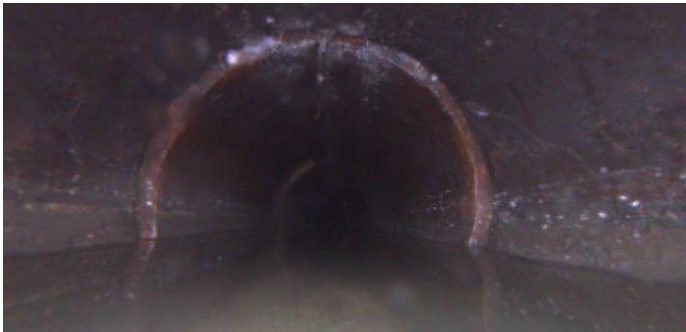
Code: **MWL**
Description: **Water Level**

Distance (ft): **.0**
Structural Grade: **0**
O&M Grade: **0**
Clock Start/From:
Clock To:
1st Value:
2nd Value:
Value Percent: **40.000**
Continuous Index:
Within 8" of Joint: **NO**
Remarks:

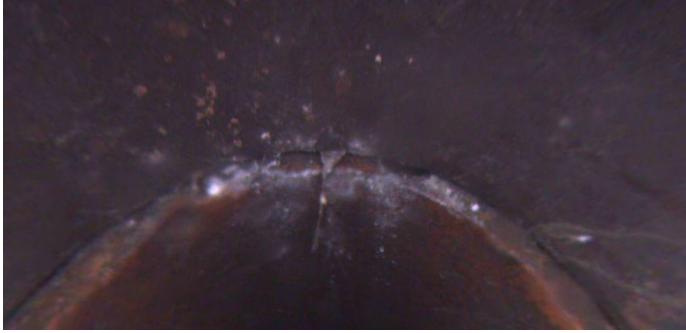
Code: **RFJ**
Description: **Roots Fine Joint**

Distance (ft): **.5**
Structural Grade: **0**
O&M Grade: **1**
Clock Start/From: **8**
Clock To: **4**
1st Value:
2nd Value:
Value Percent:
Continuous Index:
Within 8" of Joint: **YES**
Remarks:

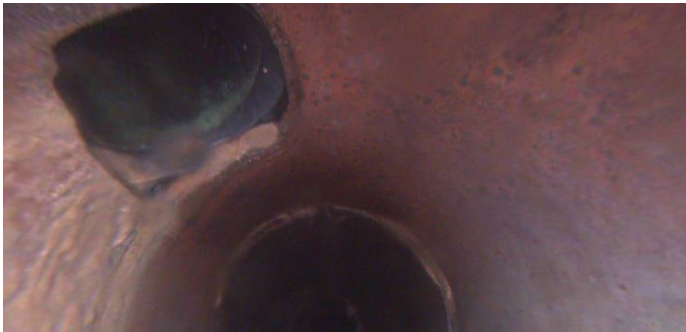
Code: **TB**
Description: **Tap Break-in**

Distance (ft): **3.6**
Structural Grade: **0**
O&M Grade: **0**
Clock Start/From: **10**
Clock To:
1st Value: **4.000**
2nd Value:
Value Percent:
Continuous Index:
Within 8" of Joint:
Remarks:

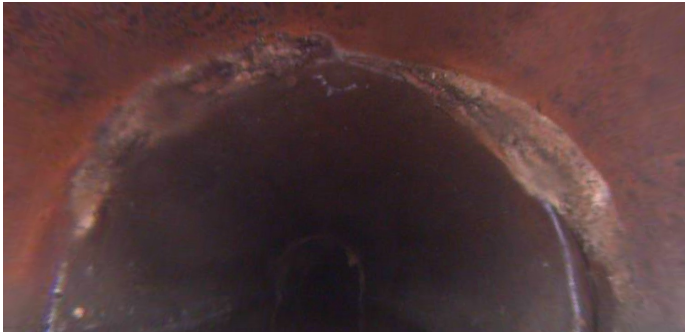
Code: **DAE**
Description: **Deposits Attached Encrustation**

Distance (ft): **4.4**
Structural Grade: **0**
O&M Grade: **2**
Clock Start/From: **8**
Clock To: **4**
1st Value:
2nd Value:
Value Percent: **5.000**
Continuous Index: **S01**
Within 8" of Joint: **YES**
Remarks:

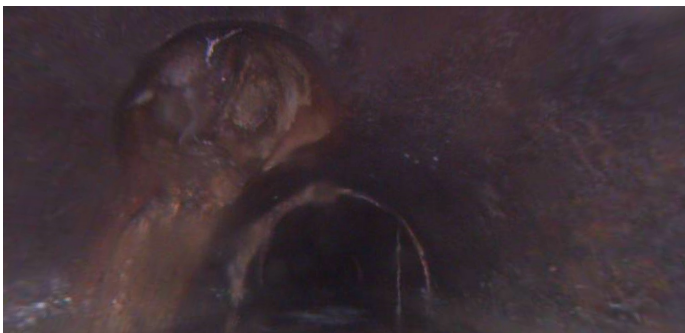
Code: **TFC**
Description: **Tap Factory Capped**

Distance (ft): **9.3**
Structural Grade: **0**
O&M Grade: **0**
Clock Start/From: **10**
Clock To:
1st Value: **4.000**
2nd Value:
Value Percent:
Continuous Index:
Within 8" of Joint:
Remarks:

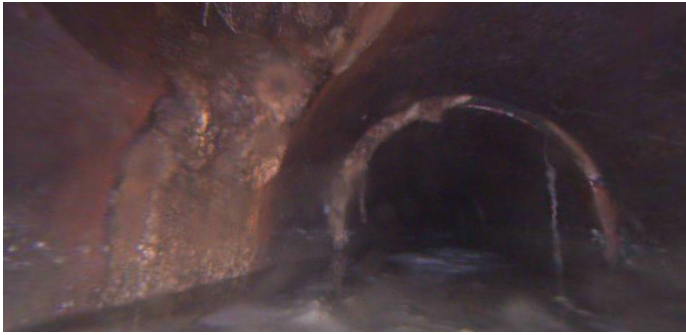
Code: **DAE**
Description: **Deposits Attached Encrustation**

Distance (ft): **9.7**
Structural Grade: **0**
O&M Grade: **2**
Clock Start/From: **9**
Clock To: **10**
1st Value:
2nd Value:
Value Percent: **5.000**
Continuous Index:
Within 8" of Joint: **NO**
Remarks:

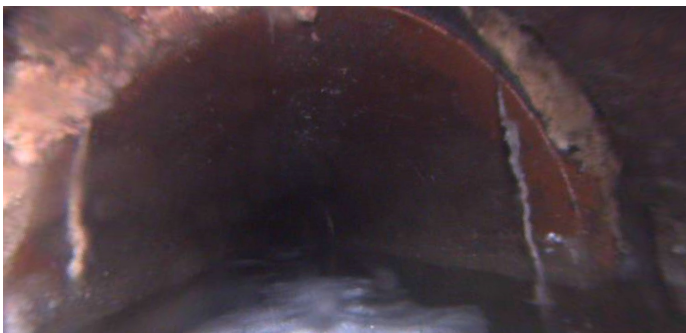
Code: **RFJ**
Description: **Roots Fine Joint**

Distance (ft): **10.4**
Structural Grade: **0**
O&M Grade: **1**
Clock Start/From: **8**
Clock To: **4**
1st Value:
2nd Value:
Value Percent:
Continuous Index: **S02**
Within 8" of Joint: **YES**
Remarks:

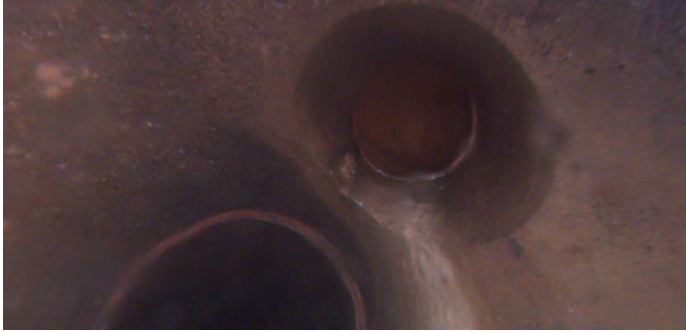
Code: **TF**
Description: **Tap Factory**

Distance (ft): **36.6**
Structural Grade: **0**
O&M Grade: **0**
Clock Start/From: **2**
Clock To:
1st Value: **4.000**
2nd Value:
Value Percent:
Continuous Index:
Within 8" of Joint:
Remarks:

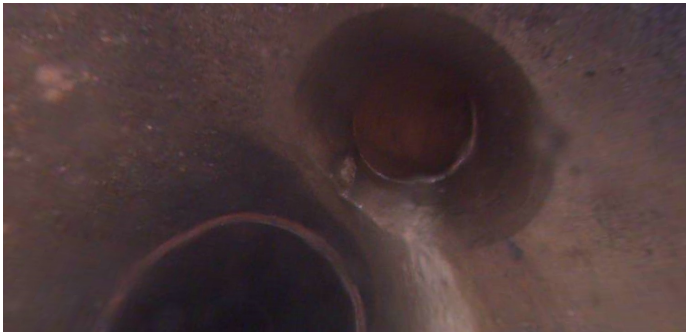
Code: **RFJ**
Description: **Roots Fine Joint**

Distance (ft): **36.6**
Structural Grade: **0**
O&M Grade: **1**
Clock Start/From: **8**
Clock To: **4**
1st Value:
2nd Value:
Value Percent:
Continuous Index: **F02**
Within 8" of Joint: **YES**
Remarks:

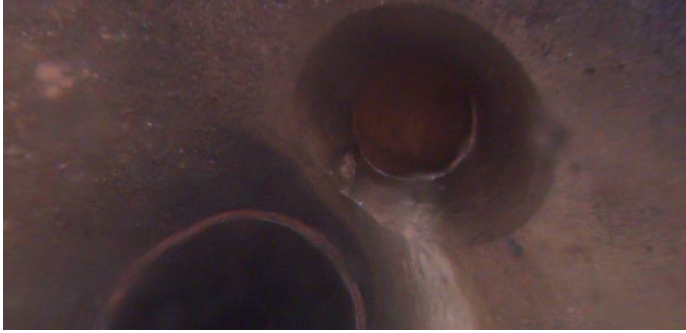
Code: **DAE**
Description: **Deposits Attached Encrustation**

Distance (ft): **36.6**
Structural Grade: **0**
O&M Grade: **2**
Clock Start/From: **8**
Clock To: **4**
1st Value:
2nd Value:
Value Percent: **5.000**
Continuous Index: **F01**
Within 8" of Joint: **YES**
Remarks:

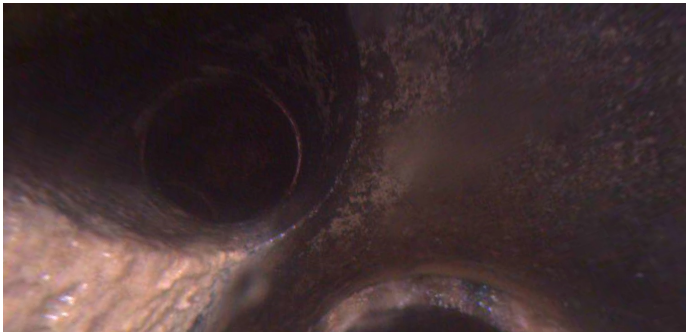
Code: **TFA**
Description: **Tap Factory Active**

Distance (ft): **73.1**
Structural Grade: **0**
O&M Grade: **0**
Clock Start/From: **10**
Clock To:
1st Value: **4.000**
2nd Value:
Value Percent:
Continuous Index:
Within 8" of Joint:
Remarks:

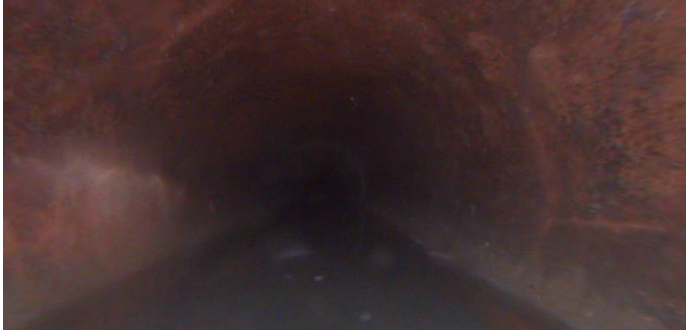
Code: **CM**
Description: **Crack Multiple**

Distance (ft): **92.0**
Structural Grade: **3**
O&M Grade: **0**
Clock Start/From: **8**
Clock To: **4**
1st Value:
2nd Value:
Value Percent:
Continuous Index:
Within 8" of Joint:
Remarks:

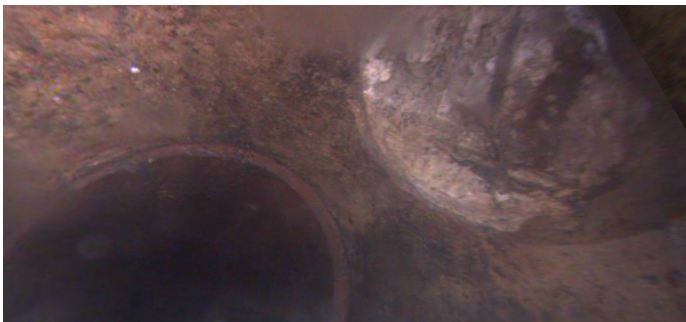
Code: **TFC**
Description: **Tap Factory Capped**

Distance (ft): **97.2**
Structural Grade: **0**
O&M Grade: **0**
Clock Start/From: **2**
Clock To:
1st Value: **4.000**
2nd Value:
Value Percent:
Continuous Index:
Within 8" of Joint:
Remarks:

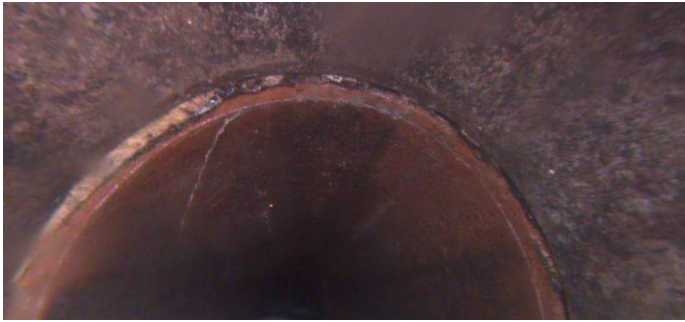
Code: **RFJ**
Description: **Roots Fine Joint**

Distance (ft): **100.6**
Structural Grade: **0**
O&M Grade: **1**
Clock Start/From: **12**
Clock To:
1st Value:
2nd Value:
Value Percent:
Continuous Index:
Within 8" of Joint: **YES**
Remarks:

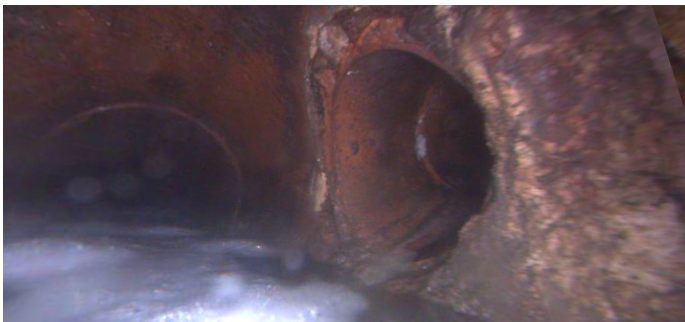
Code: **TBD**
Description: **Tap Break-in Defective**

Distance (ft): **105.5**
Structural Grade: **0**
O&M Grade: **3**
Clock Start/From: **3**
Clock To:
1st Value: **4.000**
2nd Value:
Value Percent:
Continuous Index:
Within 8" of Joint:
Remarks: **dae**

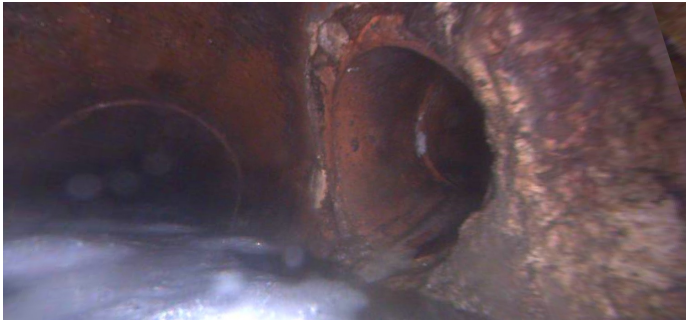
Code: **DAE**
Description: **Deposits Attached Encrustation**

Distance (ft): **105.5**
Structural Grade: **0**
O&M Grade: **2**
Clock Start/From: **1**
Clock To: **4**
1st Value:
2nd Value:
Value Percent: **10.000**
Continuous Index:
Within 8" of Joint: **NO**
Remarks:

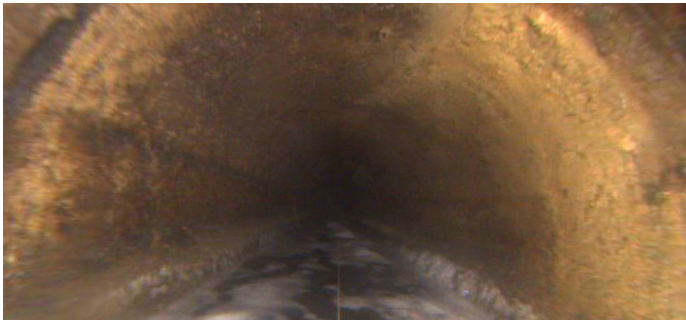
Code: **CM**
Description: **Crack Multiple**

Distance (ft): **140.8**
Structural Grade: **3**
O&M Grade: **0**
Clock Start/From: **8**
Clock To: **4**
1st Value:
2nd Value:
Value Percent:
Continuous Index:
Within 8" of Joint: **YES**
Remarks:

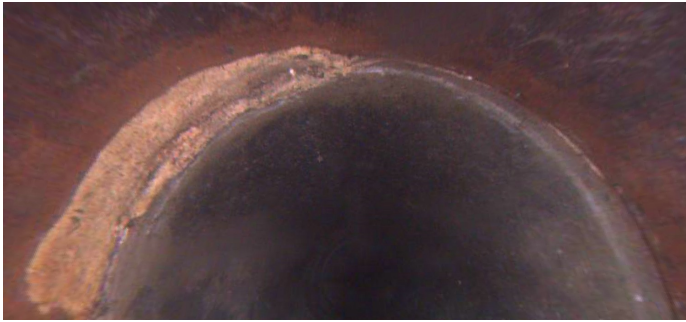
Code: **DAE**
Description: **Deposits Attached Encrustation**

Distance (ft): **148.8**
Structural Grade: **0**
O&M Grade: **2**
Clock Start/From: **9**
Clock To: **12**
1st Value:
2nd Value:
Value Percent: **5.000**
Continuous Index:
Within 8" of Joint: **YES**
Remarks:

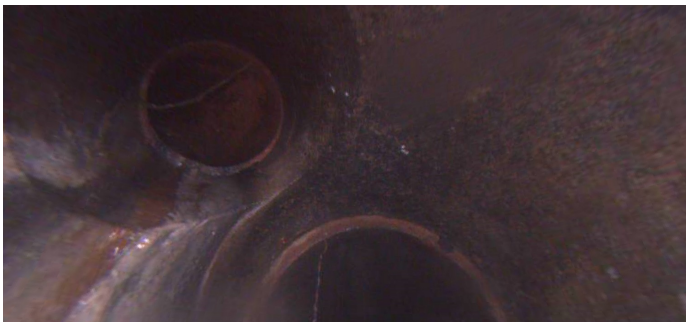
Code: **TF**
Description: **Tap Factory**

Distance (ft): **151.3**
Structural Grade: **0**
O&M Grade: **0**
Clock Start/From: **11**
Clock To:
1st Value: **4.000**
2nd Value:
Value Percent:
Continuous Index:
Within 8" of Joint:
Remarks:

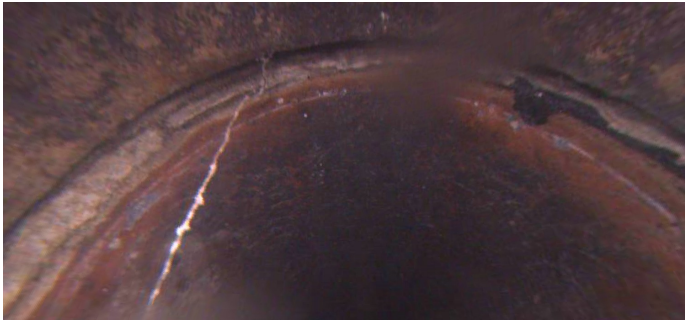
Code: **RFJ**
Description: **Roots Fine Joint**

Distance (ft): **152.1**
Structural Grade: **0**
O&M Grade: **1**
Clock Start/From: **11**
Clock To:
1st Value:
2nd Value:
Value Percent:
Continuous Index:
Within 8" of Joint: **YES**
Remarks:

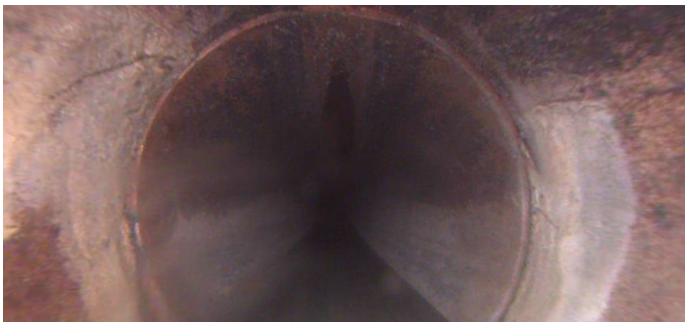
Code: **FM**
Description: **Fracture Multiple**

Distance (ft): **157.9**
Structural Grade: **4**
O&M Grade: **0**
Clock Start/From: **8**
Clock To: **4**
1st Value:
2nd Value:
Value Percent:
Continuous Index:
Within 8" of Joint: **YES**
Remarks:

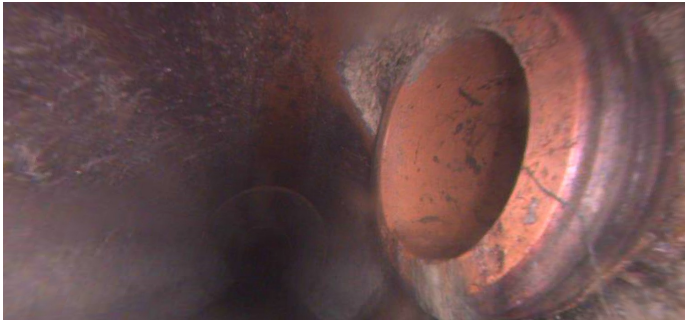
Code: **TBI**
Description: **Tap Break-in Intruding**

Distance (ft): **165.1**
Structural Grade: **0**
O&M Grade: **2**
Clock Start/From: **3**
Clock To:
1st Value: **4.000**
2nd Value: **1.000**
Value Percent:
Continuous Index:
Within 8" of Joint:
Remarks:

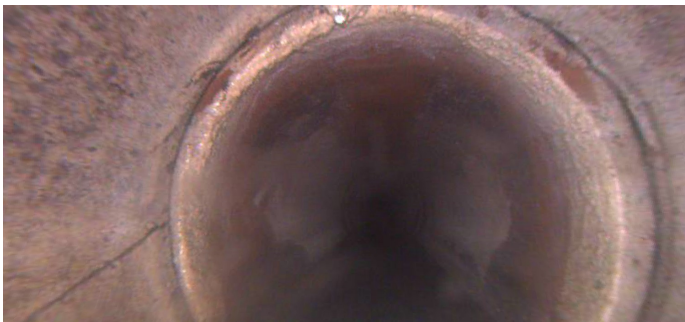
Code: **RFJ**
Description: **Roots Fine Joint**

Distance (ft): **169.9**
Structural Grade: **0**
O&M Grade: **1**
Clock Start/From: **9**
Clock To: **10**
1st Value:
2nd Value:
Value Percent:
Continuous Index:
Within 8" of Joint: **YES**
Remarks:

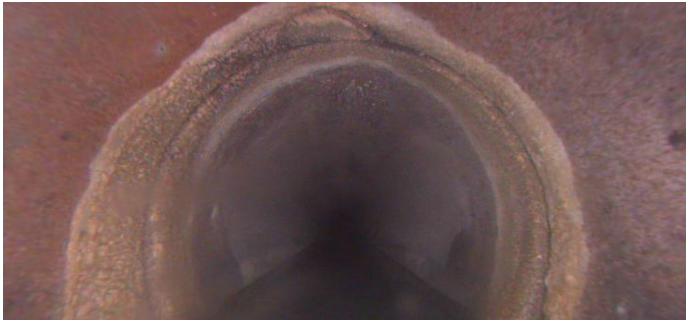
Code: **DAE**
Description: **Deposits Attached Encrustation**

Distance (ft): **172.8**
Structural Grade: **0**
O&M Grade: **2**
Clock Start/From: **8**
Clock To: **4**
1st Value:
2nd Value:
Value Percent: **5.000**
Continuous Index:
Within 8" of Joint: **YES**
Remarks:

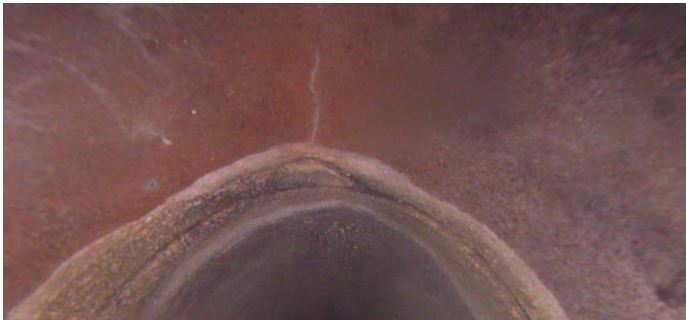
Code: **CL**
Description: **Crack Longitudinal**

Distance (ft): **172.8**
Structural Grade: **2**
O&M Grade: **0**
Clock Start/From: **12**
Clock To:
1st Value:
2nd Value:
Value Percent:
Continuous Index:
Within 8" of Joint: **YES**
Remarks:

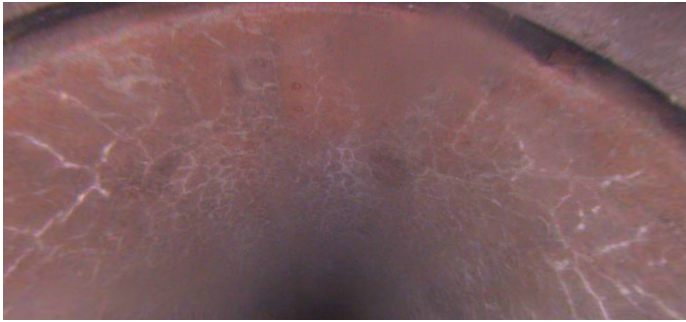
Code: **CM**
Description: **Crack Multiple**

Distance (ft): **197.4**
Structural Grade: **3**
O&M Grade: **0**
Clock Start/From: **8**
Clock To: **4**
1st Value:
2nd Value:
Value Percent:
Continuous Index: **S03**
Within 8" of Joint: **YES**
Remarks:

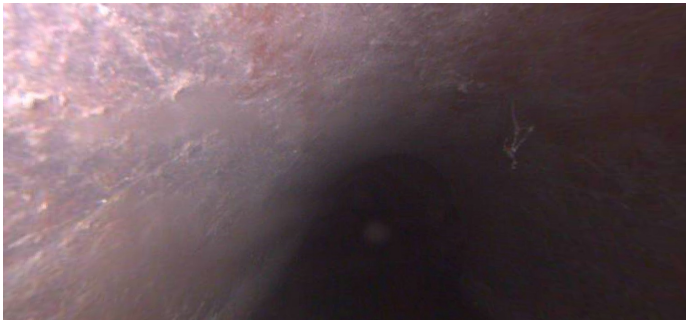
Code: **MSA**
Description: **Abandoned Survey**

Distance (ft): **213.8**
Structural Grade: **0**
O&M Grade: **0**
Clock Start/From:
Clock To:
1st Value:
2nd Value:
Value Percent:
Continuous Index:
Within 8" of Joint: **NO**
Remarks: **OVERTURNED**

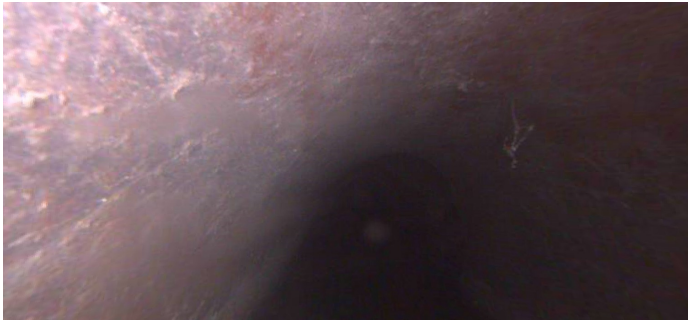
Code:	CM
Description:	Crack Multiple
Distance (ft):	213.8
Structural Grade:	3
O&M Grade:	0
Clock Start/From:	8
Clock To:	4
1st Value:	
2nd Value:	
Value Percent:	
Continuous Index:	F03
Within 8" of Joint:	YES
Remarks:
