## Profile/Photo Observation Report

Street:	<b>Dekalb St.</b>	Flow Control:	<b>Not Controlled</b>
City:	<b>Hobart, IN</b>	Year Renewed:	
Location:	<b>Light Highway</b>	Tape/Media #:	
Purpose:	<b>Routine Assessment</b>	Dia/Height:	<b>12"</b>
Use:	<b>Sanitary</b>	Material:	<b>VCP</b>
Drain Area:	<b>NA</b>	Lining:	
Category:	<b>NA</b>		
Comment:	<b>NULL - DC @ MH-M-507-059</b>

Location Details:		Direction of Survey:	<b>Upstream</b>
US MH:	<b>M-507-025</b>	DS MH:	<b>M-507-026</b>
		Total Length Surveyed (ft):	<b>51.9</b>

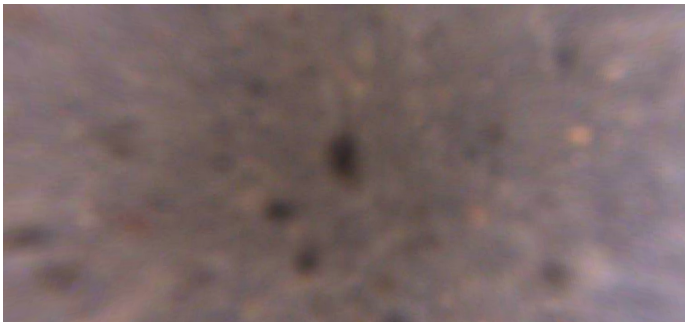
Code: **AMH**  
Description: **Manhole**

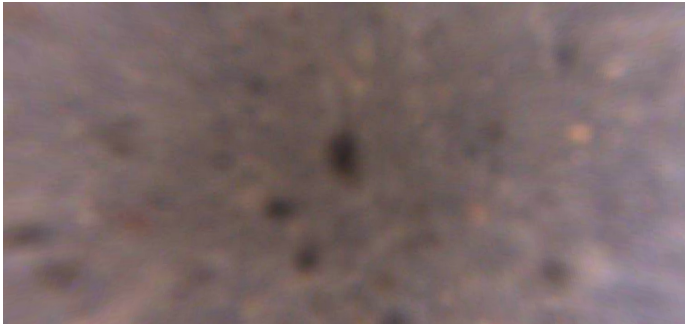
Code:	<b>MWL</b>
Description:	<b>Water Level</b>

Distance (ft):	<b>.0</b>
Structural Grade:	<b>0</b>
O&M Grade:	<b>0</b>
Clock Start/From:	
Clock To:	
1st Value:	
2nd Value:	
Value Percent:	<b>5.000</b>
Continuous Index:	
Within 8" of Joint:	<b>NO</b>
Remarks:

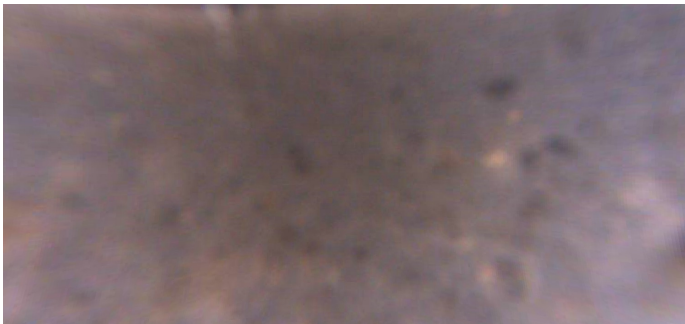
Code:	<b>MWLS</b>
Description:	<b>Water Level Sag</b>

Distance (ft):	<b>1.2</b>
Structural Grade:	<b>2</b>
O&M Grade:	<b>3</b>
Clock Start/From:	
Clock To:	
1st Value:	
2nd Value:	
Value Percent:	<b>10.000</b>
Continuous Index:	
Within 8" of Joint:	<b>NO</b>
Remarks:

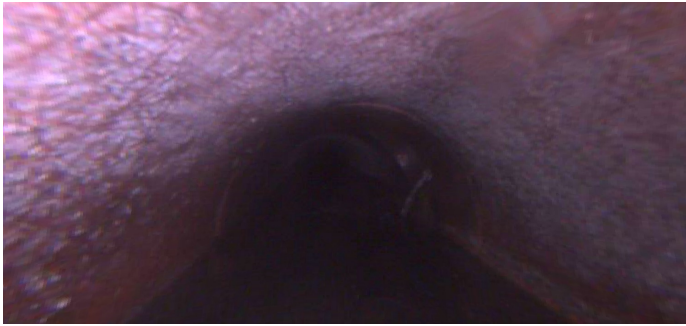
Code: **TFA**  
Description: **Tap Factory Active**

Distance (ft): **40.0**  
Structural Grade: **0**  
O&M Grade: **0**  
Clock Start/From: **2**  
Clock To:  
1st Value: **4.000**  
2nd Value:  
Value Percent:  
Continuous Index:  
Within 8" of Joint:  
Remarks:

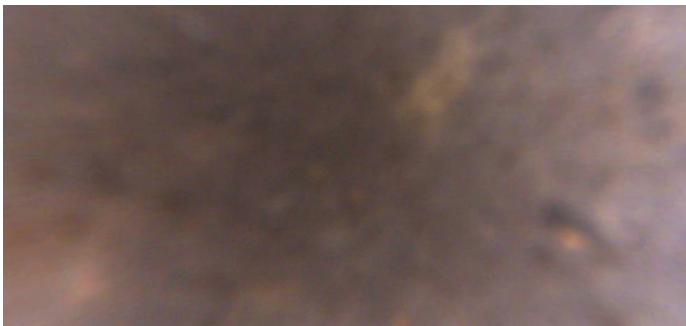
Code: **MWLS**  
Description: **Water Level Sag**

Distance (ft): **41.9**  
Structural Grade: **2**  
O&M Grade: **3**  
Clock Start/From:  
Clock To:  
1st Value:  
2nd Value:  
Value Percent: **20.000**  
Continuous Index:  
Within 8" of Joint: **NO**  
Remarks:

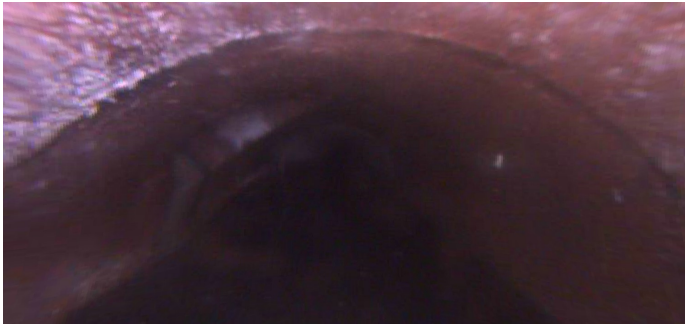
Code: **TF**  
Description: **Tap Factory**

Distance (ft): **48.4**  
Structural Grade: **0**  
O&M Grade: **0**  
Clock Start/From: **10**  
Clock To:  
1st Value: **4.000**  
2nd Value:  
Value Percent:  
Continuous Index:  
Within 8" of Joint:  
Remarks:

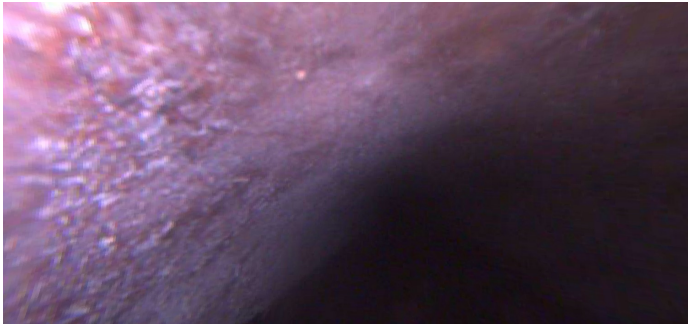
Code:	<b>MSA</b>
Description:	<b>Abandoned Survey</b>
Distance (ft):	<b>51.9</b>
Structural Grade:	<b>0</b>
O&M Grade:	<b>0</b>
Clock Start/From:	
Clock To:	
1st Value:	
2nd Value:	
Value Percent:	
Continuous Index:	
Within 8" of Joint:	<b>NO</b>
Remarks:	<b>camera stopped</b>
