Profile/Photo Observation Report

Date:	01/30/2025	Weather:		Coding:	PACP 7.0
Pipe Length (ft):	216.0	Owner:	City of Hobart	Pre Clean:	Heavy Cleaning
P.O.#:	YES502259	Surveyor:	S. Bucklin	PSR:	P-507-027-026
Customer:	City of Hobart	Clean Date:	10/08/2024	Shape:	C

Street:	S. DeKalb St.	Flow Control:	Not Controlled
City:	Hobart, IN	Year Renewed:	
Location:	Easement/Right of Way	Tape/Media #:	
Purpose:	Sewer System Evaluation Survey (SS	Dia/Height:	12"
Use:	Sanitary Sewage Pipe	Material:	VCP
Drain Area:		Lining:	None
Category:	NA		
Comment:

Location Details:		Direction of Survey:	Downstream
US MH:	M-507-027	DS MH:	M-507-026
		Total Length Surveyed (ft):	215.5

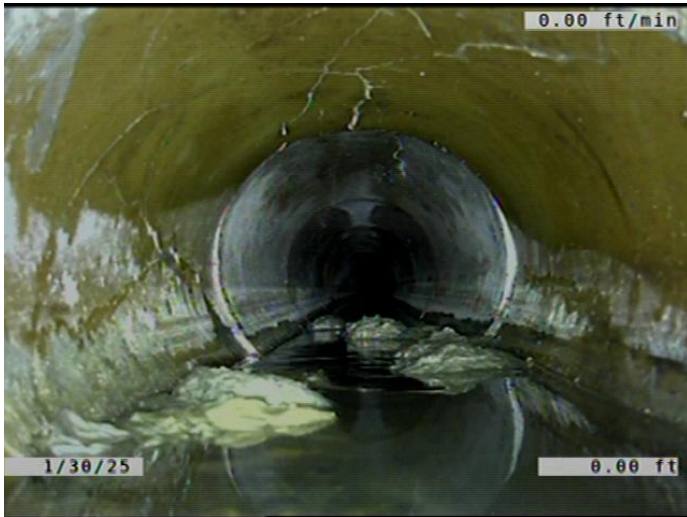
Code: **DSF**
Description: **Deposits Settled Fine**

Distance (ft): **.0**
Structural Grade: **0**
O&M Grade: **2**
Clock Start/From: **5**
Clock To: **7**
1st Value:
2nd Value:
Value Percent: **5.000**
Continuous Index: **S01**
Within 8" of Joint: **YES**
Remarks:

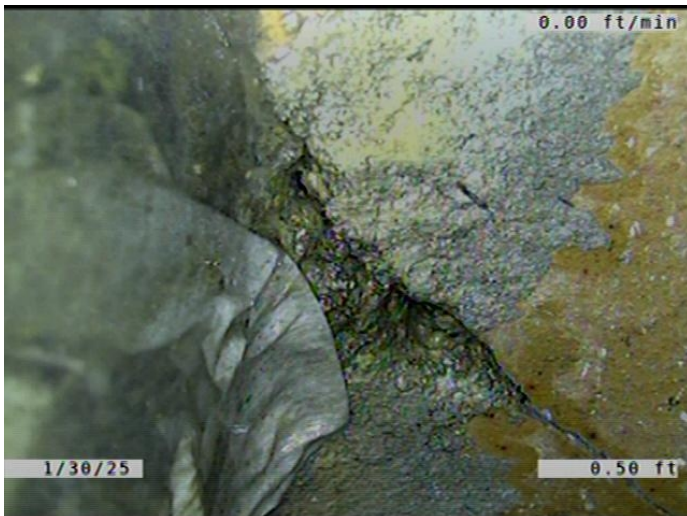
Code: **FM**
Description: **Fracture Multiple**

Distance (ft): **.5**
Structural Grade: **4**
O&M Grade: **0**
Clock Start/From: **7**
Clock To: **5**
1st Value:
2nd Value:
Value Percent:
Continuous Index:
Within 8" of Joint: **YES**
Remarks:

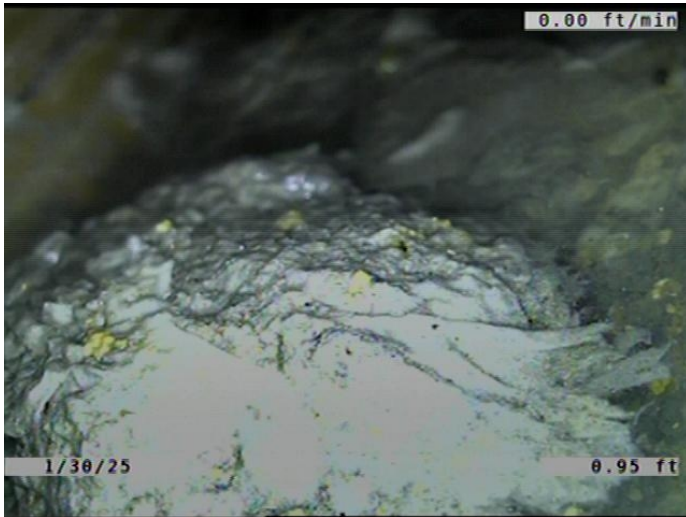
Code: **DAR**
Description: **Deposits Attached Ragging**

Distance (ft): **1.0**
Structural Grade: **0**
O&M Grade: **2**
Clock Start/From: **5**
Clock To: **7**
1st Value:
2nd Value:
Value Percent: **5.000**
Continuous Index: **S02**
Within 8" of Joint: **YES**
Remarks:

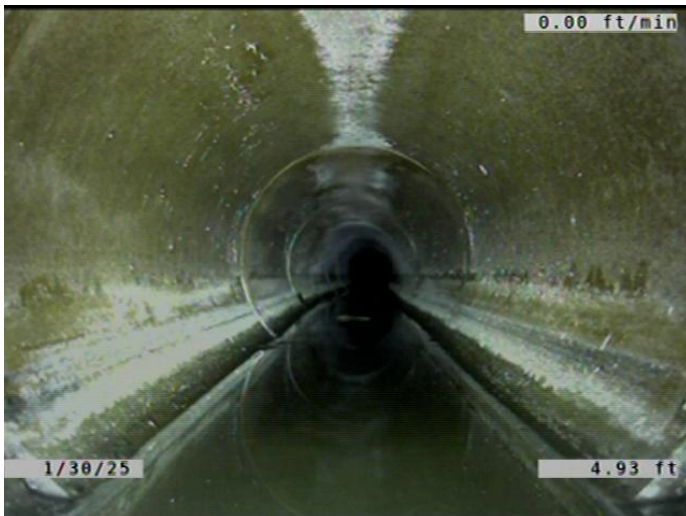
Code: **DAR**
Description: **Deposits Attached Ragging**

Distance (ft): **4.9**
Structural Grade: **0**
O&M Grade: **2**
Clock Start/From: **5**
Clock To: **7**
1st Value:
2nd Value:
Value Percent: **5.000**
Continuous Index: **F02**
Within 8" of Joint: **YES**
Remarks:

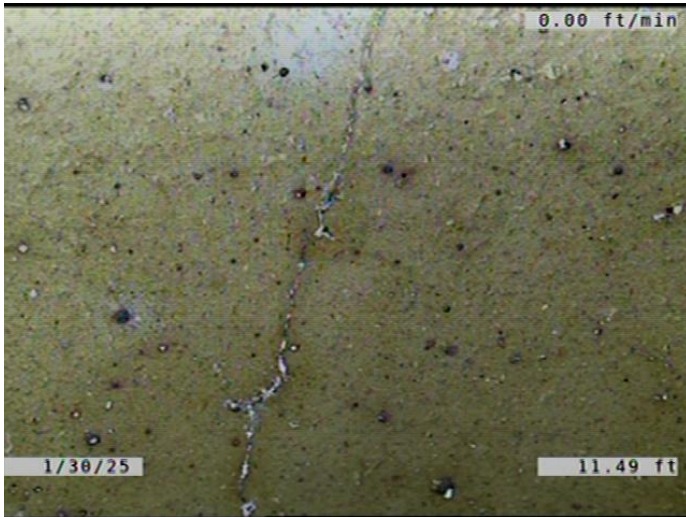
Code: **CS**
Description: **Crack Spiral**

Distance (ft): **11.5**
Structural Grade: **2**
O&M Grade: **0**
Clock Start/From: **8**
Clock To: **10**
1st Value:
2nd Value:
Value Percent:
Continuous Index:
Within 8" of Joint: **YES**
Remarks:

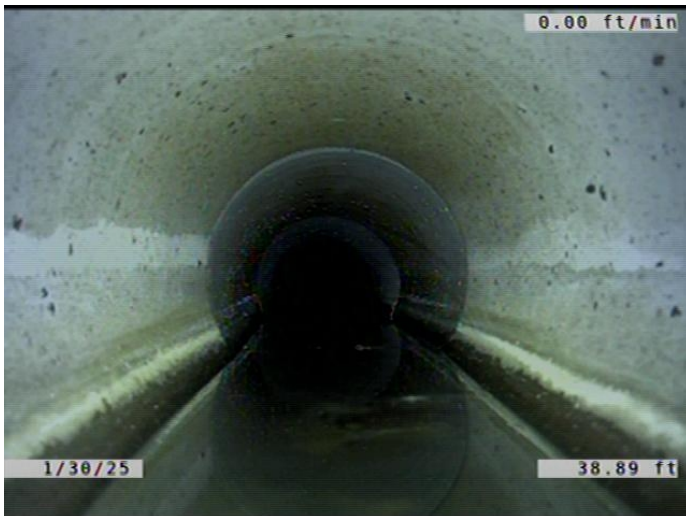
Code: **MWLS**
Description: **Miscellaneous Water Level Sag**

Distance (ft): **38.9**
Structural Grade: **2**
O&M Grade: **0**
Clock Start/From:
Clock To:
1st Value:
2nd Value:
Value Percent: **20.000**
Continuous Index: **S03**
Within 8" of Joint: **NO**
Remarks:

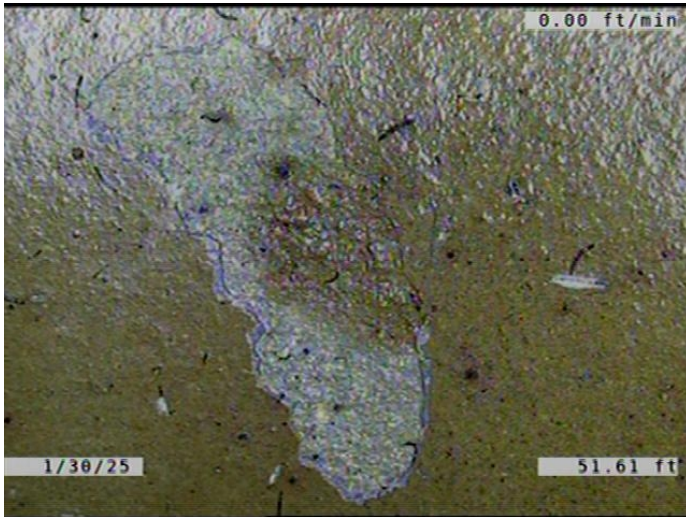
Code:	SSC
Description:	Surface Spalling of Damage Coating
Distance (ft):	51.6
Structural Grade:	1
O&M Grade:	0
Clock Start/From:	1
Clock To:	2
1st Value:	
2nd Value:	
Value Percent:	
Continuous Index:	
Within 8" of Joint:	YES
Remarks:

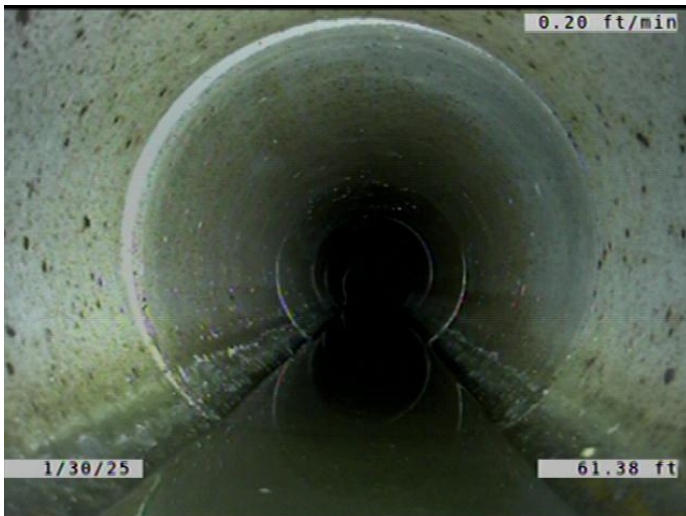
Code:	MWLS
Description:	Miscellaneous Water Level Sag
Distance (ft):	61.4
Structural Grade:	2
O&M Grade:	0
Clock Start/From:	
Clock To:	
1st Value:	
2nd Value:	
Value Percent:	20.000
Continuous Index:	F03
Within 8" of Joint:	NO
Remarks:

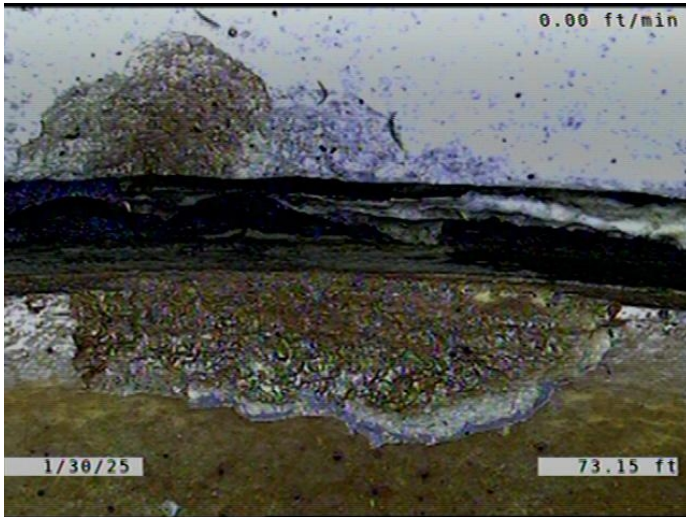
Code: **SZ**
Description: **Surface Damage Other**

Distance (ft): **73.2**
Structural Grade: **0**
O&M Grade: **0**
Clock Start/From: **11**
Clock To:
1st Value:
2nd Value:
Value Percent:
Continuous Index:
Within 8" of Joint: **YES**
Remarks: **PIECES CHIPPED AWAY FROM THE JOINT.**

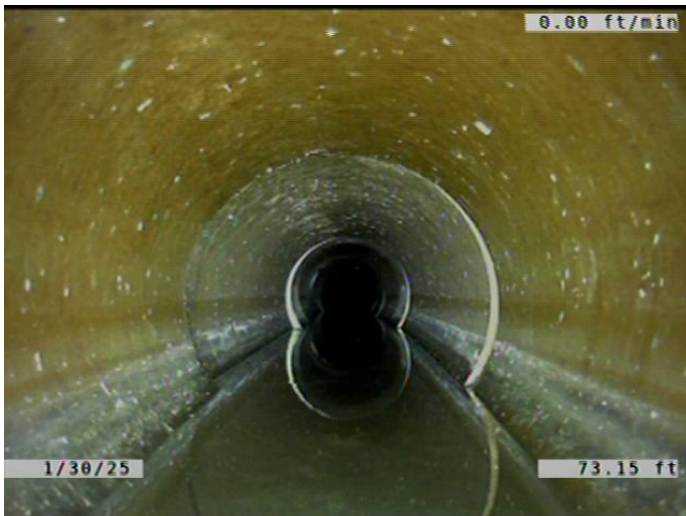
Code: **MWLS**
Description: **Miscellaneous Water Level Sag**

Distance (ft): **73.2**
Structural Grade: **2**
O&M Grade: **0**
Clock Start/From:
Clock To:
1st Value:
2nd Value:
Value Percent: **20.000**
Continuous Index: **S04**
Within 8" of Joint: **NO**
Remarks:

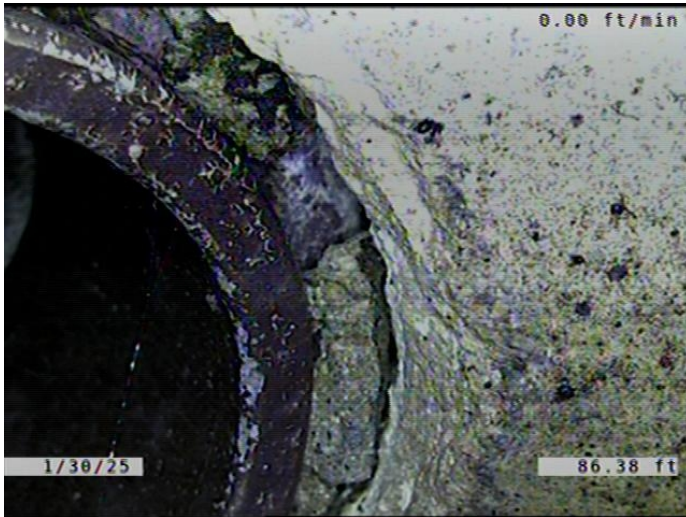
Code: **CL**
Description: **Crack Longitudinal**

Distance (ft): **86.4**
Structural Grade: **2**
O&M Grade: **0**
Clock Start/From: **10**
Clock To:
1st Value:
2nd Value:
Value Percent:
Continuous Index:
Within 8" of Joint: **NO**
Remarks:

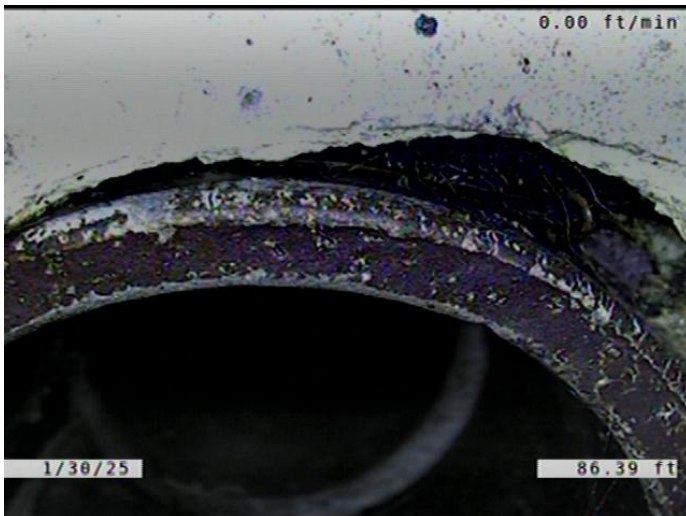
Code: **RFB**
Description: **Roots Fine Barrel**

Distance (ft): **86.4**
Structural Grade: **0**
O&M Grade: **2**
Clock Start/From: **9**
Clock To: **12**
1st Value:
2nd Value:
Value Percent:
Continuous Index:
Within 8" of Joint: **NO**
Remarks:

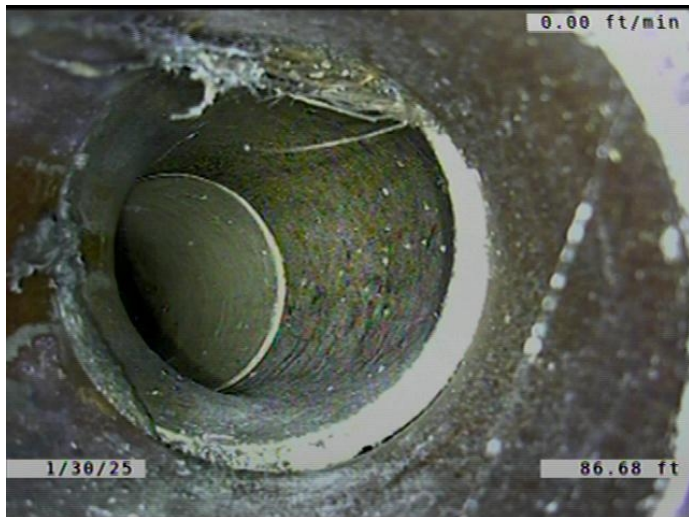
Code:	TBI
Description:	Tap Break-in Intruding
Distance (ft):	86.7
Structural Grade:	0
O&M Grade:	2
Clock Start/From:	10
Clock To:	
1st Value:	6.000
2nd Value:	1.000
Value Percent:	
Continuous Index:	
Within 8" of Joint:	YES
Remarks:	ROOTS GROWING FROM THE JOINTS INTO THE MAIN.

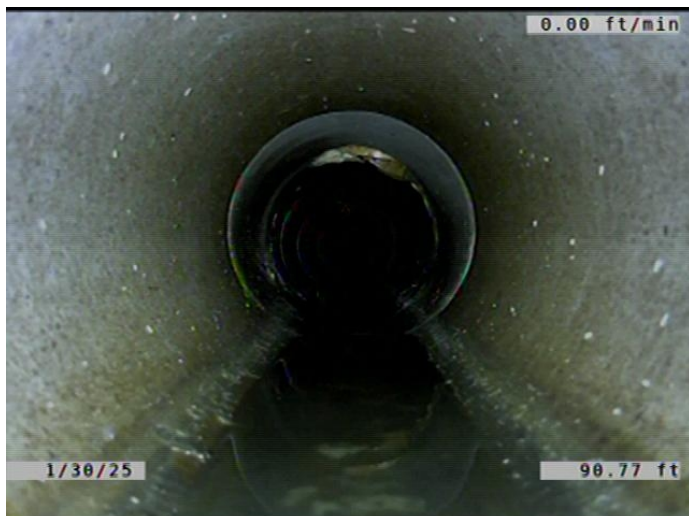
Code:	MWLS
Description:	Miscellaneous Water Level Sag
Distance (ft):	90.8
Structural Grade:	2
O&M Grade:	0
Clock Start/From:	
Clock To:	
1st Value:	
2nd Value:	
Value Percent:	20.000
Continuous Index:	F04
Within 8" of Joint:	NO
Remarks:

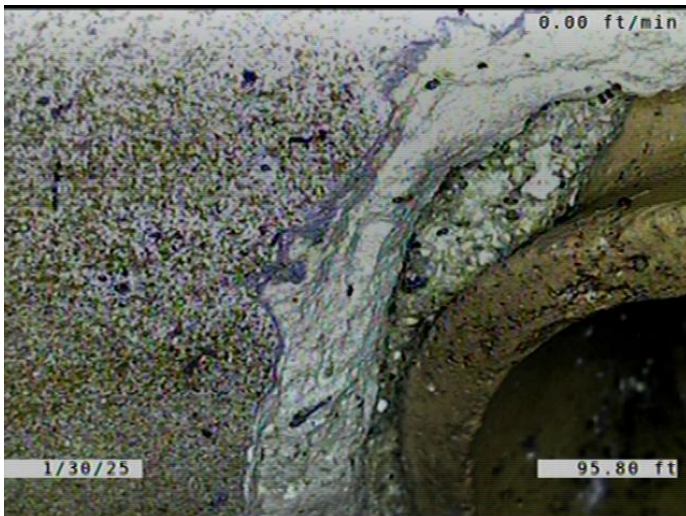
Code: **SSS**
 Description: **Surface Damage Surface Spalling**

Distance (ft): **95.8**
 Structural Grade: **2**
 O&M Grade: **0**
 Clock Start/From: **11**
 Clock To: **2**
 1st Value:
 2nd Value:
 Value Percent:
 Continuous Index:
 Within 8" of Joint: **YES**
 Remarks:

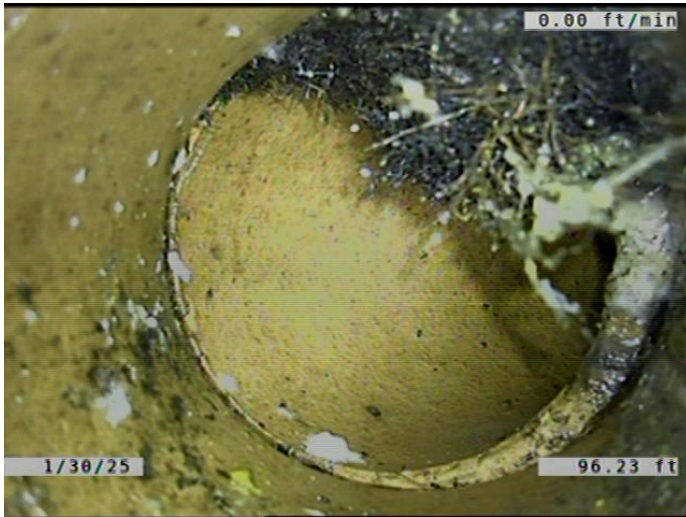
Code: **TBI**
Description: **Tap Break-in Intruding**

Distance (ft): **96.2**
Structural Grade: **0**
O&M Grade: **2**
Clock Start/From: **1**
Clock To:
1st Value: **6.000**
2nd Value: **1.000**
Value Percent:
Continuous Index:
Within 8" of Joint: **YES**
Remarks: **ROOTS GROWING FROM THE JOINTS INTO THE MAIN.**

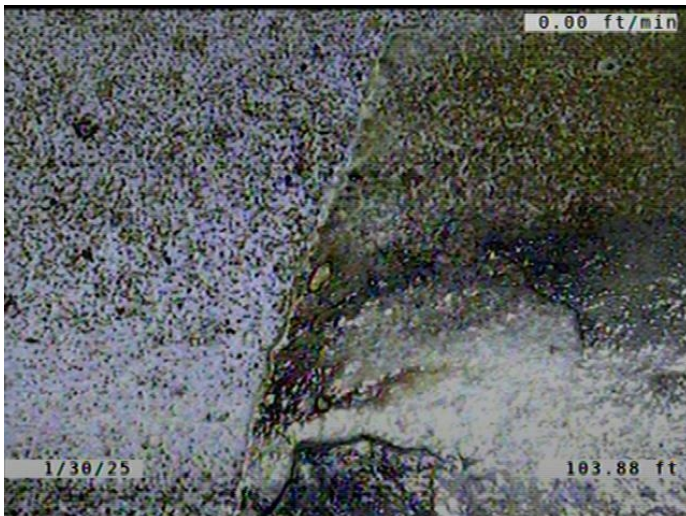
Code: **CL**
Description: **Crack Longitudinal**

Distance (ft): **103.9**
Structural Grade: **2**
O&M Grade: **0**
Clock Start/From: **8**
Clock To:
1st Value:
2nd Value:
Value Percent:
Continuous Index:
Within 8" of Joint: **YES**
Remarks:

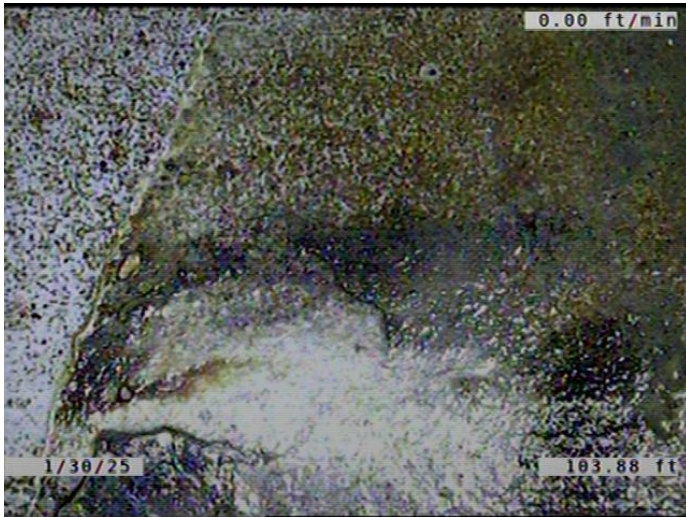
Code: **DAE**
Description: **Deposits Attached Encrustation**

Distance (ft): **103.9**
Structural Grade: **0**
O&M Grade: **2**
Clock Start/From: **7**
Clock To: **8**
1st Value:
2nd Value:
Value Percent: **5.000**
Continuous Index:
Within 8" of Joint: **YES**
Remarks:

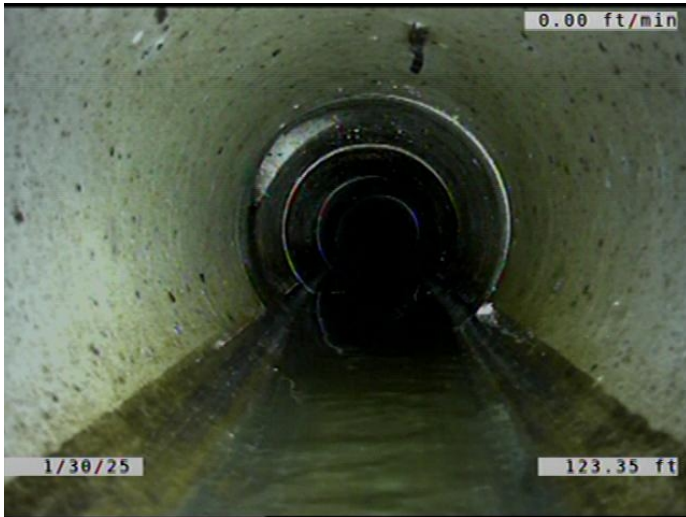
Code: **MWLS**
Description: **Miscellaneous Water Level Sag**

Distance (ft): **123.4**
Structural Grade: **2**
O&M Grade: **0**
Clock Start/From:
Clock To:
1st Value:
2nd Value:
Value Percent: **25.000**
Continuous Index: **S05**
Within 8" of Joint: **NO**
Remarks:

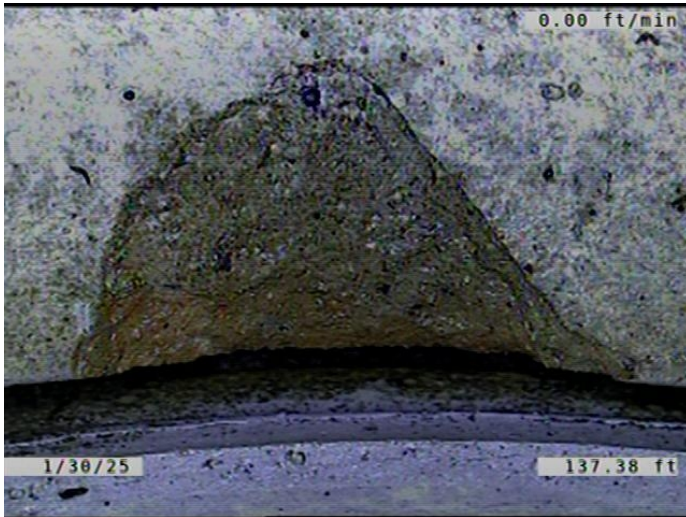
Code: **SZ**
Description: **Surface Damage Other**

Distance (ft): **137.4**
Structural Grade: **0**
O&M Grade: **0**
Clock Start/From: **10**
Clock To: **11**
1st Value:
2nd Value:
Value Percent:
Continuous Index:
Within 8" of Joint: **YES**
Remarks: **PIECE CHIPPED AWAY FROM THE JOINT.**

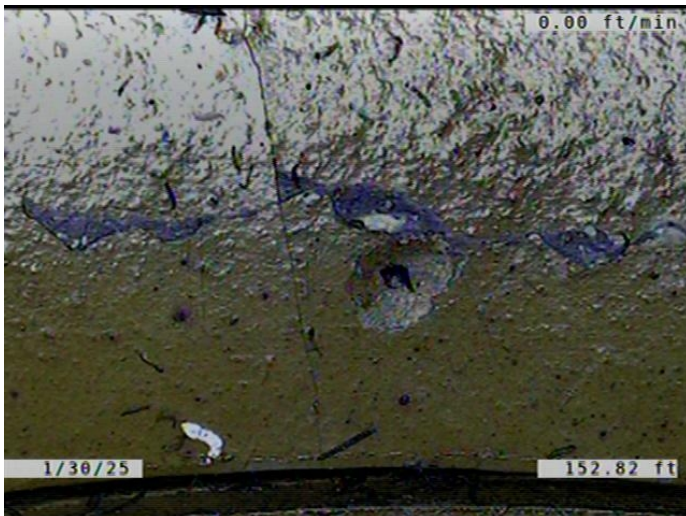
Code: **CM**
Description: **Crack Multiple**

Distance (ft): **152.8**
Structural Grade: **3**
O&M Grade: **0**
Clock Start/From: **9**
Clock To: **11**
1st Value:
2nd Value:
Value Percent:
Continuous Index:
Within 8" of Joint: **YES**
Remarks:

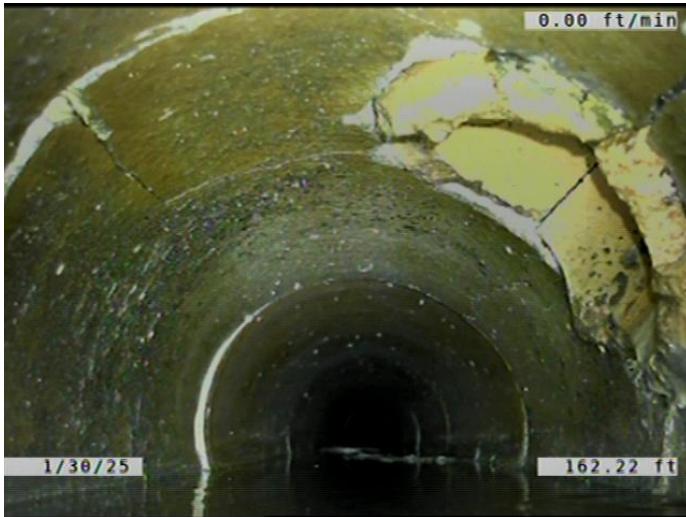
Code: **FM**
Description: **Fracture Multiple**

Distance (ft): **162.2**
Structural Grade: **4**
O&M Grade: **0**
Clock Start/From: **8**
Clock To: **4**
1st Value:
2nd Value:
Value Percent:
Continuous Index:
Within 8" of Joint: **YES**
Remarks:

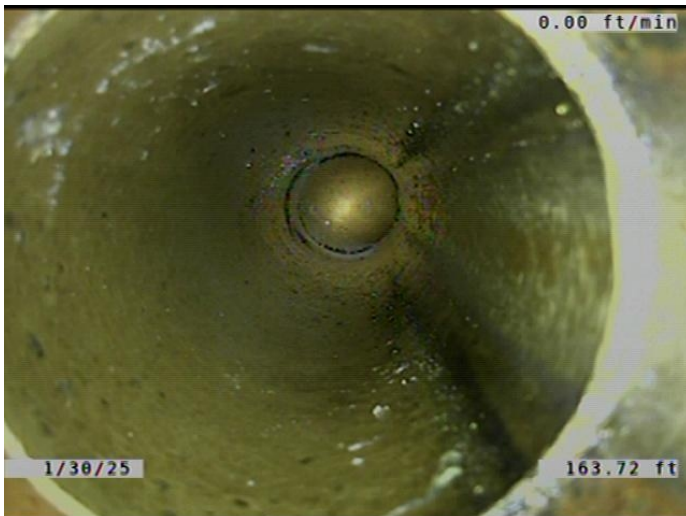
Code: **TBI**
Description: **Tap Break-in Intruding**

Distance (ft): **163.7**
Structural Grade: **0**
O&M Grade: **2**
Clock Start/From: **1**
Clock To:
1st Value: **6.000**
2nd Value: **1.000**
Value Percent:
Continuous Index:
Within 8" of Joint: **YES**
Remarks: **CONSTANTLY RUNNING WATER.**

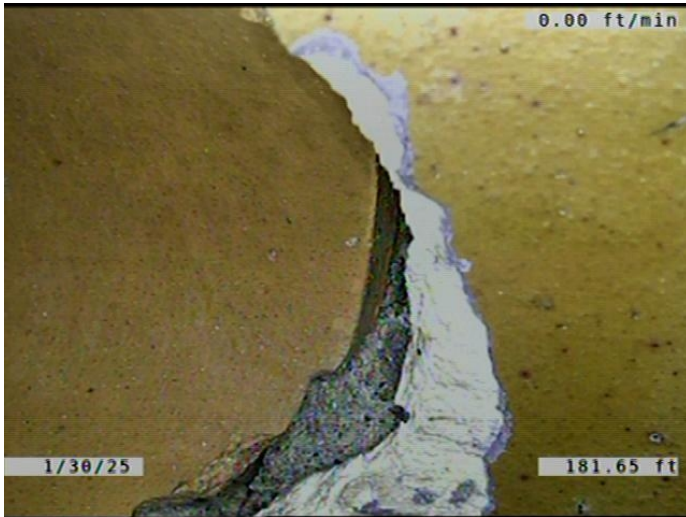
Code: **SSS**
Description: **Surface Damage Surface Spalling**

Distance (ft): **181.6**
Structural Grade: **2**
O&M Grade: **0**
Clock Start/From: **9**
Clock To: **11**
1st Value:
2nd Value:
Value Percent:
Continuous Index:
Within 8" of Joint: **YES**
Remarks:

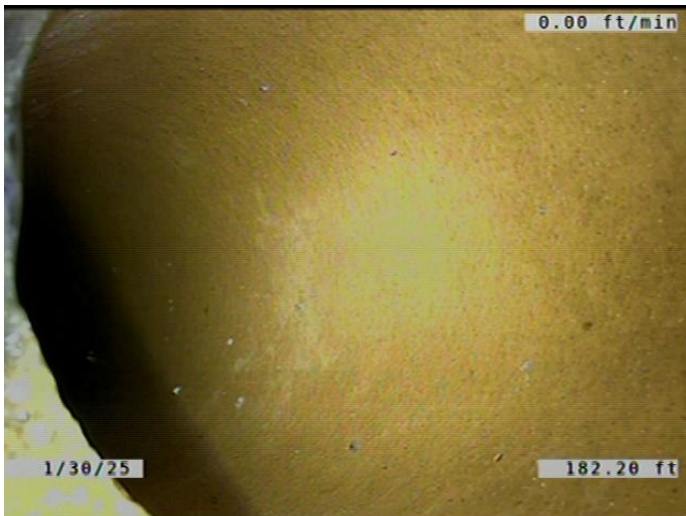
Code: **TBI**
Description: **Tap Break-in Intruding**

Distance (ft): **182.2**
Structural Grade: **0**
O&M Grade: **2**
Clock Start/From: **10**
Clock To:
1st Value: **6.000**
2nd Value: **1.000**
Value Percent:
Continuous Index:
Within 8" of Joint: **YES**
Remarks:

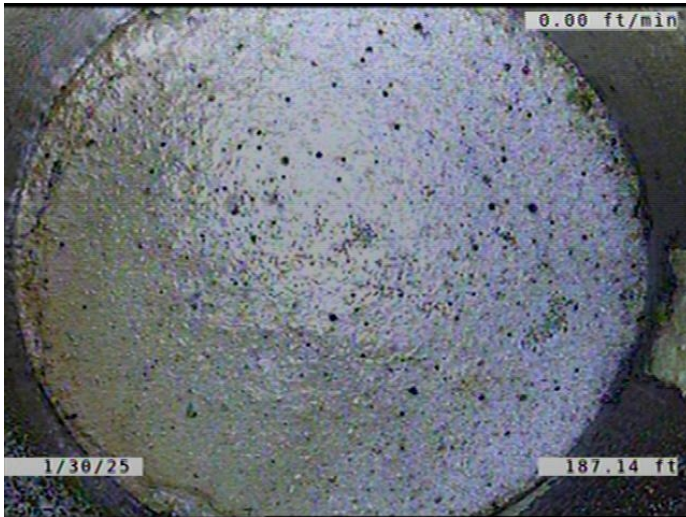
Code:	TFD
Description:	Tap Factory Defective
Distance (ft):	187.1
Structural Grade:	0
O&M Grade:	3
Clock Start/From:	2
Clock To:	
1st Value:	6.000
2nd Value:	
Value Percent:	
Continuous Index:	
Within 8" of Joint:	YES
Remarks:	CAPPED. ENCRUSTATION COMING AROUND THE CAP INTO THE MAIN.

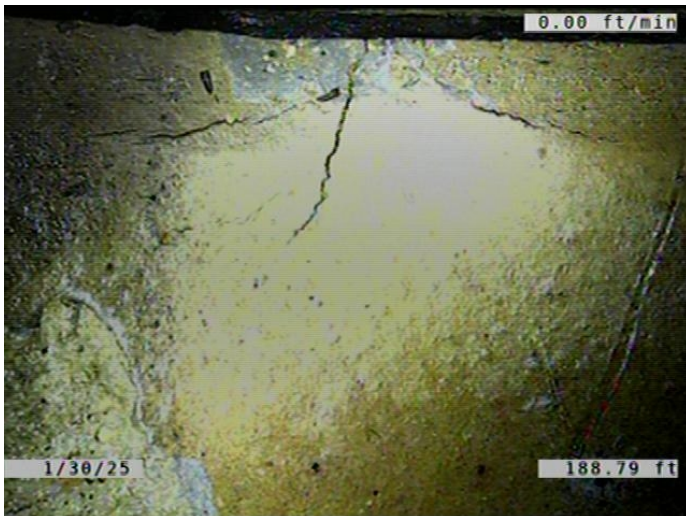
Code:	CM
Description:	Crack Multiple
Distance (ft):	188.8
Structural Grade:	3
O&M Grade:	0
Clock Start/From:	9
Clock To:	10
1st Value:	
2nd Value:	
Value Percent:	
Continuous Index:	
Within 8" of Joint:	YES
Remarks:

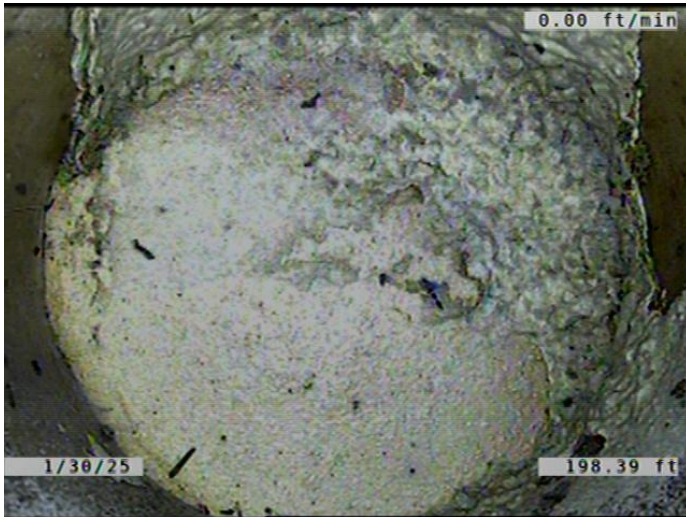
Code:	TFD
Description:	Tap Factory Defective
Distance (ft):	198.4
Structural Grade:	0
O&M Grade:	3
Clock Start/From:	11
Clock To:	
1st Value:	6.000
2nd Value:	
Value Percent:	
Continuous Index:	
Within 8" of Joint:	YES
Remarks:	CAPPED. ENCRUSTATION COMING AROUND THE CAP INTO THE MAIN.

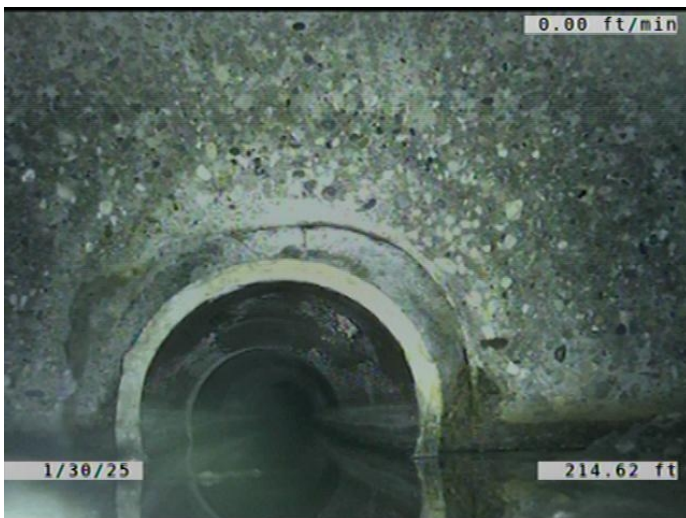
Code:	DSF
Description:	Deposits Settled Fine
Distance (ft):	214.6
Structural Grade:	0
O&M Grade:	2
Clock Start/From:	5
Clock To:	7
1st Value:	
2nd Value:	
Value Percent:	5.000
Continuous Index:	F01
Within 8" of Joint:	YES
Remarks:

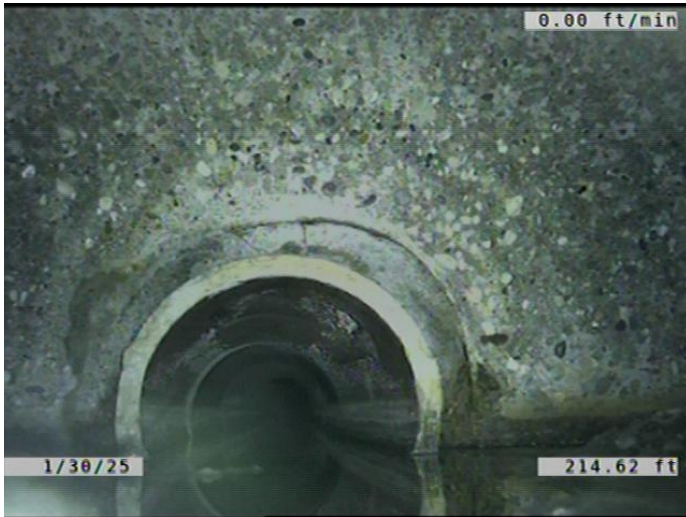
Code: **MWLS**
Description: **Miscellaneous Water Level Sag**

Distance (ft): **214.6**
Structural Grade: **2**
O&M Grade: **0**
Clock Start/From:
Clock To:
1st Value:
2nd Value:
Value Percent: **25.000**
Continuous Index: **F05**
Within 8" of Joint: **NO**
Remarks:
