Profile/Photo Observation Report

Date:	12/11/2024	Weather:		Coding:	PACP 7.0
Pipe Length (ft):	196.0	Owner:	City of Hobart	Pre Clean:	Heavy Cleaning
P.O.#:	YES502259	Surveyor:	S. Bucklin	PSR:	P-507-028-027
Customer:	City of Hobart	Clean Date:	09/27/2024	Shape:	C

Street:	South Dekalb Street	Flow Control:	Not Controlled
City:	Hobart, IN	Year Renewed:	
Location:	Local rural streets with light traffic, t	Tape/Media #:	
Purpose:	Sewer System Evaluation Survey (SS	Dia/Height:	10"
Use:	Sanitary Sewage Pipe	Material:	VCP
Drain Area:		Lining:	None
Category:	NA		
Comment:			
Location Details:		Direction of Survey:	Downstream
US MH:	M-507-028	DS MH:	M-507-027
		Total Length Surveyed (ft):	191.9

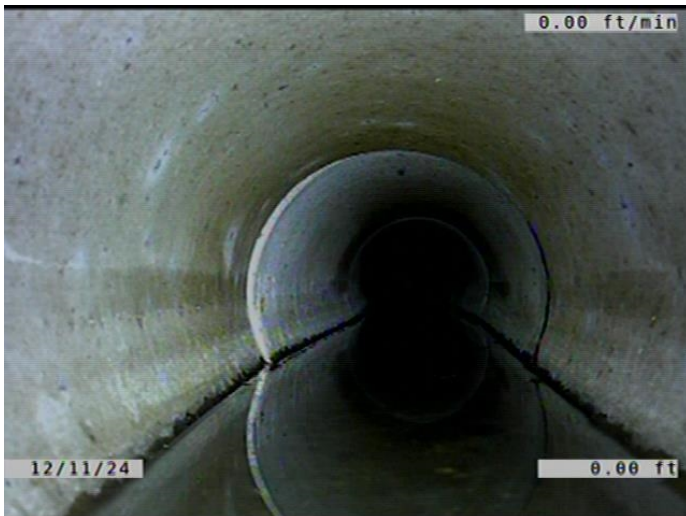
Code: **DSF**
Description: **Deposits Settled Fine**

Distance (ft): **.0**
Structural Grade: **0**
O&M Grade: **2**
Clock Start/From: **5**
Clock To: **7**
1st Value:
2nd Value:
Value Percent: **5.000**
Continuous Index: **S01**
Within 8" of Joint: **YES**
Remarks:

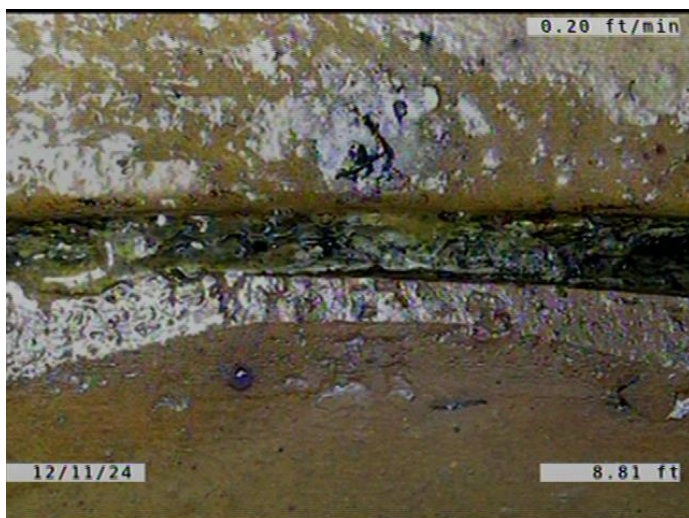
Code: **DAE**
 Description: **Deposits Attached Encrustation**

Distance (ft): **8.8**
 Structural Grade: **0**
 O&M Grade: **2**
 Clock Start/From: **8**
 Clock To: **4**
 1st Value:
 2nd Value:
 Value Percent: **5.000**
 Continuous Index:
 Within 8" of Joint: **YES**
 Remarks: **JOINT IS WET ALSO.**

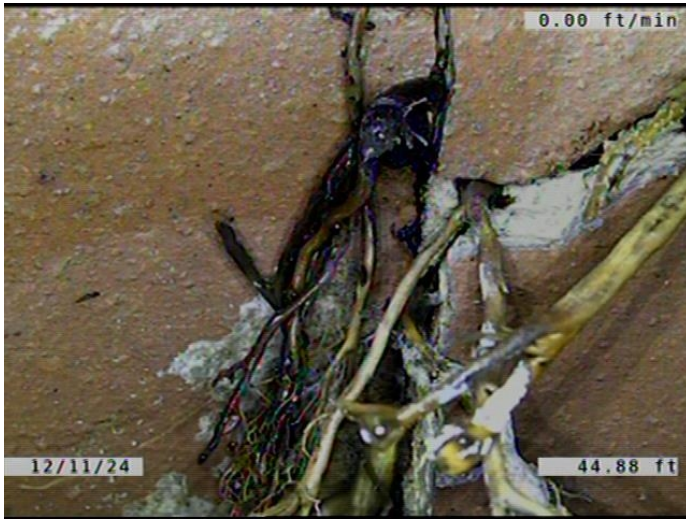
Code: **RMB**
Description: **Roots Medium Barrel**

Distance (ft): **44.9**
Structural Grade: **0**
O&M Grade: **4**
Clock Start/From: **10**
Clock To: **2**
1st Value:
2nd Value:
Value Percent: **15.000**
Continuous Index:
Within 8" of Joint: **NO**
Remarks:

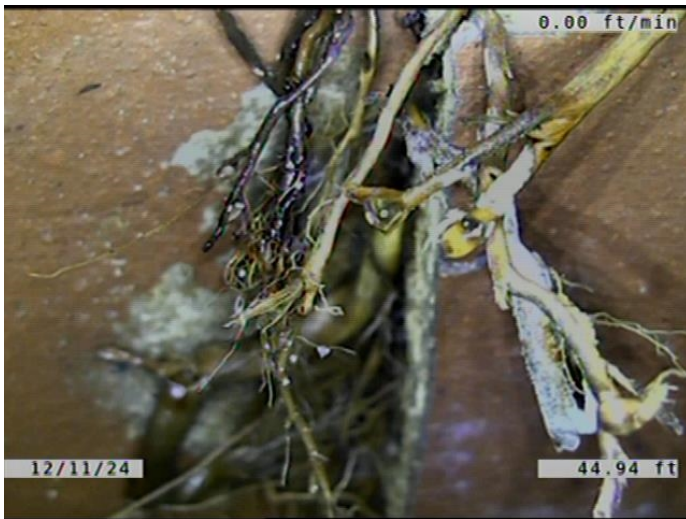
Code: **IWB**
Description: **Infiltration Weeper Barrel**

Distance (ft): **44.9**
Structural Grade: **0**
O&M Grade: **2**
Clock Start/From: **11**
Clock To: **1**
1st Value:
2nd Value:
Value Percent:
Continuous Index:
Within 8" of Joint: **YES**
Remarks:

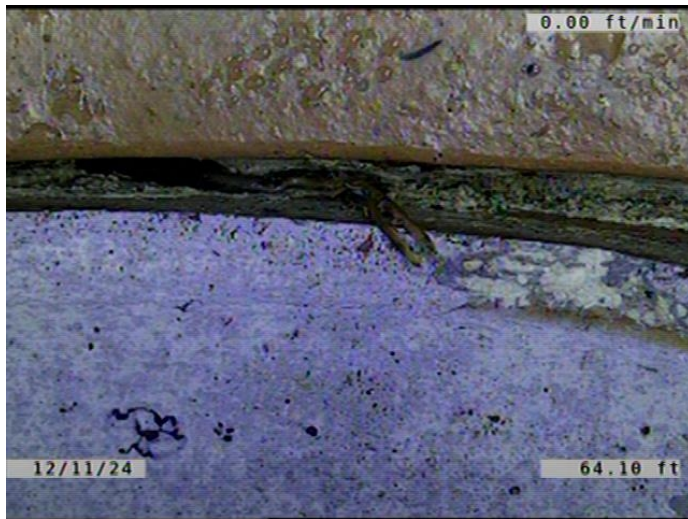
Code: **RFJ**
 Description: **Roots Fine Joint**

Distance (ft): **64.1**
 Structural Grade: **0**
 O&M Grade: **1**
 Clock Start/From: **1**
 Clock To:
 1st Value:
 2nd Value:
 Value Percent:
 Continuous Index:
 Within 8" of Joint: **YES**
 Remarks:

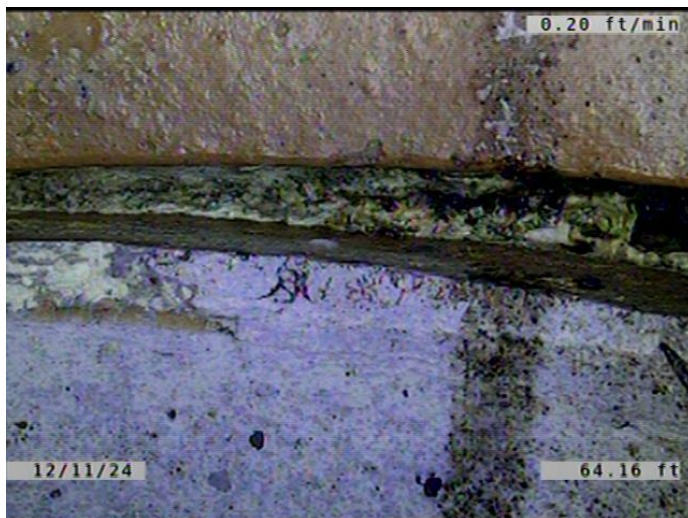
Code: **DAE**
 Description: **Deposits Attached Encrustation**

Distance (ft): **64.1**
 Structural Grade: **0**
 O&M Grade: **2**
 Clock Start/From: **8**
 Clock To: **4**
 1st Value:
 2nd Value:
 Value Percent: **5.000**
 Continuous Index:
 Within 8" of Joint: **YES**
 Remarks:

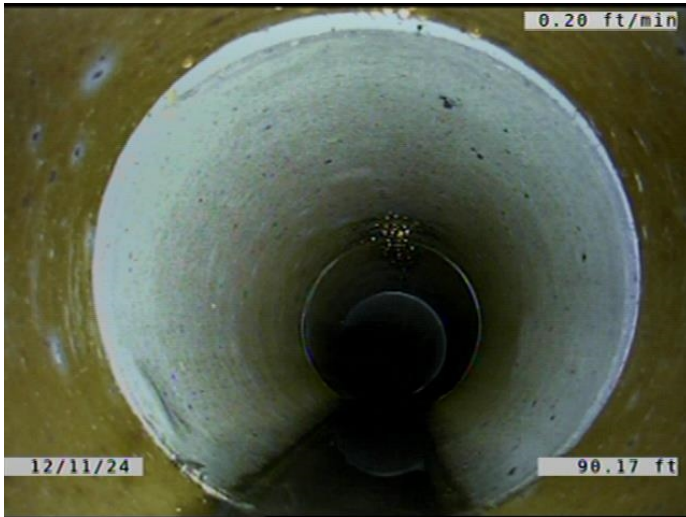
Code: **MWLS**
Description: **Miscellaneous Water Level Sag**

Distance (ft): **90.2**
Structural Grade: **2**
O&M Grade: **0**
Clock Start/From:
Clock To:
1st Value:
2nd Value:
Value Percent: **15.000**
Continuous Index: **F02**
Within 8" of Joint: **NO**
Remarks:

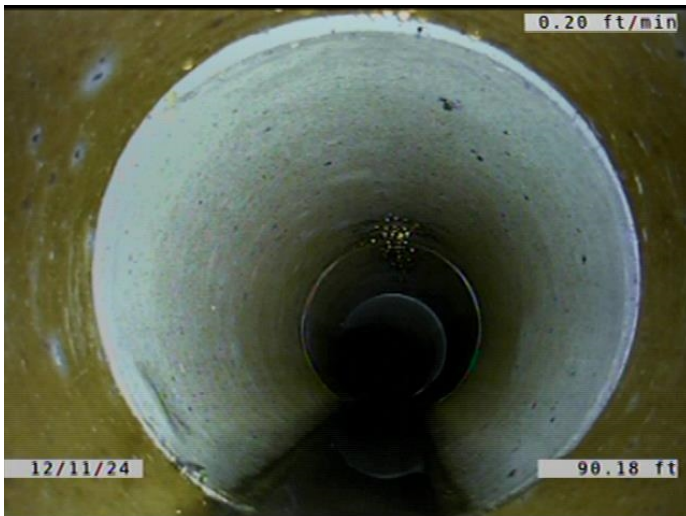
Code: **DSF**
Description: **Deposits Settled Fine**

Distance (ft): **90.2**
Structural Grade: **0**
O&M Grade: **2**
Clock Start/From: **5**
Clock To: **7**
1st Value:
2nd Value:
Value Percent: **5.000**
Continuous Index: **F01**
Within 8" of Joint: **YES**
Remarks:

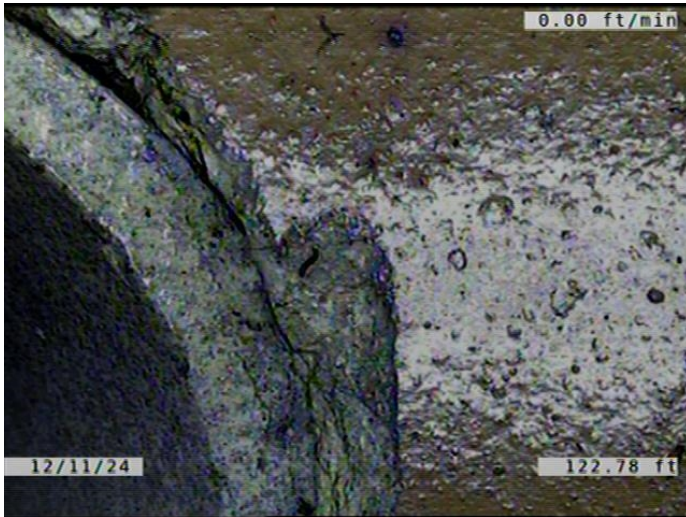
Code: **FM**
 Description: **Fracture Multiple**

Distance (ft): **122.8**
 Structural Grade: **4**
 O&M Grade: **0**
 Clock Start/From: **9**
 Clock To: **12**
 1st Value:
 2nd Value:
 Value Percent:
 Continuous Index:
 Within 8" of Joint: **YES**
 Remarks:

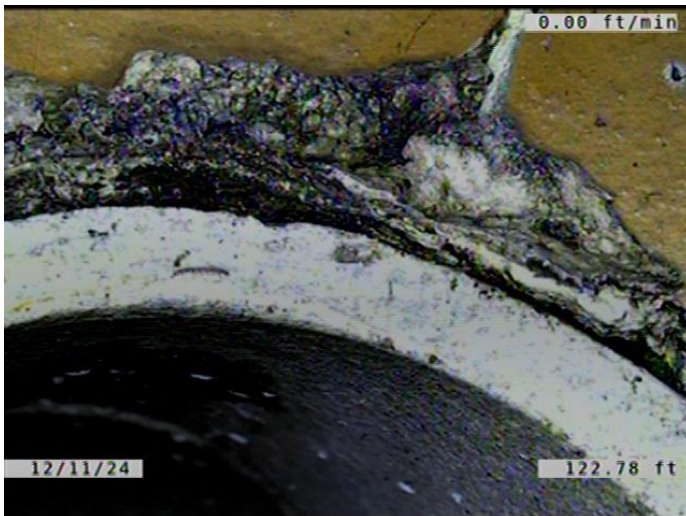
Code: **DAE**
 Description: **Deposits Attached Encrustation**

Distance (ft): **122.8**
 Structural Grade: **0**
 O&M Grade: **2**
 Clock Start/From: **9**
 Clock To: **12**
 1st Value:
 2nd Value:
 Value Percent: **5.000**
 Continuous Index:
 Within 8" of Joint: **YES**
 Remarks:

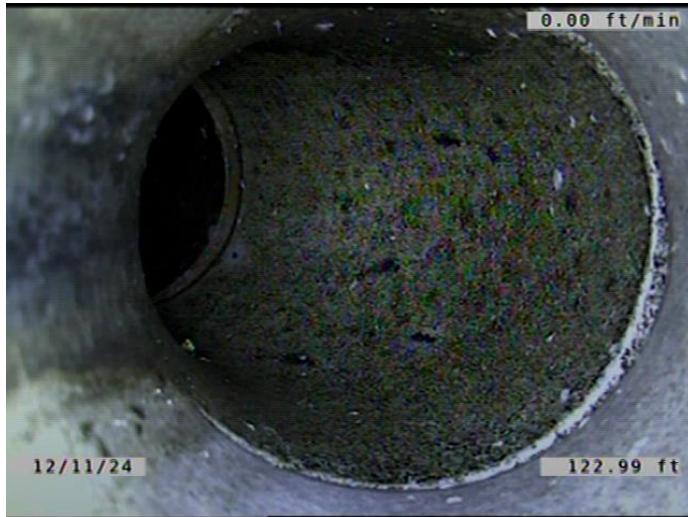
Code:	TBI
Description:	Tap Break-in Intruding
Distance (ft):	123.0
Structural Grade:	0
O&M Grade:	2
Clock Start/From:	10
Clock To:	
1st Value:	6.000
2nd Value:	1.000
Value Percent:	
Continuous Index:	
Within 8" of Joint:	NO
Remarks:	ACTIVITY. CONSTANTLY RUNNING WATER.

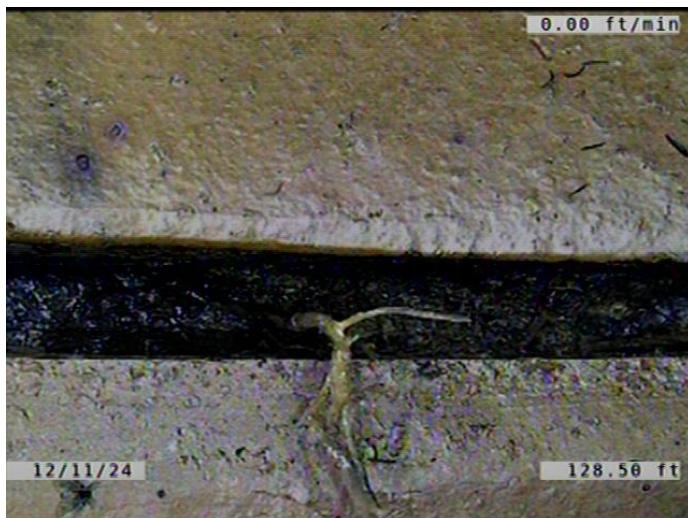
Code:	RFJ
Description:	Roots Fine Joint
Distance (ft):	128.5
Structural Grade:	0
O&M Grade:	1
Clock Start/From:	10
Clock To:	11
1st Value:	
2nd Value:	
Value Percent:	
Continuous Index:	
Within 8" of Joint:	YES
Remarks:

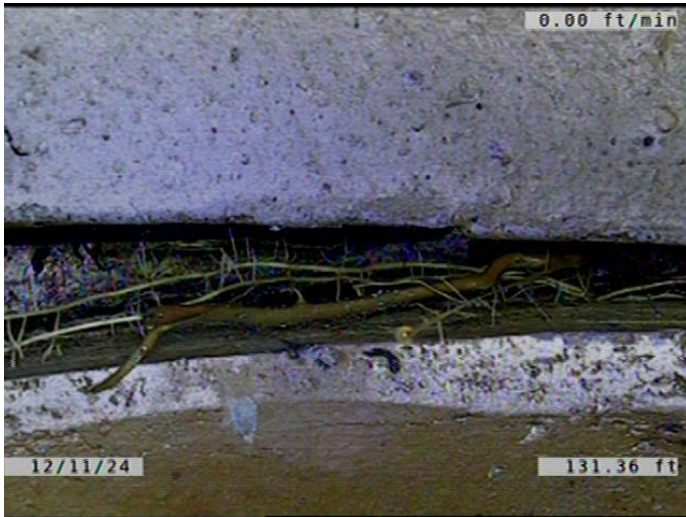
Code: **RFJ**
Description: **Roots Fine Joint**

Distance (ft): **131.4**
Structural Grade: **0**
O&M Grade: **1**
Clock Start/From: **11**
Clock To: **1**
1st Value:
2nd Value:
Value Percent:
Continuous Index:
Within 8" of Joint: **YES**
Remarks:

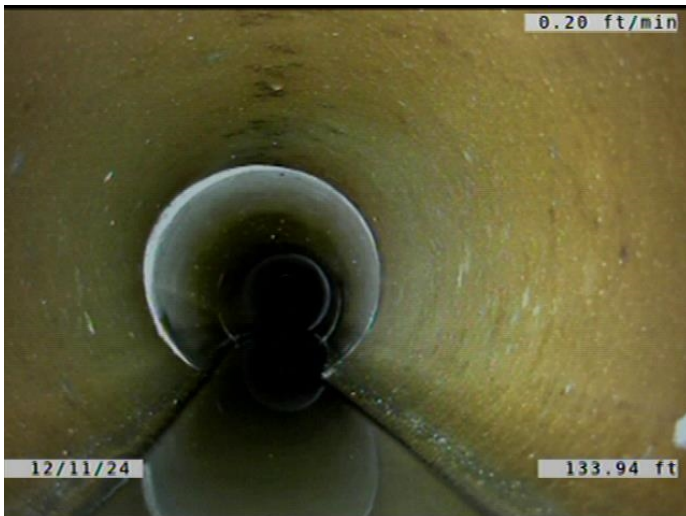
Code: **LL**
Description: **Line Left**

Distance (ft): **133.9**
Structural Grade: **0**
O&M Grade: **1**
Clock Start/From:
Clock To:
1st Value:
2nd Value:
Value Percent: **5.000**
Continuous Index:
Within 8" of Joint: **NO**
Remarks:

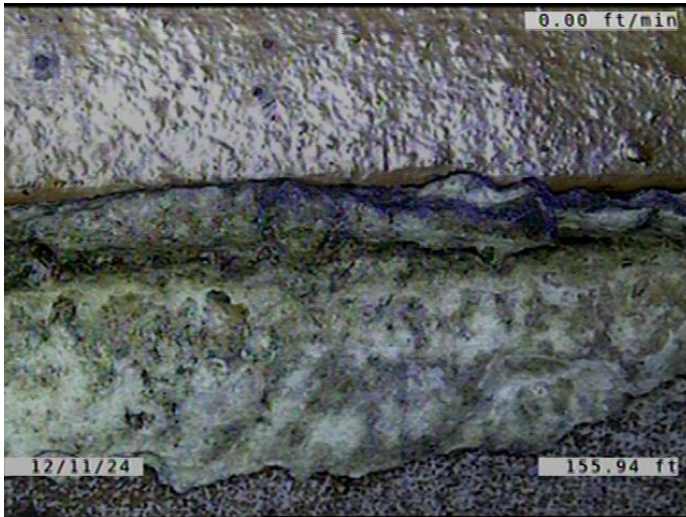
Code: **DAE**
Description: **Deposits Attached Encrustation**

Distance (ft): **155.9**
Structural Grade: **0**
O&M Grade: **2**
Clock Start/From: **7**
Clock To: **5**
1st Value:
2nd Value:
Value Percent: **5.000**
Continuous Index: **S05**
Within 8" of Joint: **YES**
Remarks:

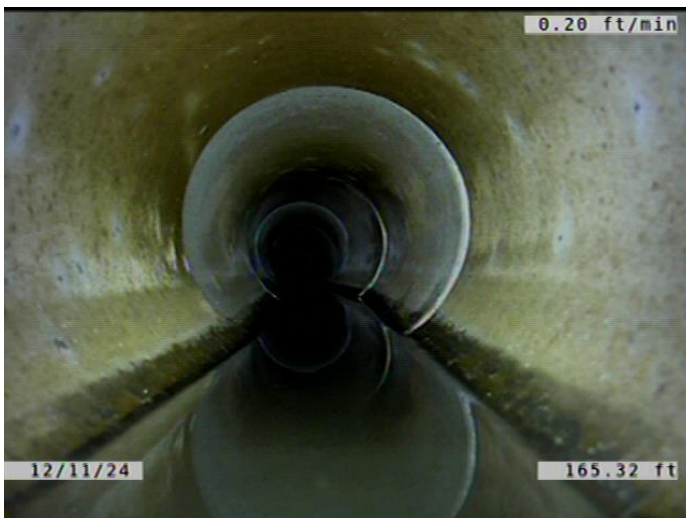
Code: **DAE**
Description: **Deposits Attached Encrustation**

Distance (ft): **165.3**
Structural Grade: **0**
O&M Grade: **2**
Clock Start/From: **7**
Clock To: **5**
1st Value:
2nd Value:
Value Percent: **5.000**
Continuous Index: **F05**
Within 8" of Joint: **YES**
Remarks:
