## Profile/Photo Observation Report

Date:	<b>12/11/2024</b>	Weather:		Coding:	<b>PACP 7.0</b>
Pipe Length (ft):	<b>235.0</b>	Owner:	<b>City of Hobart</b>	Pre Clean:	<b>Heavy Cleaning</b>
P.O.#:	<b>YES502259</b>	Surveyor:	<b>S. Bucklin</b>	PSR:	<b>P-507-035-028</b>
Customer:	<b>City of Hobart</b>	Clean Date:	<b>09/27/2024</b>	Shape:	<b>C</b>

Street:	<b>South Dekalb Street</b>	Flow Control:	<b>Not Controlled</b>
City:	<b>Hobart, IN</b>	Year Renewed:	
Location:	<b>Yard</b>	Tape/Media #:	
Purpose:	<b>Sewer System Evaluation Survey (SS</b>	Dia/Height:	<b>10"</b>
Use:	<b>Sanitary Sewage Pipe</b>	Material:	<b>VCP</b>
Drain Area:		Lining:	<b>None</b>
Category:	<b>NA</b>		
Comment:			
Location Details:		Direction of Survey:	<b>Upstream</b>
US MH:	<b>M-507-035</b>	DS MH:	<b>M-507-028</b>
		Total Length Surveyed (ft):	<b>89.3</b>

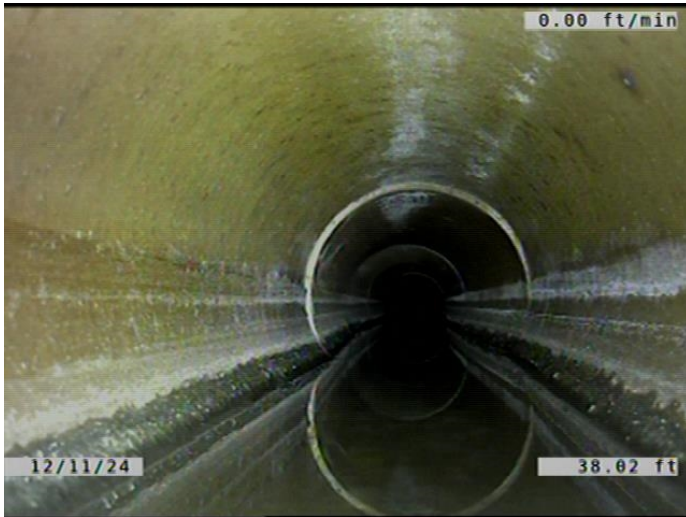
Code: **LR**  
Description: **Line Right**

Distance (ft): **38.0**  
Structural Grade: **0**  
O&M Grade: **1**  
Clock Start/From:  
Clock To:  
1st Value:  
2nd Value:  
Value Percent: **5.000**  
Continuous Index:  
Within 8" of Joint: **NO**  
Remarks:

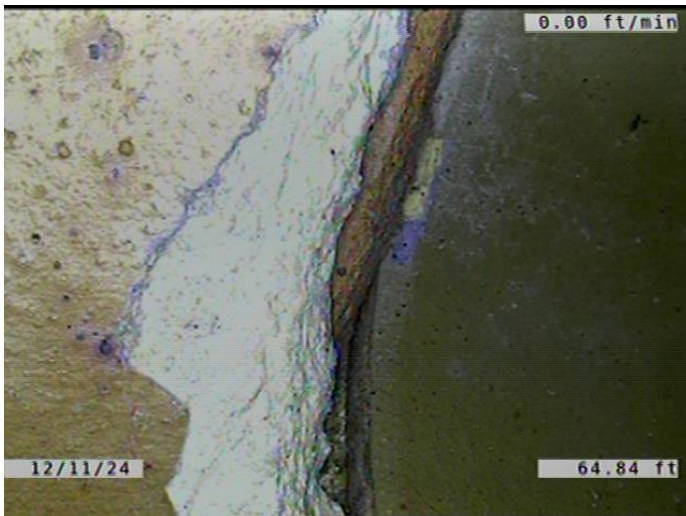
Code: **HSV**  
Description: **Hole Soil Visible**

Distance (ft): **64.8**  
Structural Grade: **5**  
O&M Grade: **0**  
Clock Start/From: **12**  
Clock To: **3**  
1st Value:  
2nd Value:  
Value Percent:  
Continuous Index:  
Within 8" of Joint: **YES**  
Remarks:

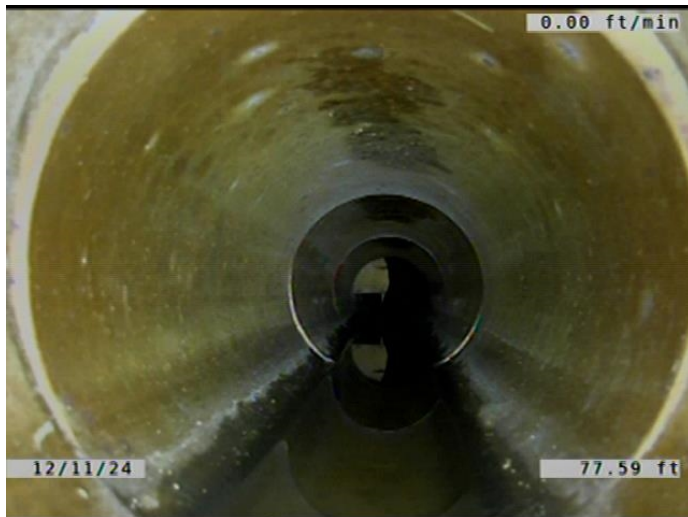
Code: **MWLS**  
 Description: **Miscellaneous Water Level Sag**

Distance (ft): **77.6**  
 Structural Grade: **2**  
 O&M Grade: **0**  
 Clock Start/From:  
 Clock To:  
 1st Value:  
 2nd Value:  
 Value Percent: **10.000**  
 Continuous Index: **S03**  
 Within 8" of Joint: **NO**  
 Remarks:

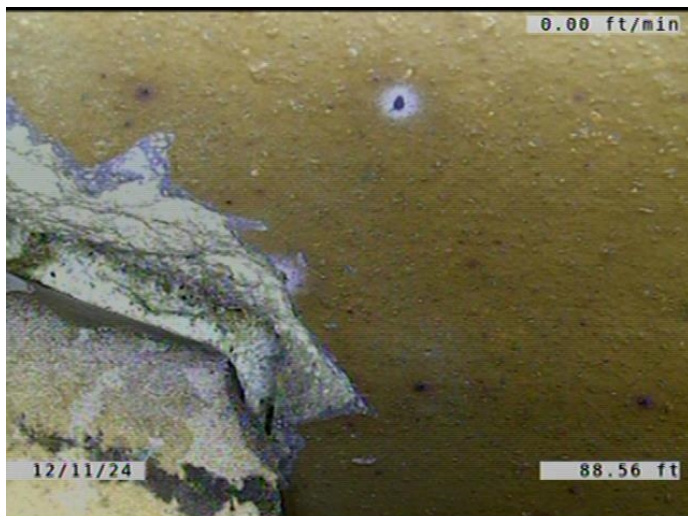
Code: **SSS**  
 Description: **Surface Damage Surface Spalling**

Distance (ft): **88.6**  
 Structural Grade: **2**  
 O&M Grade: **0**  
 Clock Start/From: **9**  
 Clock To: **12**  
 1st Value:  
 2nd Value:  
 Value Percent:  
 Continuous Index:  
 Within 8" of Joint: **YES**  
 Remarks:
