Profile/Photo Observation Report

Date:	12/11/2024	Weather:		Coding:	PACP 7.0
Pipe Length (ft):	235.0	Owner:	City of Hobart	Pre Clean:	Heavy Cleaning
P.O.#:	YES502259	Surveyor:	S. Bucklin	PSR:	P-507-035-028
Customer:	City of Hobart	Clean Date:	09/27/2024	Shape:	C

Street:	South Dekalb Street	Flow Control:	Not Controlled
City:	Hobart, IN	Year Renewed:	
Location:	Yard	Tape/Media #:	
Purpose:	Sewer System Evaluation Survey (SS	Dia/Height:	10"
Use:	Sanitary Sewage Pipe	Material:	VCP
Drain Area:		Lining:	None
Category:	NA		
Comment:			
Location Details:		Direction of Survey:	Downstream
US MH:	M-507-035	DS MH:	M-507-028
		Total Length Surveyed (ft):	116.8

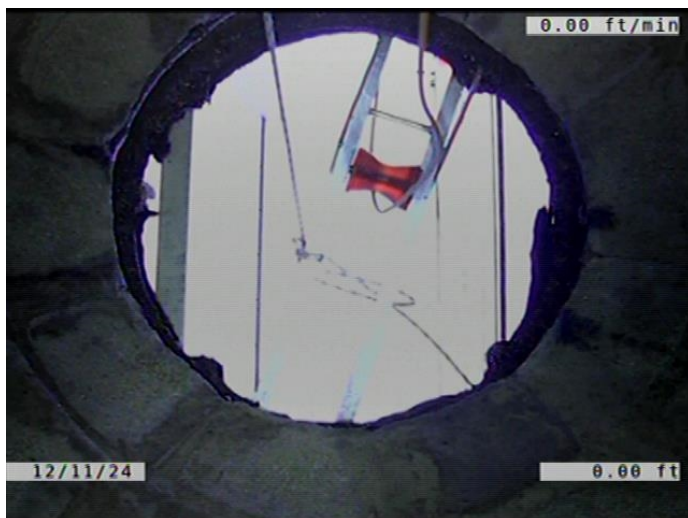
Code: **AMH**
 Description: **Manhole**

Distance (ft): **.0**
 Structural Grade: **0**
 O&M Grade: **0**
 Clock Start/From:
 Clock To:
 1st Value:
 2nd Value:
 Value Percent:
 Continuous Index:
 Within 8" of Joint: **NO**
 Remarks: **M-507-035**

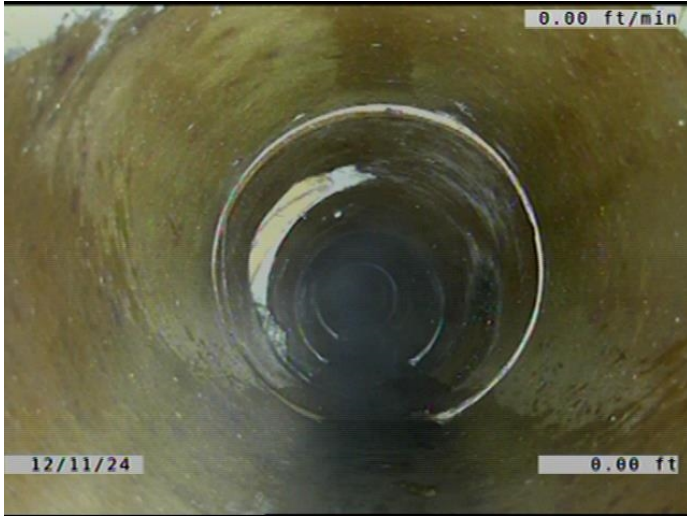
Code: **MWL**
Description: **Miscellaneous Water Level**

Distance (ft): **.0**
Structural Grade: **0**
O&M Grade: **0**
Clock Start/From:
Clock To:
1st Value:
2nd Value:
Value Percent: **5.000**
Continuous Index:
Within 8" of Joint: **NO**
Remarks:

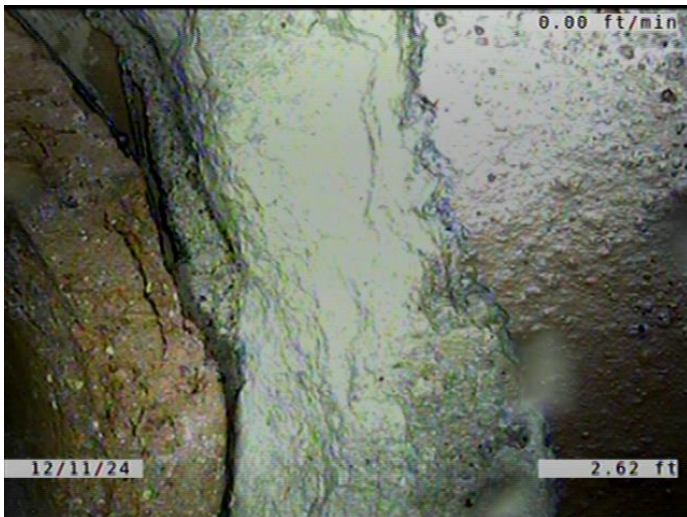
Code: **SSS**
Description: **Surface Damage Surface Spalling**

Distance (ft): **2.6**
Structural Grade: **2**
O&M Grade: **0**
Clock Start/From: **9**
Clock To: **12**
1st Value:
2nd Value:
Value Percent:
Continuous Index:
Within 8" of Joint: **YES**
Remarks:

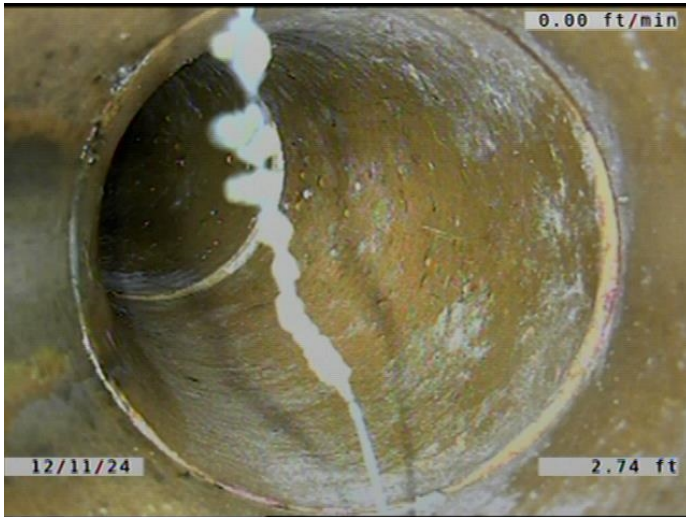
Code: **TBD**
Description: **Tap Break-in/Hammer Defective**

Distance (ft): **2.7**
Structural Grade: **0**
O&M Grade: **3**
Clock Start/From: **10**
Clock To:
1st Value: **6.000**
2nd Value:
Value Percent:
Continuous Index:
Within 8" of Joint: **NO**
Remarks: **Defective**

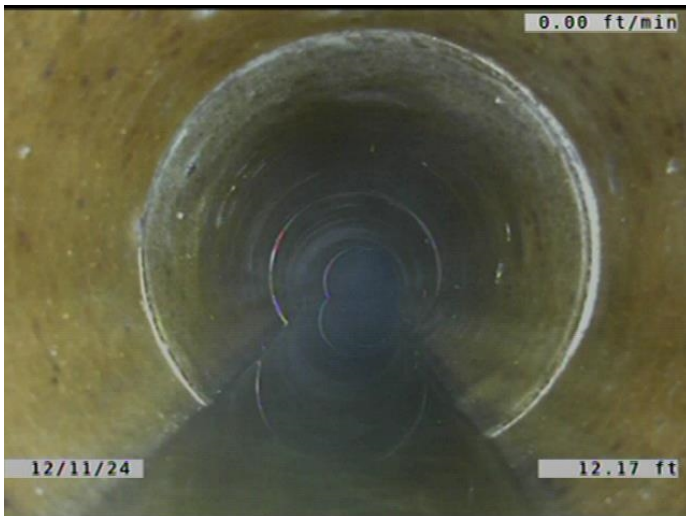
Code: **MWLS**
Description: **Miscellaneous Water Level Sag**

Distance (ft): **12.2**
Structural Grade: **3**
O&M Grade: **0**
Clock Start/From:
Clock To:
1st Value:
2nd Value:
Value Percent: **35.000**
Continuous Index: **S01**
Within 8" of Joint: **NO**
Remarks:

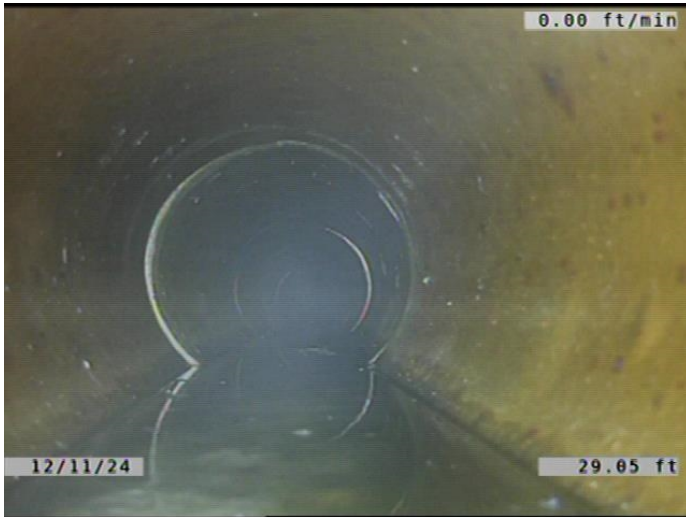
Code: **LL**
Description: **Line Left**

Distance (ft): **29.0**
Structural Grade: **0**
O&M Grade: **1**
Clock Start/From:
Clock To:
1st Value:
2nd Value:
Value Percent: **5.000**
Continuous Index:
Within 8" of Joint: **NO**
Remarks:

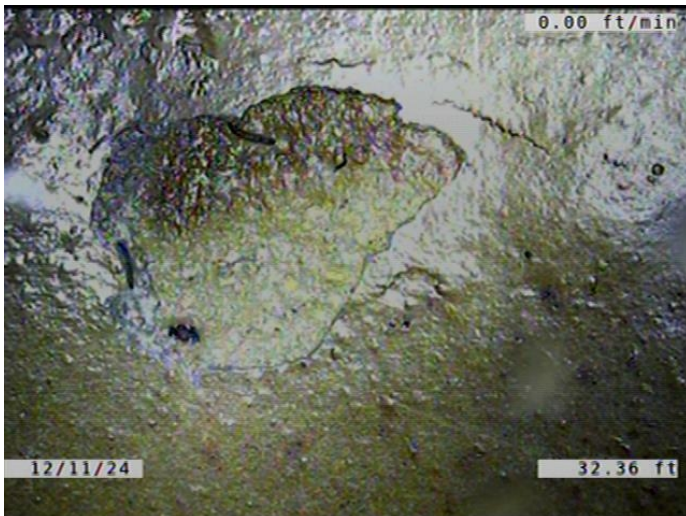
Code: **SSS**
Description: **Surface Damage Surface Spalling**

Distance (ft): **32.4**
Structural Grade: **2**
O&M Grade: **0**
Clock Start/From: **2**
Clock To:
1st Value:
2nd Value:
Value Percent:
Continuous Index:
Within 8" of Joint: **YES**
Remarks:

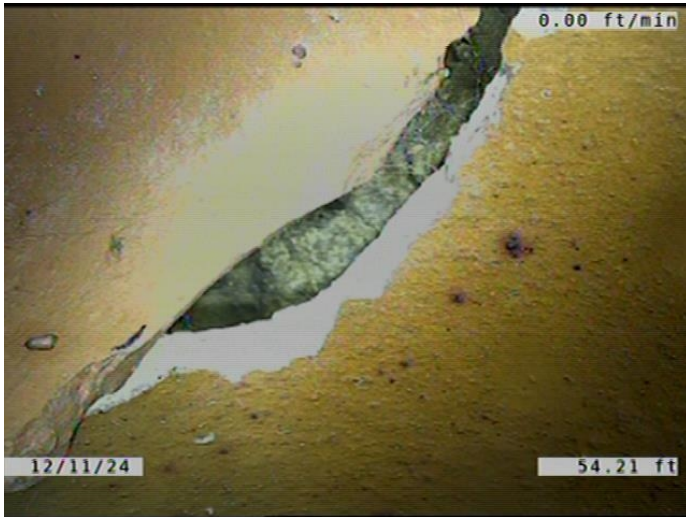
Code: **HVV**
 Description: **Hole Void Visible**

Distance (ft): **54.2**
 Structural Grade: **5**
 O&M Grade: **0**
 Clock Start/From: **9**
 Clock To: **12**
 1st Value:
 2nd Value:
 Value Percent:
 Continuous Index:
 Within 8" of Joint: **YES**
 Remarks:

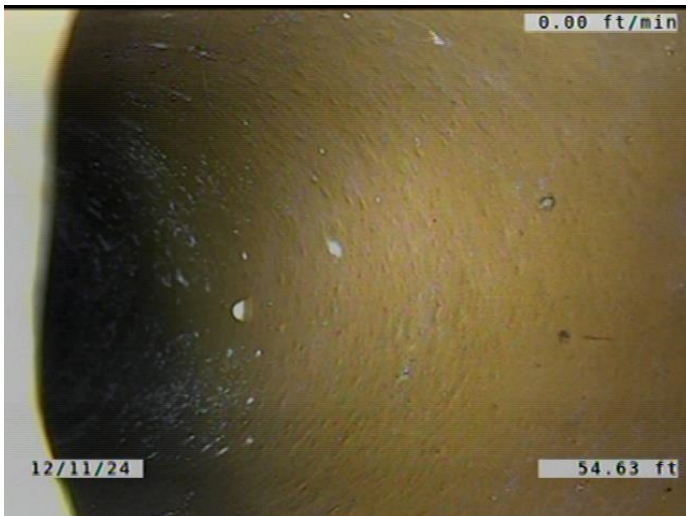
Code: **TBI**
 Description: **Tap Break-in Intruding**

Distance (ft): **54.6**
 Structural Grade: **0**
 O&M Grade: **2**
 Clock Start/From: **10**
 Clock To:
 1st Value: **6.000**
 2nd Value: **2.000**
 Value Percent:
 Continuous Index:
 Within 8" of Joint: **NO**
 Remarks:

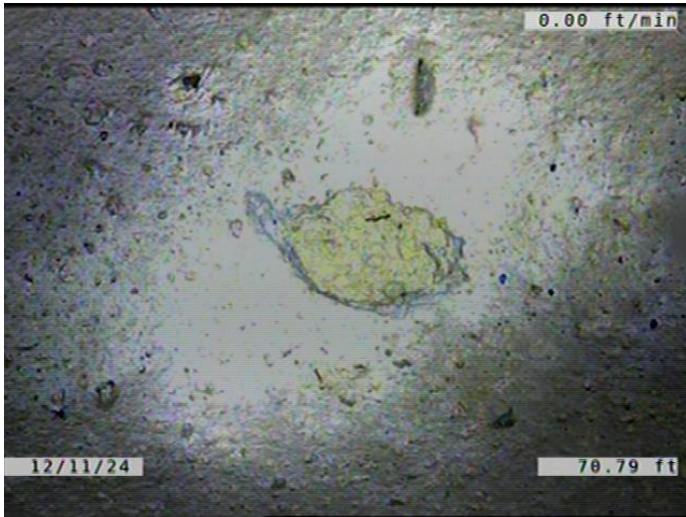
Code: **SSS**
 Description: **Surface Damage Surface Spalling**

Distance (ft): **70.8**
 Structural Grade: **2**
 O&M Grade: **0**
 Clock Start/From: **12**
 Clock To: **1**
 1st Value:
 2nd Value:
 Value Percent:
 Continuous Index:
 Within 8" of Joint: **YES**
 Remarks:

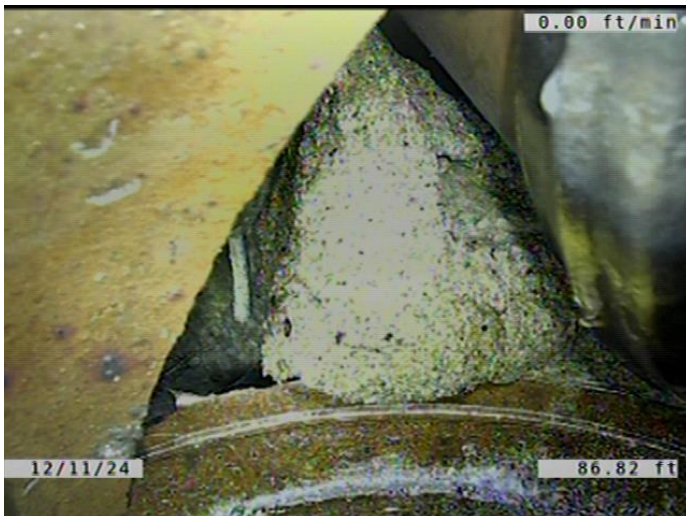
Code: **RPPD**
 Description: **Point Repair Patch Patch Defective**

Distance (ft): **86.8**
 Structural Grade: **4**
 O&M Grade: **0**
 Clock Start/From: **9**
 Clock To: **1**
 1st Value:
 2nd Value:
 Value Percent:
 Continuous Index:
 Within 8" of Joint: **YES**
 Remarks: **Soil visible**

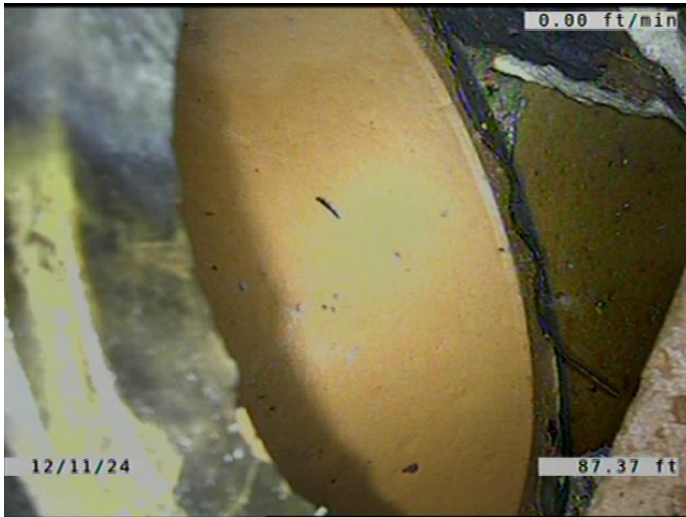
Code: **TBI**
 Description: **Tap Break-in Intruding**

Distance (ft): **87.4**
 Structural Grade: **0**
 O&M Grade: **2**
 Clock Start/From: **11**
 Clock To:
 1st Value: **6.000**
 2nd Value: **2.000**
 Value Percent:
 Continuous Index:
 Within 8" of Joint: **NO**
 Remarks: **CONSTANTLY DRIPPING WATER. VOID UNDER THE SERVICE.**

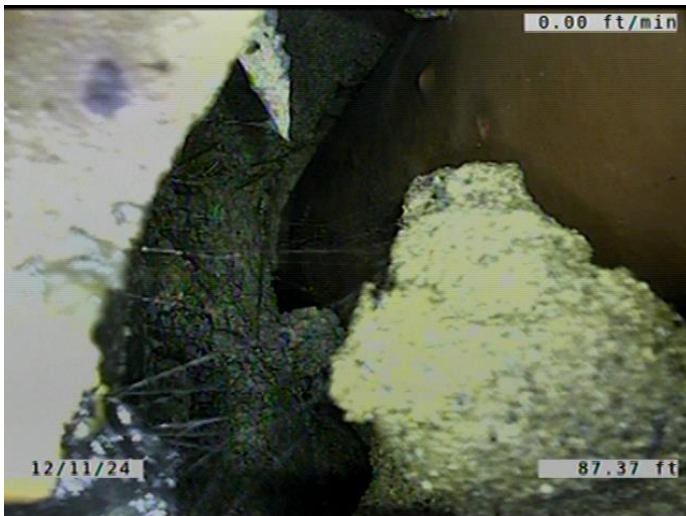
Code: **BSV**
 Description: **Broken Soil Visible**

Distance (ft): **87.4**
 Structural Grade: **5**
 O&M Grade: **0**
 Clock Start/From: **9**
 Clock To: **12**
 1st Value:
 2nd Value:
 Value Percent:
 Continuous Index:
 Within 8" of Joint: **YES**
 Remarks:

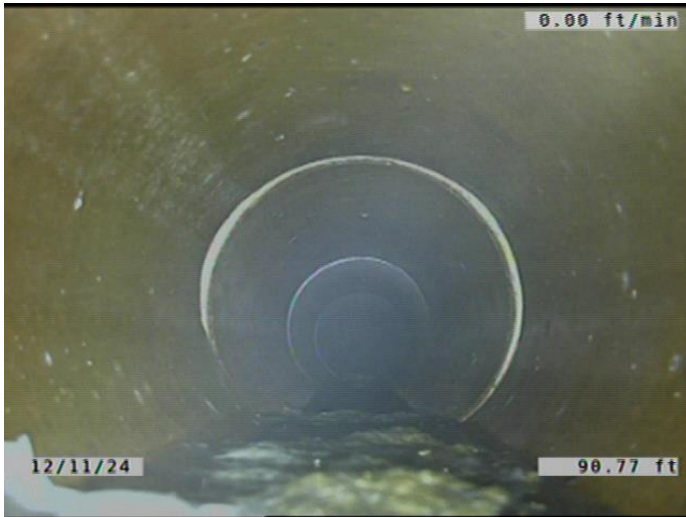
Code: **MWLS**
Description: **Miscellaneous Water Level Sag**

Distance (ft): **90.8**
Structural Grade: **3**
O&M Grade: **0**
Clock Start/From:
Clock To:
1st Value:
2nd Value:
Value Percent: **35.000**
Continuous Index: **F01**
Within 8" of Joint: **NO**
Remarks:

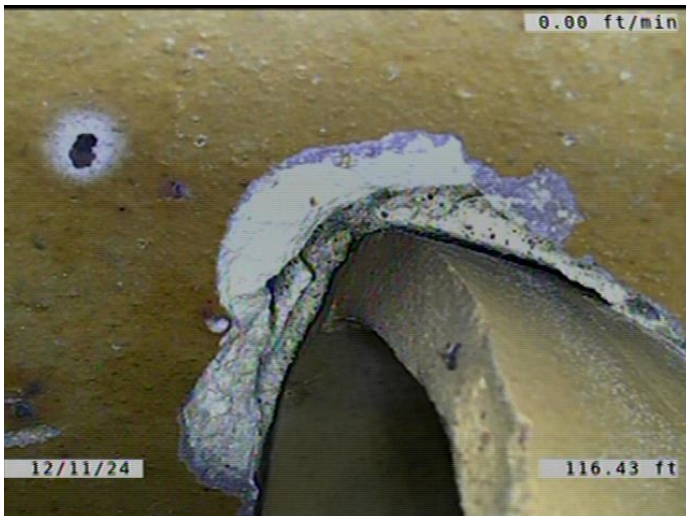
Code: **HSV**
Description: **Hole Soil Visible**

Distance (ft): **116.4**
Structural Grade: **5**
O&M Grade: **0**
Clock Start/From: **12**
Clock To: **3**
1st Value:
2nd Value:
Value Percent:
Continuous Index:
Within 8" of Joint: **YES**
Remarks:

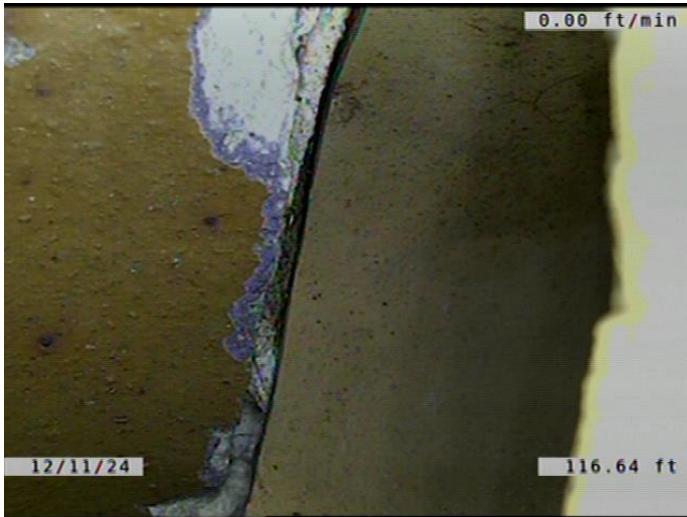
Code: **TBI**
 Description: **Tap Break-in Intruding**

Distance (ft): **116.6**
 Structural Grade: **0**
 O&M Grade: **2**
 Clock Start/From: **2**
 Clock To:
 1st Value: **6.000**
 2nd Value: **5.000**
 Value Percent:
 Continuous Index:
 Within 8" of Joint: **NO**
 Remarks: **Active**

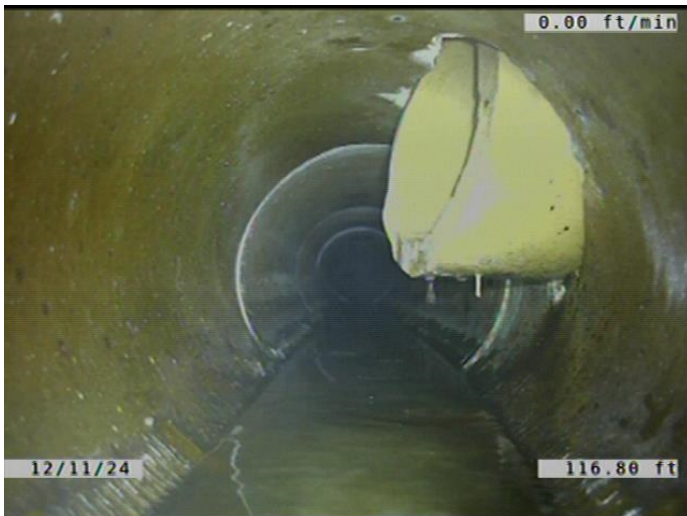
Code: **MSA**
 Description: **Miscellaneous Survey Abandoned**

Distance (ft): **116.8**
 Structural Grade: **0**
 O&M Grade: **0**
 Clock Start/From:
 Clock To:
 1st Value:
 2nd Value:
 Value Percent:
 Continuous Index:
 Within 8" of Joint: **NO**
 Remarks: **CAMERA CANT MAKE IT PAST PROTRUDING TAP. MADE IT TO THE**
