Profile/Photo Observation Report

| Street: | OFF CSOKASY LN | Flow Control: | Not Controlled |
| City: | Hobart, IN | Year Renewed: | |
| US MH: | M-507-029 | DS MH: | M-507-030 |

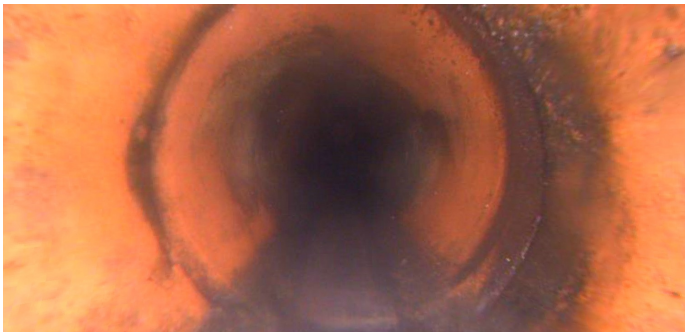
| Code: | IW |
| Description: | Infil Weeper |

| Distance (ft): | 33.1 |
| O&M Grade: | 2 |
| Clock Start/From: | 8 |
| Clock To: | 4 |

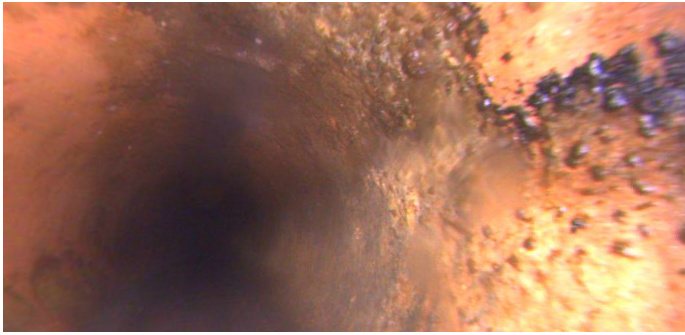
Code: **FL**
Description: **Fracture Longitudinal**

Distance (ft): **34.0**
Structural Grade: **3**
O&M Grade: **0**
Clock Start/From: **2**
Clock To:
1st Value:
2nd Value:
Value Percent:
Continuous Index:
Within 8" of Joint:
Remarks:

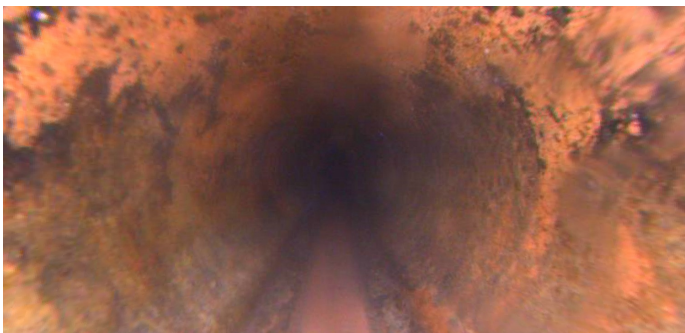
Code: **DAE**
Description: **Deposits Attached Encrustation**

Distance (ft): **39.4**
Structural Grade: **0**
O&M Grade: **2**
Clock Start/From: **7**
Clock To: **5**
1st Value:
2nd Value:
Value Percent: **5.000**
Continuous Index: **S01**
Within 8" of Joint: **NO**
Remarks:

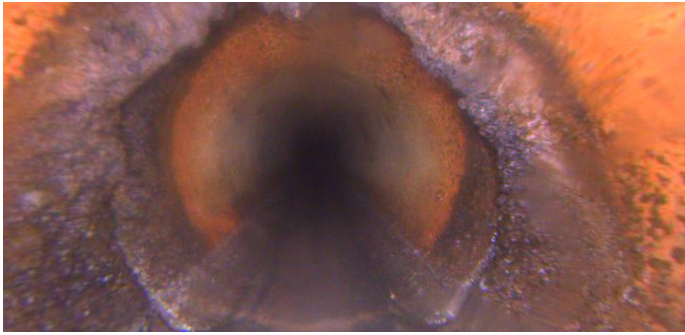
| Code: | DAE |
| Description: | Deposits Attached Encrustation |

| Distance (ft): | 43.2 |
| O&M Grade: | 2 |
| Value Percent: | 10.000 |

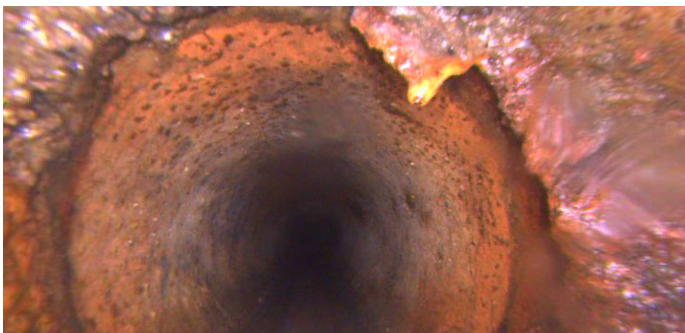
| Code: | ID |
| Description: | Infil Dripper |

| Distance (ft): | 53.4 |
| O&M Grade: | 3 |
| Clock Start/From: | 1 |

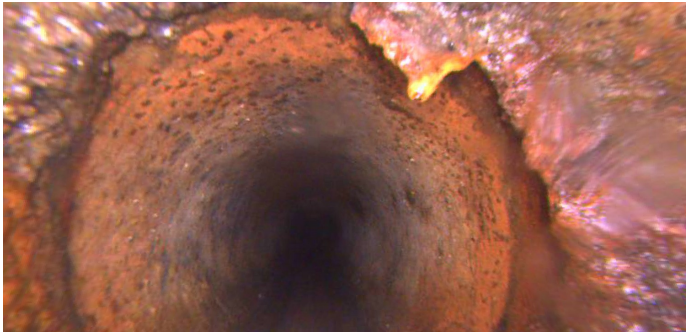
Code: **DAE**
Description: **Deposits Attached Encrustation**

Distance (ft): **53.4**
Structural Grade: **0**
O&M Grade: **2**
Clock Start/From: **8**
Clock To: **4**
1st Value:
2nd Value:
Value Percent: **10.000**
Continuous Index:
Within 8" of Joint: **YES**
Remarks:

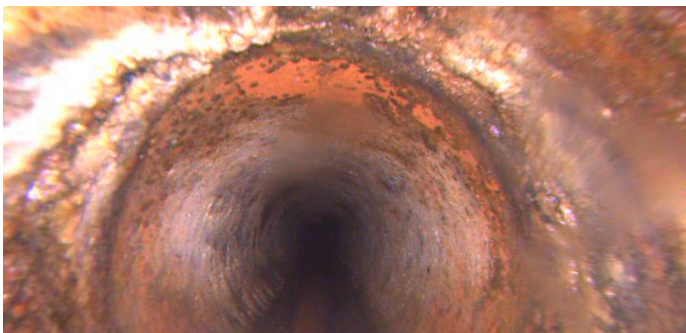
Code: **DAE**
Description: **Deposits Attached Encrustation**

Distance (ft): **63.5**
Structural Grade: **0**
O&M Grade: **2**
Clock Start/From: **8**
Clock To: **4**
1st Value:
2nd Value:
Value Percent: **5.000**
Continuous Index:
Within 8" of Joint: **YES**
Remarks:

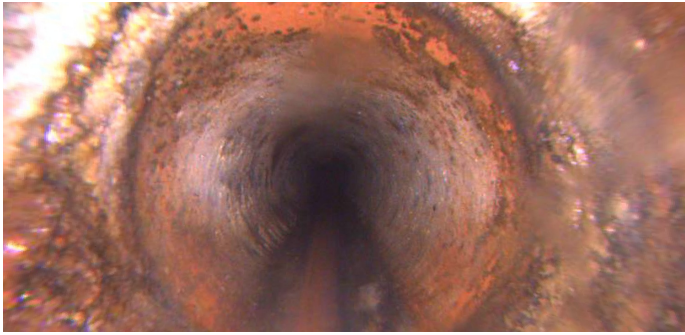
Code: **IW**
Description: **Infil Weeper**

Distance (ft): **63.5**
Structural Grade: **0**
O&M Grade: **2**
Clock Start/From: **8**
Clock To: **4**
1st Value:
2nd Value:
Value Percent:
Continuous Index:
Within 8" of Joint: **YES**
Remarks:

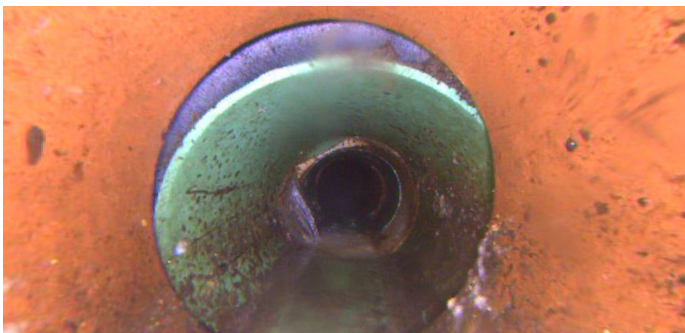
Code: **DAE**
Description: **Deposits Attached Encrustation**

Distance (ft): **88.4**
Structural Grade: **0**
O&M Grade: **2**
Clock Start/From: **7**
Clock To: **5**
1st Value:
2nd Value:
Value Percent: **5.000**
Continuous Index: **F01**
Within 8" of Joint: **NO**
Remarks:

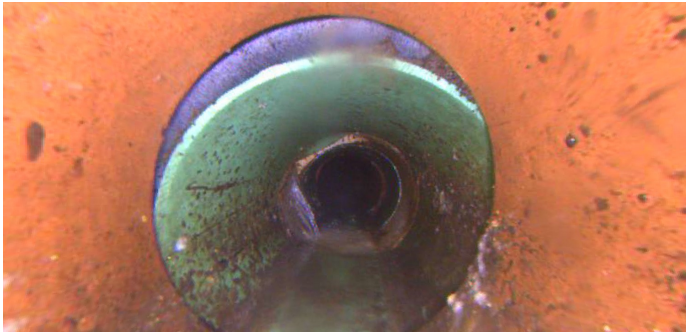
Code: **JOL**
Description: **Joint Offset Large**

Distance (ft): **88.4**
Structural Grade: **2**
O&M Grade: **0**
Clock Start/From:
Clock To:
1st Value:
2nd Value:
Value Percent:
Continuous Index:
Within 8" of Joint: **NO**
Remarks:

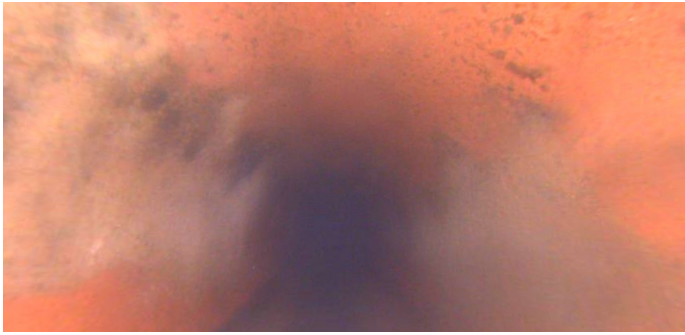
Code: **DAE**
Description: **Deposits Attached Encrustation**

Distance (ft): **98.1**
Structural Grade: **0**
O&M Grade: **2**
Clock Start/From: **8**
Clock To: **4**
1st Value:
2nd Value:
Value Percent: **5.000**
Continuous Index: **S02**
Within 8" of Joint: **NO**
Remarks:

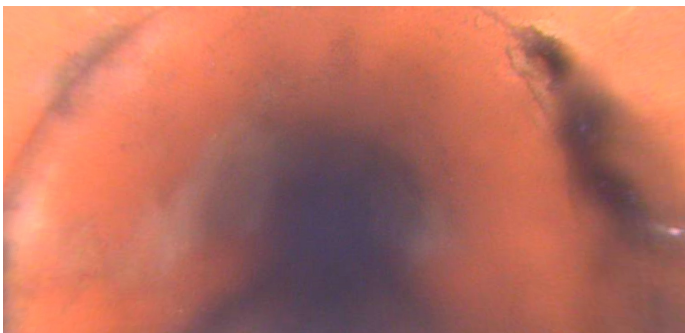
Code: **IW**
Description: **Infil Weeper**

Distance (ft): **100.7**
Structural Grade: **0**
O&M Grade: **2**
Clock Start/From: **8**
Clock To: **4**
1st Value:
2nd Value:
Value Percent:
Continuous Index:
Within 8" of Joint: **YES**
Remarks:

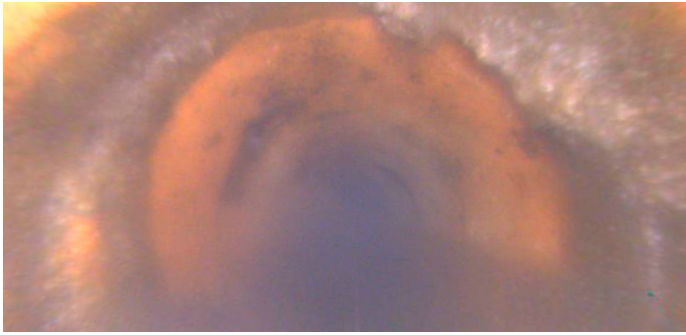
Code: **DAE**
Description: **Deposits Attached Encrustation**

Distance (ft): **131.5**
Structural Grade: **0**
O&M Grade: **2**
Clock Start/From: **8**
Clock To: **4**
1st Value:
2nd Value:
Value Percent: **10.000**
Continuous Index:
Within 8" of Joint: **YES**
Remarks:

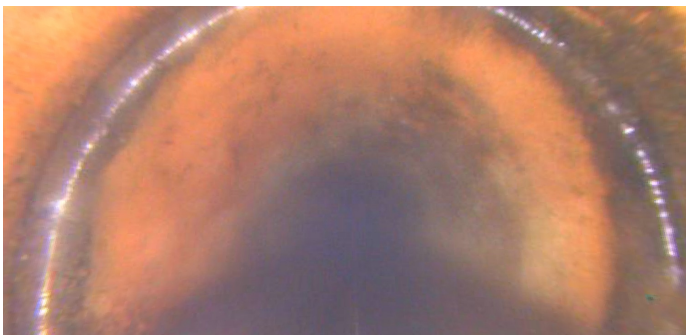
Code: **IW**
Description: **Infil Weeper**

Distance (ft): **141.5**
Structural Grade: **0**
O&M Grade: **2**
Clock Start/From: **8**
Clock To: **4**
1st Value:
2nd Value:
Value Percent:
Continuous Index:
Within 8" of Joint: **YES**
Remarks:

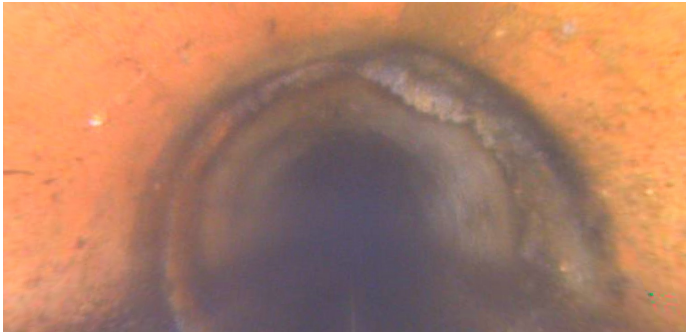
Code: **DAE**
Description: **Deposits Attached Encrustation**

Distance (ft): **146.7**
Structural Grade: **0**
O&M Grade: **2**
Clock Start/From: **8**
Clock To: **4**
1st Value:
2nd Value:
Value Percent: **10.000**
Continuous Index:
Within 8" of Joint: **YES**
Remarks:

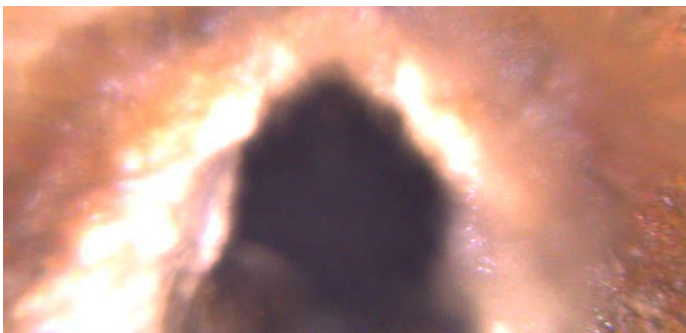
| Comment: | P_C at O_C 155 ft build up at O_C . Flow direction wrong | | |

Code: **DAE**
Description: **Deposits Attached Encrustation**

Distance (ft): **155.9**
Structural Grade: **0**
O&M Grade: **5**
Clock Start/From: **8**
Clock To: **4**
1st Value:
2nd Value:
Value Percent: **40.000**
Continuous Index:
Within 8" of Joint: **NO**
Remarks: **at MH**

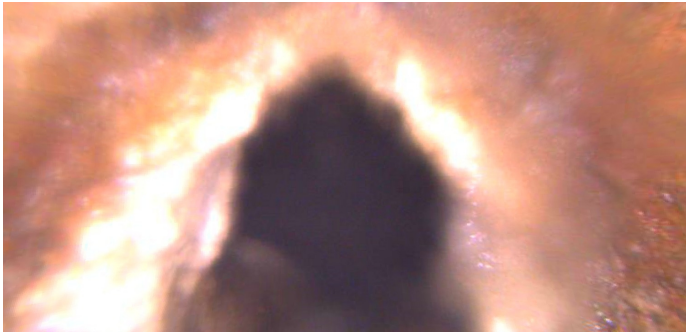
Code: **DAE**
Description: **Deposits Attached Encrustation**

Distance (ft): **155.9**
Structural Grade: **0**
O&M Grade: **2**
Clock Start/From: **8**
Clock To: **4**
1st Value:
2nd Value:
Value Percent: **5.000**
Continuous Index: **F02**
Within 8" of Joint: **NO**
Remarks:
