Profile/Photo Observation Report

Date:	10/25/2021	Weather:		Coding:	PACP 6.0
Pipe Length (ft):		Owner:	Hobart, IN	Pre Clean:	Not Known
P.O.#:	1004_1	Surveyor:	M. Pielacha	PSR:	P-507-082-029
Customer:	Hobart, IN	Clean Date:		Shape:	C

Street:	Off Dekalb Court	Flow Control:	Not Controlled
City:	Hobart, IN	Year Renewed:	
Location:	Yard	Tape/Media #:	1004
Purpose:	Routine Assessment	Dia/Height:	12"
Use:	Sanitary	Material:	VCP
Drain Area:		Lining:	
Category:	NA		
Comment:			
Location Details:		Direction of Survey:	Downstream
US MH:	M-507-29	DS MH:	M-507-82
		Total Length Surveyed (ft):	.1

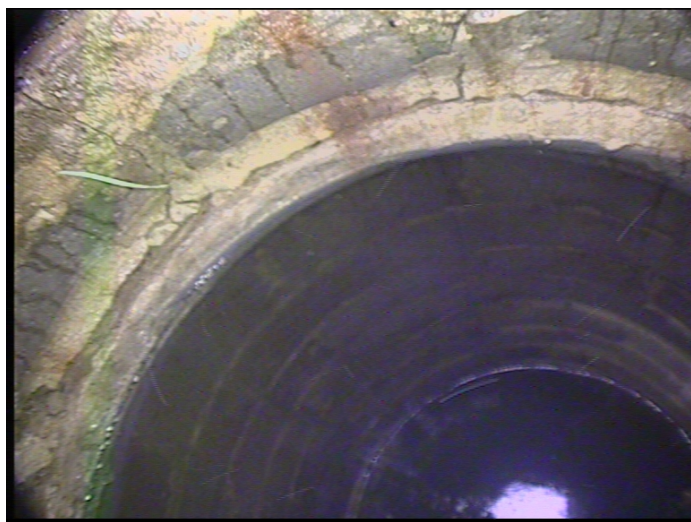
Code: **AMH**
Description: **Manhole**

Distance (ft): **.0**
Structural Grade: **0**
O&M Grade: **0**
Clock Start/From:
Clock To:
1st Value:
2nd Value:
Value Percent:
Continuous Index:
Within 8" of Joint: **NO**
Remarks: **M-507-29**

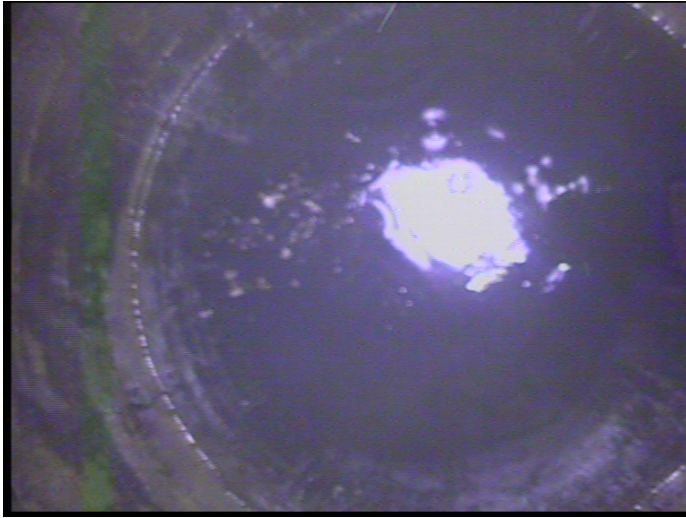
Code: **MWL**
Description: **Water Level**

Distance (ft): **.0**
Structural Grade: **0**
O&M Grade: **0**
Clock Start/From:
Clock To:
1st Value:
2nd Value:
Value Percent: **100.000**
Continuous Index:
Within 8" of Joint: **NO**
Remarks: **surcharged**

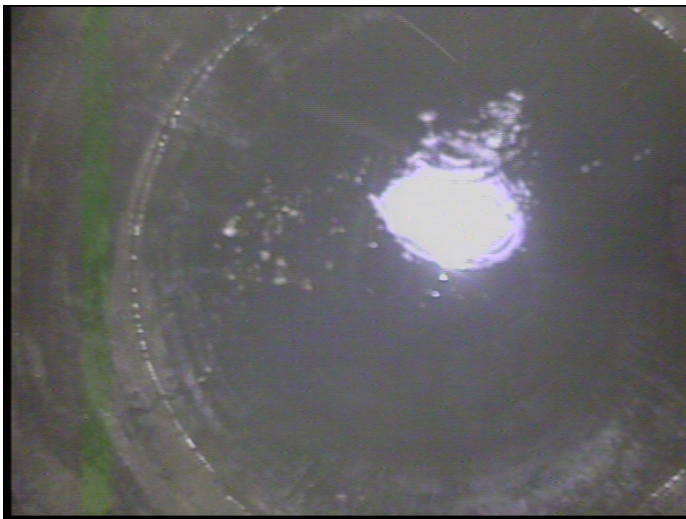
Code: **MSA**
Description: **Abandoned Survey**

Distance (ft): **.0**
Structural Grade: **0**
O&M Grade: **0**
Clock Start/From:
Clock To:
1st Value:
2nd Value:
Value Percent:
Continuous Index:
Within 8" of Joint: **NO**
Remarks: **surcharged**
