## Profile/Photo Observation Report

Street:	<b>S DECATUR ST</b>	Flow Control:	<b>Not Controlled</b>
City:	<b>Hobart, IN</b>	Year Renewed:	
Location:	<b>Woods</b>	Tape/Media #:	
Purpose:	<b>Routine Assessment</b>	Dia/Height:	<b>8"</b>
Use:	<b>Sanitary</b>	Material:	<b>PVC</b>
Drain Area:	<b>NA</b>	Lining:	
Category:	<b>NA</b>		
Comment:	<b>R_M at 229 ft nothing visible . Flow direction wrong</b>		
Location Details:		Direction of Survey:	<b>Upstream</b>
US MH:	<b>M-507-029</b>	DS MH:	<b>M-507-100</b>
		Total Length Surveyed (ft):	<b>230.1</b>

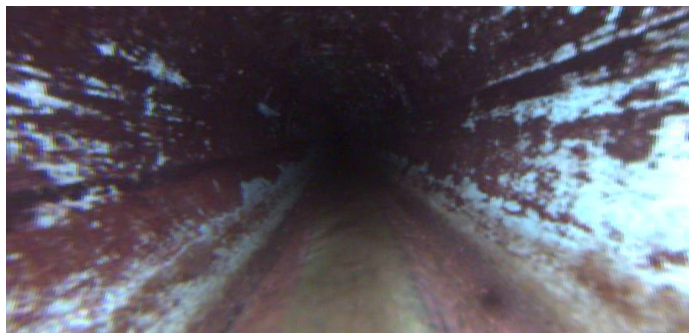
Code: **AMH**  
Description: **Manhole**

Distance (ft): **.0**  
Structural Grade: **0**  
O&M Grade: **0**  
Clock Start/From:  
Clock To:  
1st Value:  
2nd Value:  
Value Percent:  
Continuous Index:  
Within 8" of Joint: **NO**  
Remarks: **M-507-100**

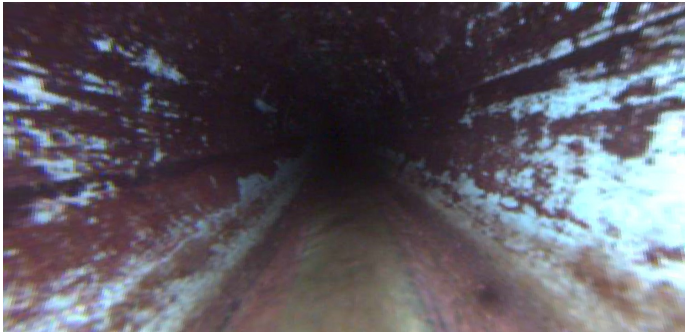
Code:	<b>MWL</b>
Description:	<b>Water Level</b>

Distance (ft):	<b>.0</b>
Structural Grade:	<b>0</b>
O&M Grade:	<b>0</b>
Clock Start/From:	
Clock To:	
1st Value:	
2nd Value:	
Value Percent:	<b>5.000</b>
Continuous Index:	
Within 8" of Joint:	<b>NO</b>
Remarks:

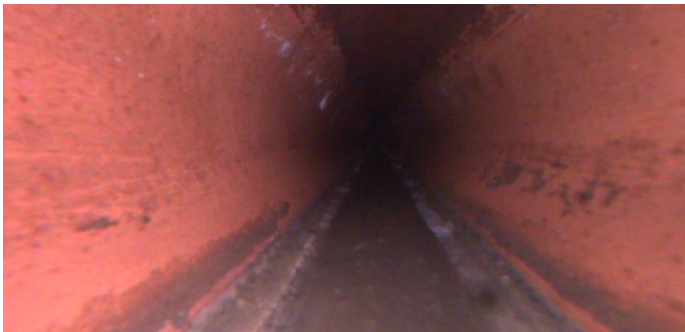
Code:	<b>MMC</b>
Description:	<b>Material Change</b>

Distance (ft):	<b>104.1</b>
Structural Grade:	<b>0</b>
O&M Grade:	<b>0</b>
Clock Start/From:	
Clock To:	
1st Value:	
2nd Value:	
Value Percent:	
Continuous Index:	
Within 8" of Joint:	<b>NO</b>
Remarks:	<b>VCP</b>

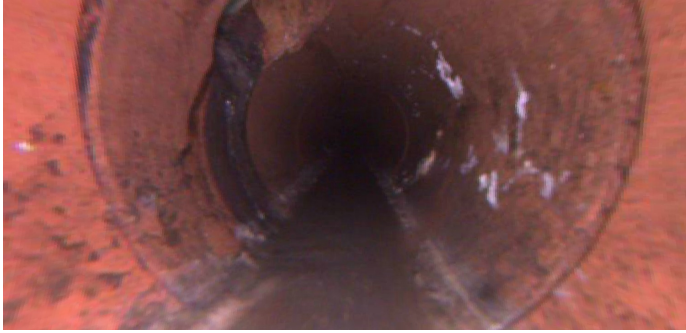
Code: **DAE**  
Description: **Deposits Attached Encrustation**

Distance (ft): **145.6**  
Structural Grade: **0**  
O&M Grade: **2**  
Clock Start/From: **7**  
Clock To: **10**  
1st Value:  
2nd Value:  
Value Percent: **5.000**  
Continuous Index:  
Within 8" of Joint: **NO**  
Remarks:

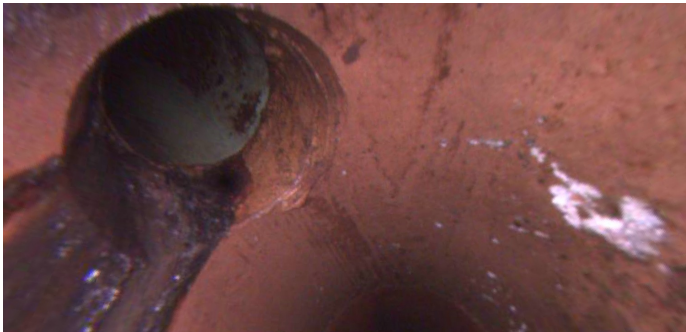
Code: **TFA**  
Description: **Tap Factory Active**

Distance (ft): **146.3**  
Structural Grade: **0**  
O&M Grade: **0**  
Clock Start/From: **11**  
Clock To:  
1st Value: **4.000**  
2nd Value:  
Value Percent:  
Continuous Index:  
Within 8" of Joint:  
Remarks:

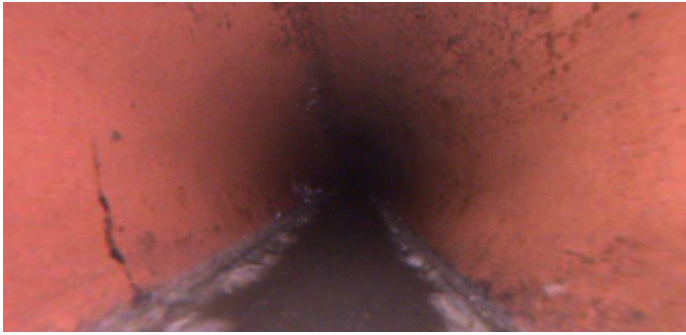
Code: **FC**  
Description: **Fracture Circumferential**

Distance (ft): **148.2**  
Structural Grade: **2**  
O&M Grade: **0**  
Clock Start/From: **8**  
Clock To: **9**  
1st Value:  
2nd Value:  
Value Percent:  
Continuous Index:  
Within 8" of Joint:  
Remarks:

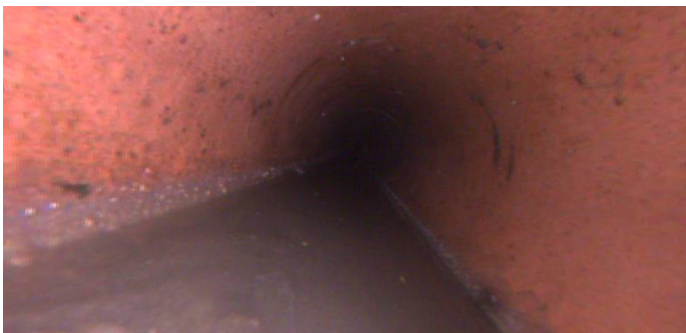
Code: **MSA**  
Description: **Abandoned Survey**

Distance (ft): **230.1**  
Structural Grade: **0**  
O&M Grade: **0**  
Clock Start/From:  
Clock To:  
1st Value:  
2nd Value:  
Value Percent:  
Continuous Index:  
Within 8" of Joint: **NO**  
Remarks: **UNKNOWN**
