## Profile/Photo Observation Report

Date:	<b>03/28/2018</b>	Weather:		Coding:	<b>PACP 6.0</b>
Pipe Length (ft):	<b>246.9</b>	Owner:	<b>NA</b>	Pre Clean:	<b>No Pre-Cleaning</b>
P.O.#:		Surveyor:	<b>Selasie Honu</b>	PSR:	<b>P-507-100-029</b>
Customer:		Clean Date:	<b>01/01/1900</b>	Shape:	<b>C</b>

Street:	<b>FOXCROFT STREET</b>	Flow Control:	<b>Not Controlled</b>
City:	<b>Hobart, IN</b>	Year Renewed:	
Location:	<b>Woods</b>	Tape/Media #:	
Purpose:	<b>Routine Assessment</b>	Dia/Height:	<b>8"</b>
Use:	<b>Sanitary</b>	Material:	<b>PVC</b>
Drain Area:	<b>NA</b>	Lining:	
Category:	<b>NA</b>		
Comment:	<b>R_M at 229 ft nothing visible . Flow direction wrong</b>		
Location Details:		Direction of Survey:	<b>Upstream</b>
US MH:	<b>M-507-029</b>	DS MH:	<b>M-507-100</b>
		Total Length Surveyed (ft):	<b>230.1</b>

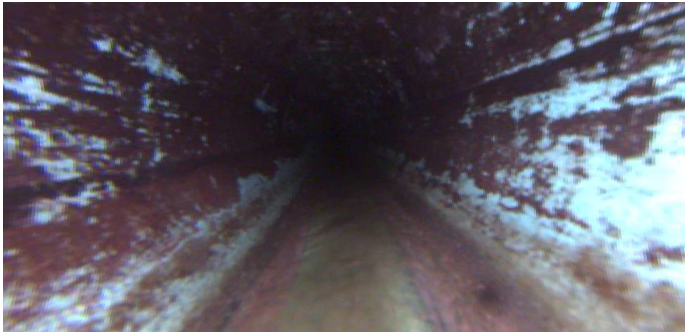
Code:	<b>MWL</b>
Description:	<b>Water Level</b>

Distance (ft):	<b>.0</b>
Structural Grade:	<b>0</b>
O&M Grade:	<b>0</b>
Clock Start/From:	
Clock To:	
1st Value:	
2nd Value:	
Value Percent:	<b>5.000</b>
Continuous Index:	
Within 8" of Joint:	<b>NO</b>
Remarks:

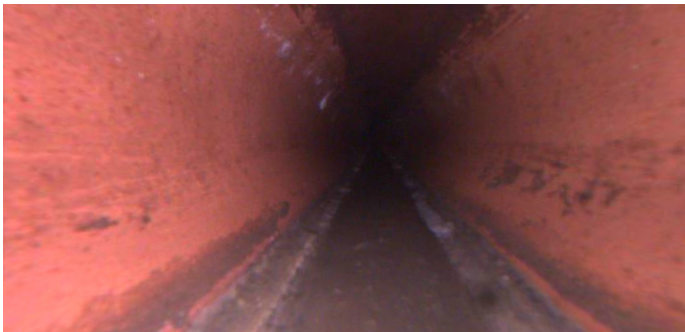
Code:	<b>MMC</b>
Description:	<b>Material Change</b>

Distance (ft):	<b>104.1</b>
Structural Grade:	<b>0</b>
O&M Grade:	<b>0</b>
Clock Start/From:	
Clock To:	
1st Value:	
2nd Value:	
Value Percent:	
Continuous Index:	
Within 8" of Joint:	<b>NO</b>
Remarks:	<b>VCP</b>

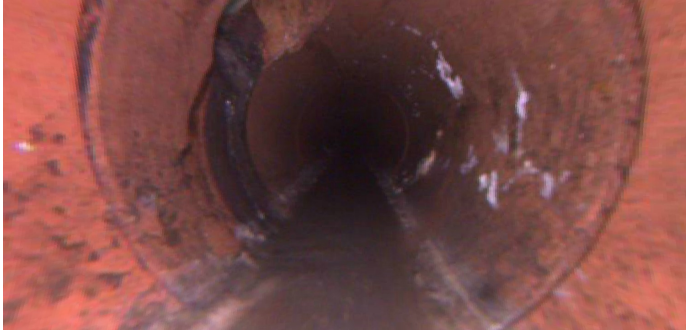
Code: **DAE**  
Description: **Deposits Attached Encrustation**

Distance (ft): **145.6**  
Structural Grade: **0**  
O&M Grade: **2**  
Clock Start/From: **7**  
Clock To: **10**  
1st Value:  
2nd Value:  
Value Percent: **5.000**  
Continuous Index:  
Within 8" of Joint: **NO**  
Remarks:

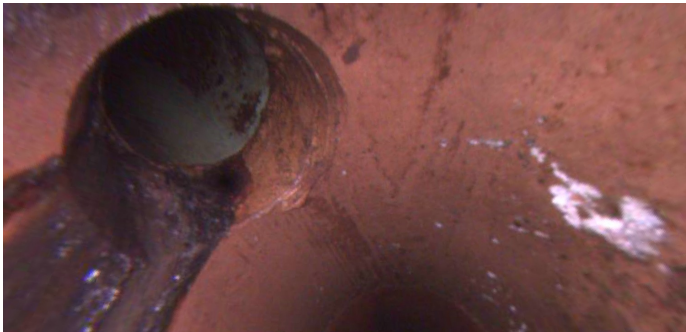
Code: **TFA**  
Description: **Tap Factory Active**

Distance (ft): **146.3**  
Structural Grade: **0**  
O&M Grade: **0**  
Clock Start/From: **11**  
Clock To:  
1st Value: **4.000**  
2nd Value:  
Value Percent:  
Continuous Index:  
Within 8" of Joint:  
Remarks:

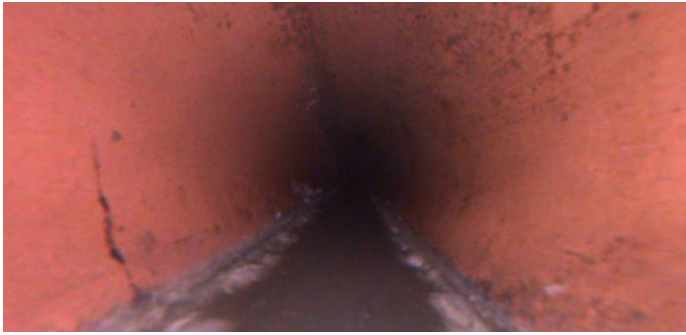
Code: **FC**  
Description: **Fracture Circumferential**

Distance (ft): **148.2**  
Structural Grade: **2**  
O&M Grade: **0**  
Clock Start/From: **8**  
Clock To: **9**  
1st Value:  
2nd Value:  
Value Percent:  
Continuous Index:  
Within 8" of Joint:  
Remarks:

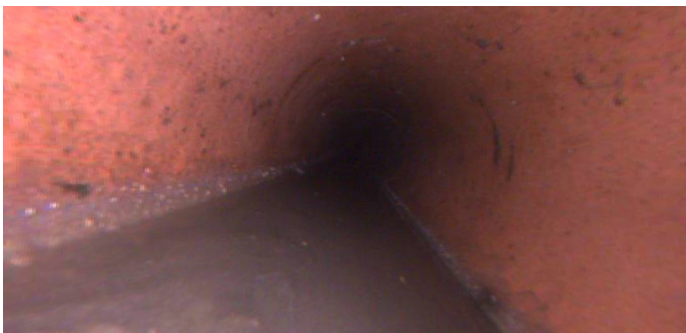
Code: **MSA**  
Description: **Abandoned Survey**

Distance (ft): **230.1**  
Structural Grade: **0**  
O&M Grade: **0**  
Clock Start/From:  
Clock To:  
1st Value:  
2nd Value:  
Value Percent:  
Continuous Index:  
Within 8" of Joint: **NO**  
Remarks: **UNKNOWN**
