Profile/Photo Observation Report

Street:	S DECATUR ST	Flow Control:	Not Controlled
City:	Hobart, IN	Year Renewed:	
Location:	Woods	Tape/Media #:	
Purpose:	Routine Assessment	Dia/Height:	12"
Use:	Sanitary	Material:	VCP
Drain Area:	NA	Lining:	
Category:	NA		
Comment:	R_M at 32 ft debris . Flow direction wrong		
Location Details:		Direction of Survey:	Downstream
US MH:	M-507-029	DS MH:	M-507-100
		Total Length Surveyed (ft):	35.8

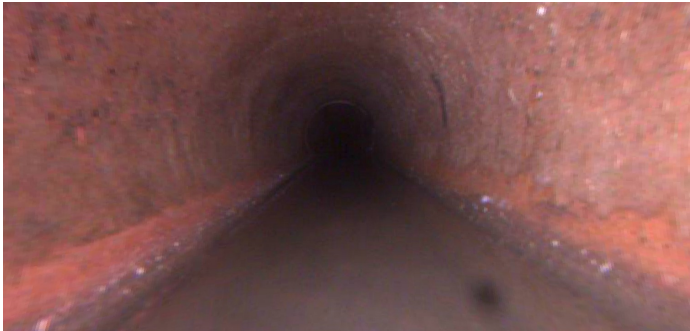
Code: AMH

Description: Manhole

Remarks: M-507-029

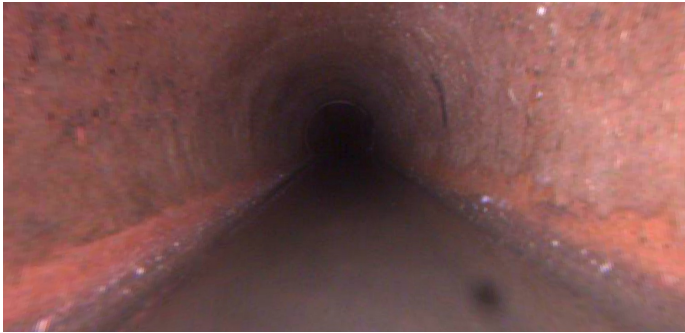
Code:	MWL
Description:	Water Level

Distance (ft):	.0
Structural Grade:	0
O&M Grade:	0
Clock Start/From:	
Clock To:	
1st Value:	
2nd Value:	
Value Percent:	5.000
Continuous Index:	
Within 8" of Joint:	NO
Remarks:

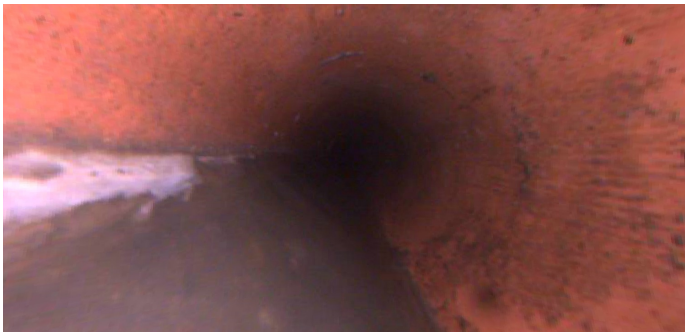
Code:	MSA
Description:	Abandoned Survey

Distance (ft):	35.8
Structural Grade:	0
O&M Grade:	0
Clock Start/From:	
Clock To:	
1st Value:	
2nd Value:	
Value Percent:	
Continuous Index:	
Within 8" of Joint:	NO
Remarks:	camera stopped
