Profile/Photo Observation Report

Street:	FOXCROFT STREET	Flow Control:	Not Controlled
City:	Hobart, IN	Year Renewed:	
Location:	Woods	Tape/Media #:	
Purpose:	Routine Assessment	Dia/Height:	12"
Use:	Sanitary	Material:	VCP
Drain Area:	NA	Lining:	
Category:	NA		
Comment:	R_M at 32 ft debris . Flow direction wrong		
Location Details:		Direction of Survey:	Downstream
US MH:	M-507-029	DS MH:	M-507-100
		Total Length Surveyed (ft):	35.8

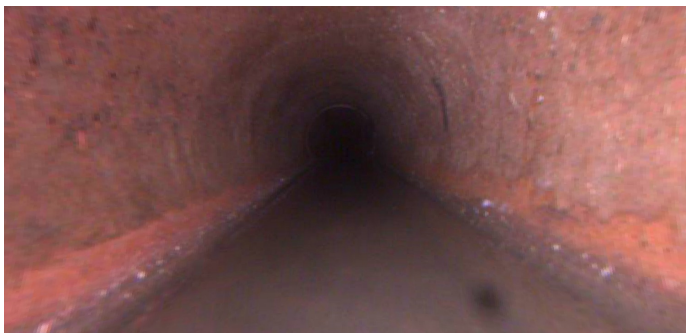
Code: **AMH**
Description: **Manhole**

Distance (ft): **.0**
Structural Grade: **0**
O&M Grade: **0**
Clock Start/From:
Clock To:
1st Value:
2nd Value:
Value Percent:
Continuous Index:
Within 8" of Joint: **NO**
Remarks: **M-507-029**

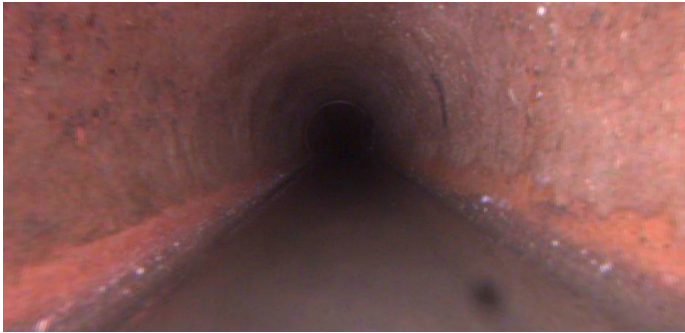
Code:	MWL
Description:	Water Level

Distance (ft):	.0
Structural Grade:	0
O&M Grade:	0
Clock Start/From:	
Clock To:	
1st Value:	
2nd Value:	
Value Percent:	5.000
Continuous Index:	
Within 8" of Joint:	NO
Remarks:

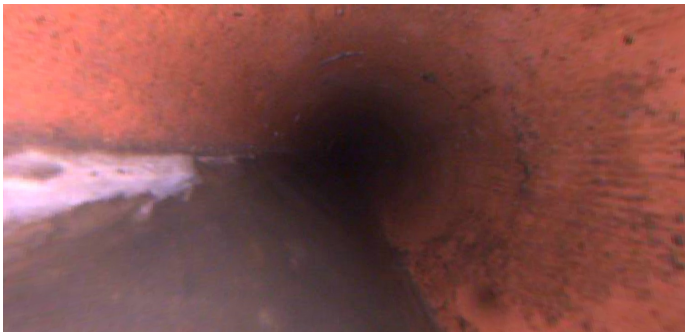
Code:	MSA
Description:	Abandoned Survey

Distance (ft):	35.8
Structural Grade:	0
O&M Grade:	0
Clock Start/From:	
Clock To:	
1st Value:	
2nd Value:	
Value Percent:	
Continuous Index:	
Within 8" of Joint:	NO
Remarks:	camera stopped
