## Profile/Photo Observation Report

Date:	<b>03/29/2018</b>	Weather:		Coding:	<b>PACP 6.0</b>
Pipe Length (ft):	<b>118.4</b>	Owner:	<b>NA</b>	Pre Clean:	<b>No Pre-Cleaning</b>
P.O.#:		Surveyor:	<b>Jen Costello</b>	PSR:	<b>P-507-033-032</b>
Customer:		Clean Date:	<b>01/01/1900</b>	Shape:	<b>C</b>

Street:	<b>ALLEY BETWEEN S DECATUR ST &amp; S</b>	Flow Control:	<b>Not Controlled</b>
City:	<b>Hobart, IN</b>	Year Renewed:	
Location:	<b>Yard</b>	Tape/Media #:	
Purpose:	<b>Routine Assessment</b>	Dia/Height:	<b>10"</b>
Use:	<b>Sanitary</b>	Material:	<b>VCP</b>
Drain Area:	<b>NA</b>	Lining:	
Category:	<b>NA</b>		
Comment:	<b>Flow direction wrong</b>		
Location Details:		Direction of Survey:	<b>Upstream</b>
US MH:	<b>M-507-032</b>	DS MH:	<b>M-507-033</b>
		Total Length Surveyed (ft):	<b>136.4</b>

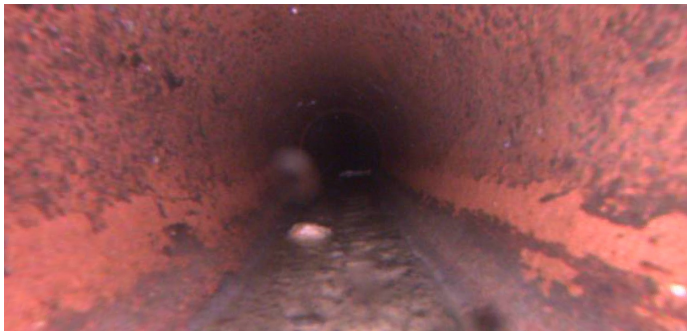
78.9	TFA	Tap Factory Active	219	NA
	130.7	CM	Crack Multiple	335	S 3
	134.4	DAE	Deposits Attached Encrustation	354	M 2
	136.4	AMH	Manhole	369	NA
<div> <div>Code:</div> <div>AMH</div> </div> <div> <div>Description:</div> <div>Manhole</div> </div> <div> <div>Distance (ft):</div> <div>.0</div> </div> <div> <div>Structural Grade:</div> <div>0</div> </div> <div> <div>O&amp;M Grade:</div> <div>0</div> </div> <div> <div>Clock Start/From:</div> <div></div> </div> <div> <div>Clock To:</div> <div></div> </div> <div> <div>1st Value:</div> <div></div> </div> <div> <div>2nd Value:</div> <div></div> </div> <div> <div>Value Percent:</div> <div></div> </div> <div> <div>Continuous Index:</div> <div></div> </div> <div> <div>Within 8" of Joint:</div> <div>NO</div> </div> <div> <div>Remarks:</div> <div>M-507-033</div> </div>

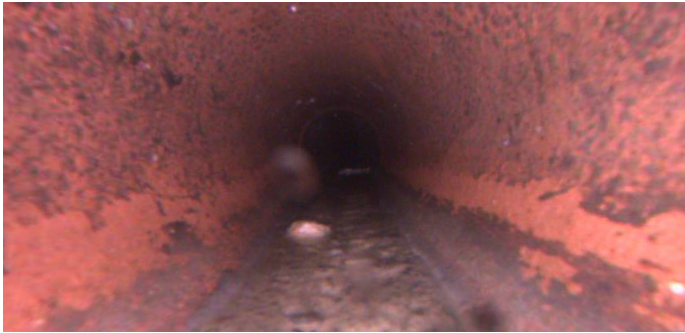
Code:	<b>MWL</b>
Description:	<b>Water Level</b>

Distance (ft):	<b>.0</b>
Structural Grade:	<b>0</b>
O&M Grade:	<b>0</b>
Clock Start/From:	
Clock To:	
1st Value:	
2nd Value:	
Value Percent:	<b>5.000</b>
Continuous Index:	
Within 8" of Joint:	<b>NO</b>
Remarks:

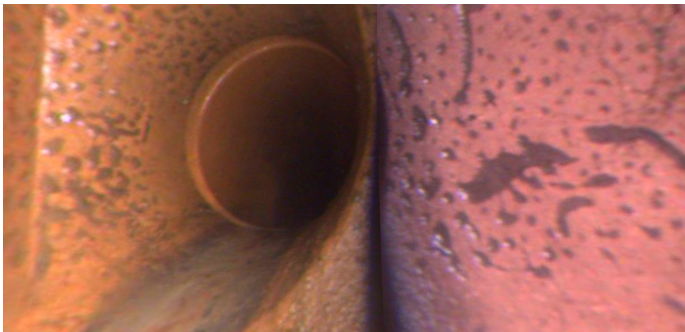
Code:	<b>TFA</b>
Description:	<b>Tap Factory Active</b>

Distance (ft):	<b>19.7</b>
Structural Grade:	<b>0</b>
O&M Grade:	<b>0</b>
Clock Start/From:	<b>9</b>
Clock To:	
1st Value:	<b>4.000</b>
2nd Value:	
Value Percent:	
Continuous Index:	
Within 8" of Joint:	
Remarks:

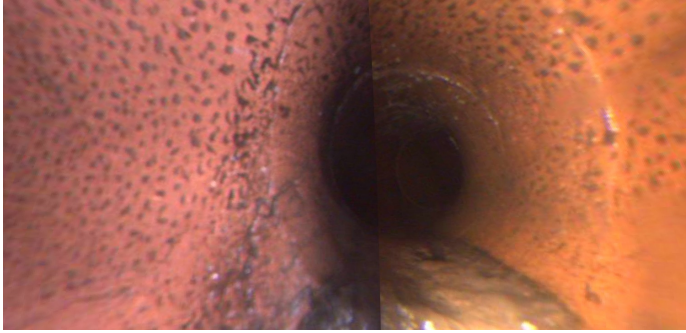
Code: **TFA**  
Description: **Tap Factory Active**

Distance (ft): **51.5**  
Structural Grade: **0**  
O&M Grade: **0**  
Clock Start/From: **3**  
Clock To:  
1st Value: **4.000**  
2nd Value:  
Value Percent:  
Continuous Index:  
Within 8" of Joint:  
Remarks:

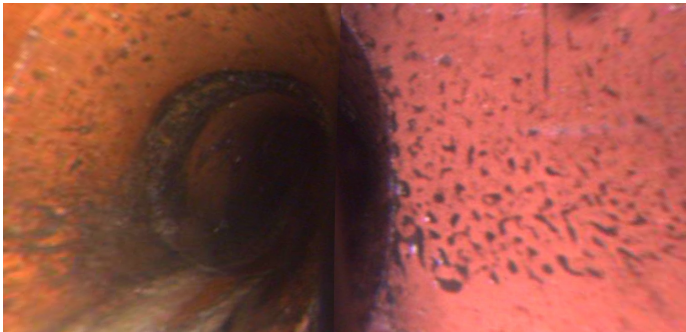
Code: **TFA**  
Description: **Tap Factory Active**

Distance (ft): **78.9**  
Structural Grade: **0**  
O&M Grade: **0**  
Clock Start/From: **9**  
Clock To:  
1st Value: **4.000**  
2nd Value:  
Value Percent:  
Continuous Index:  
Within 8" of Joint:  
Remarks:

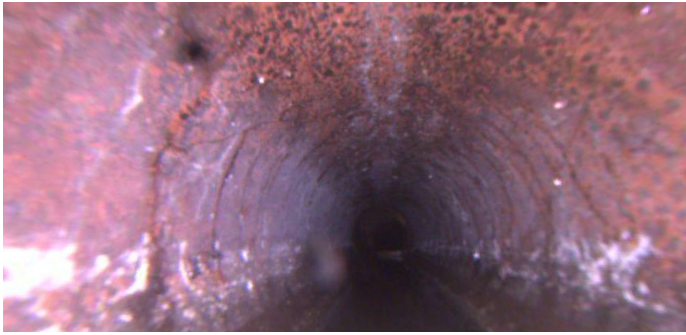
Code: **CM**  
Description: **Crack Multiple**

Distance (ft): **130.7**  
Structural Grade: **3**  
O&M Grade: **0**  
Clock Start/From: **8**  
Clock To: **4**  
1st Value:  
2nd Value:  
Value Percent:  
Continuous Index:  
Within 8" of Joint:  
Remarks:

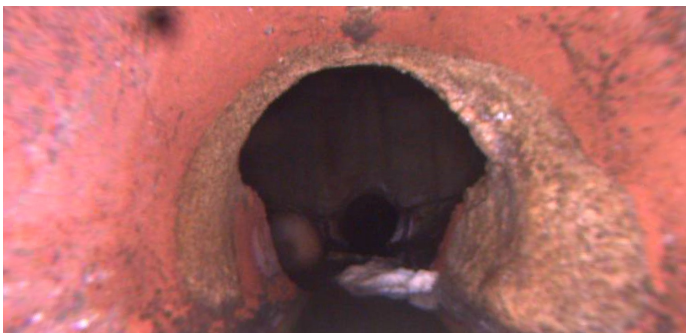
Code: **DAE**  
Description: **Deposits Attached Encrustation**

Distance (ft): **134.4**  
Structural Grade: **0**  
O&M Grade: **2**  
Clock Start/From: **8**  
Clock To: **4**  
1st Value:  
2nd Value:  
Value Percent: **10.000**  
Continuous Index:  
Within 8" of Joint:  
Remarks: **AT MH**

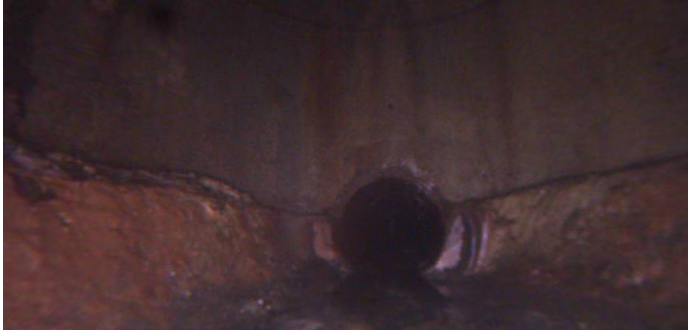
Code:	AMH
Description:	Manhole
Distance (ft):	136.4
Structural Grade:	0
O&M Grade:	0
Clock Start/From:	
Clock To:	
1st Value:	
2nd Value:	
Value Percent:	
Continuous Index:	
Within 8" of Joint:	NO
Remarks:	M-507-032
