Profile/Photo Observation Report

Date:	03/29/2018	Weather:		Coding:	PACP 6.0
Pipe Length (ft):	118.4	Owner:	NA	Pre Clean:	No Pre-Cleaning
P.O.#:		Surveyor:	Jen Costello	PSR:	P-507-033-032
Customer:		Clean Date:	01/01/1900	Shape:	C

Street:	FOXCROFT STREET	Flow Control:	Not Controlled
City:	Hobart, IN	Year Renewed:	
Location:	Yard	Tape/Media #:	
Purpose:	Routine Assessment	Dia/Height:	10"
Use:	Sanitary	Material:	VCP
Drain Area:	NA	Lining:	
Category:	NA		
Comment:	Flow direction wrong		
Location Details:		Direction of Survey:	Upstream
US MH:	M-507-032	DS MH:	M-507-033
		Total Length Surveyed (ft):	136.4

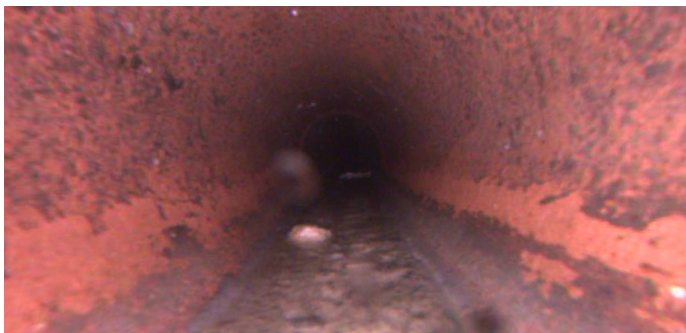
Code: **AMH**
Description: **Manhole**

Distance (ft): **.0**
Structural Grade: **0**
O&M Grade: **0**
Clock Start/From:
Clock To:
1st Value:
2nd Value:
Value Percent:
Continuous Index:
Within 8" of Joint: **NO**
Remarks: **M-507-033**

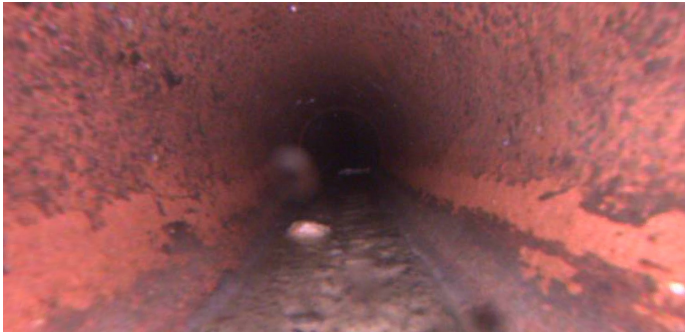
Code:	MWL
Description:	Water Level

Distance (ft):	.0
Structural Grade:	0
O&M Grade:	0
Clock Start/From:	
Clock To:	
1st Value:	
2nd Value:	
Value Percent:	5.000
Continuous Index:	
Within 8" of Joint:	NO
Remarks:

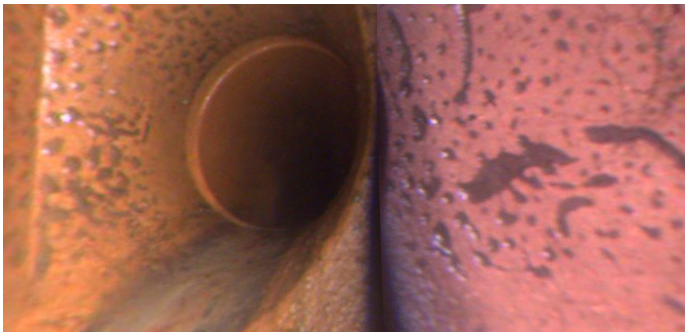
Code:	TFA
Description:	Tap Factory Active

Distance (ft):	19.7
Structural Grade:	0
O&M Grade:	0
Clock Start/From:	9
Clock To:	
1st Value:	4.000
2nd Value:	
Value Percent:	
Continuous Index:	
Within 8" of Joint:	
Remarks:

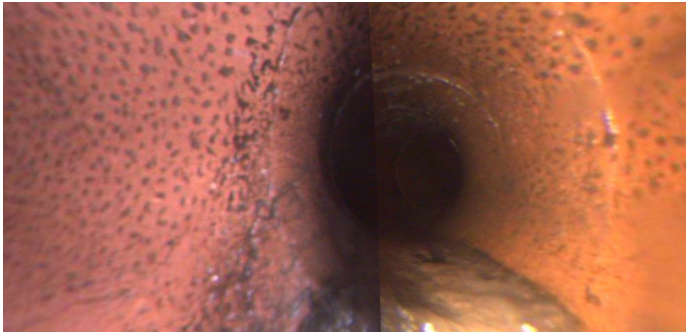
Code: **TFA**
Description: **Tap Factory Active**

Distance (ft): **51.5**
Structural Grade: **0**
O&M Grade: **0**
Clock Start/From: **3**
Clock To:
1st Value: **4.000**
2nd Value:
Value Percent:
Continuous Index:
Within 8" of Joint:
Remarks:

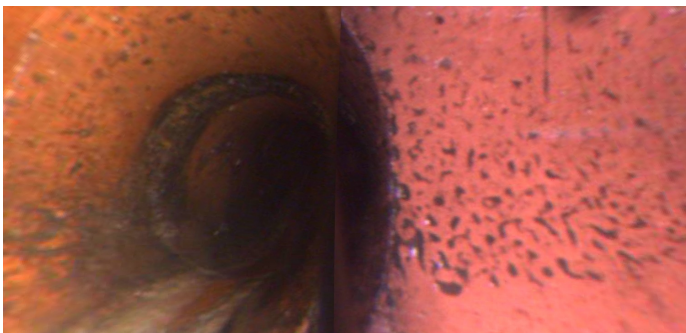
Code: **TFA**
Description: **Tap Factory Active**

Distance (ft): **78.9**
Structural Grade: **0**
O&M Grade: **0**
Clock Start/From: **9**
Clock To:
1st Value: **4.000**
2nd Value:
Value Percent:
Continuous Index:
Within 8" of Joint:
Remarks:

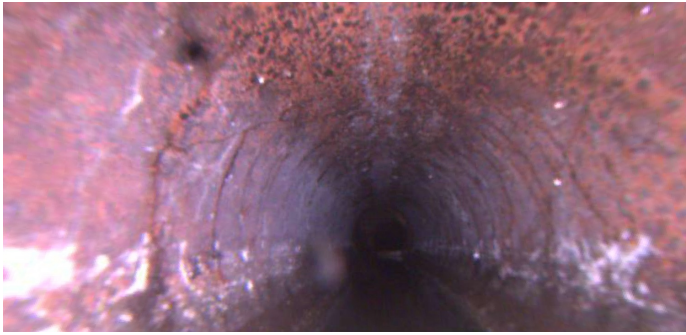
Code: **CM**
Description: **Crack Multiple**

Distance (ft): **130.7**
Structural Grade: **3**
O&M Grade: **0**
Clock Start/From: **8**
Clock To: **4**
1st Value:
2nd Value:
Value Percent:
Continuous Index:
Within 8" of Joint:
Remarks:

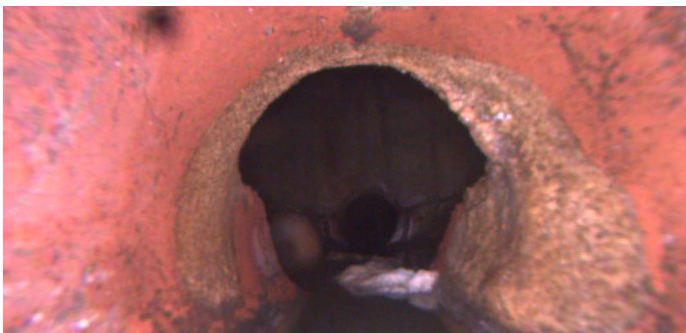
Code: **DAE**
Description: **Deposits Attached Encrustation**

Distance (ft): **134.4**
Structural Grade: **0**
O&M Grade: **2**
Clock Start/From: **8**
Clock To: **4**
1st Value:
2nd Value:
Value Percent: **10.000**
Continuous Index:
Within 8" of Joint:
Remarks: **AT MH**

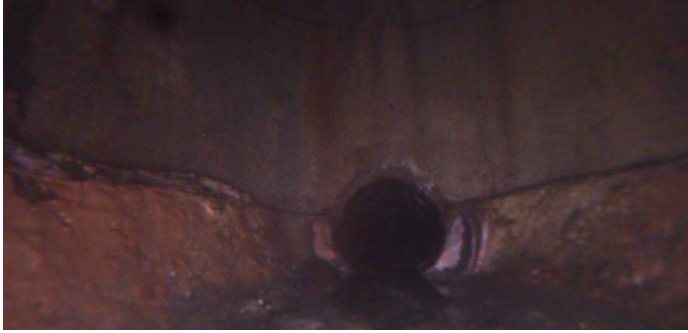
Code: **AMH**
Description: **Manhole**

Distance (ft): **136.4**
Structural Grade: **0**
O&M Grade: **0**
Clock Start/From:
Clock To:
1st Value:
2nd Value:
Value Percent:
Continuous Index:
Within 8" of Joint: **NO**
Remarks: **M-507-032**
