## Profile/Photo Observation Report

Street:	<b>CSOKASY LN &amp; S DEKALB ST</b>	Flow Control:	<b>Not Controlled</b>
City:	<b>Hobart, IN</b>	Year Renewed:	
Location:	<b>Yard</b>	Tape/Media #:	
Purpose:	<b>Routine Assessment</b>	Dia/Height:	<b>8"</b>
Use:	<b>Sanitary</b>	Material:	<b>VCP</b>
Drain Area:	<b>NA</b>	Lining:	
Category:	<b>NA</b>		
Comment:	<b>P_C at 91 ft debris. Flow direction wrong</b>		
Location Details:		Direction of Survey:	<b>Downstream</b>
US MH:	<b>M-507-036</b>	DS MH:	<b>M-507-031</b>
		Total Length Surveyed (ft):	<b>93.0</b>

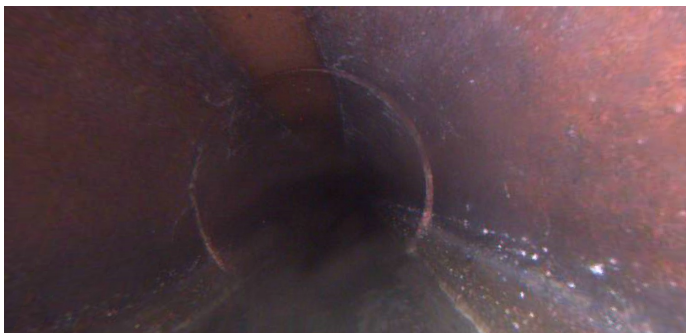
Code: **AMH**  
Description: **Manhole**

Distance (ft): **.0**  
Structural Grade: **0**  
O&M Grade: **0**  
Clock Start/From:  
Clock To:  
1st Value:  
2nd Value:  
Value Percent:  
Continuous Index:  
Within 8" of Joint: **NO**  
Remarks: **M-507-036**

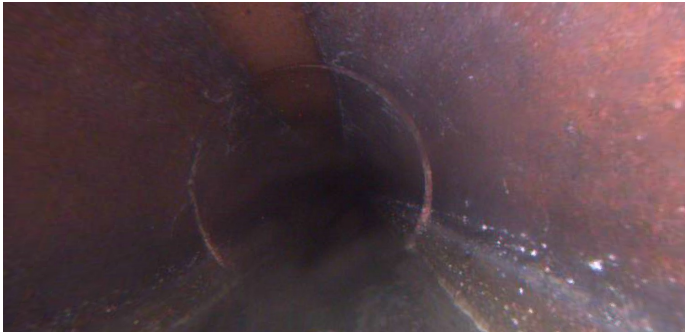
Code:	<b>MWL</b>
Description:	<b>Water Level</b>

Distance (ft):	<b>.0</b>
Structural Grade:	<b>0</b>
O&M Grade:	<b>0</b>
Clock Start/From:	
Clock To:	
1st Value:	
2nd Value:	
Value Percent:	<b>10.000</b>
Continuous Index:	
Within 8" of Joint:	<b>NO</b>
Remarks:

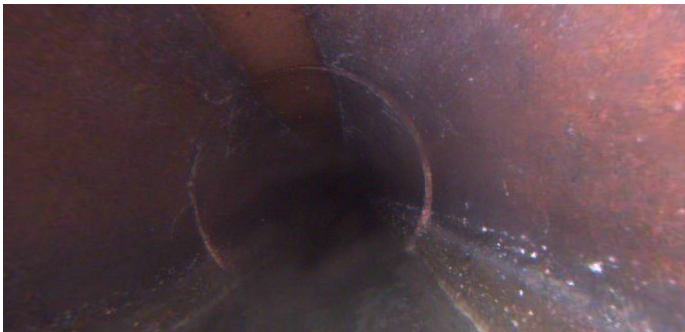
Code:	<b>DAGS</b>
Description:	<b>Deposits Attached Grease</b>

Distance (ft):	<b>.0</b>
Structural Grade:	<b>0</b>
O&M Grade:	<b>2</b>
Clock Start/From:	<b>8</b>
Clock To:	<b>4</b>
1st Value:	
2nd Value:	
Value Percent:	<b>5.000</b>
Continuous Index:	<b>S01</b>
Within 8" of Joint:	<b>NO</b>
Remarks:

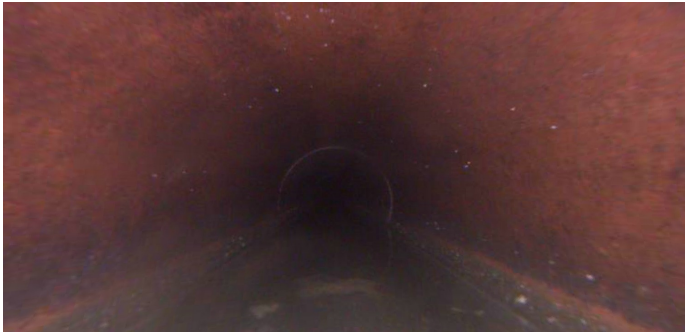
Code: **DAGS**  
Description: **Deposits Attached Grease**

Distance (ft): **19.9**  
Structural Grade: **0**  
O&M Grade: **2**  
Clock Start/From: **8**  
Clock To: **4**  
1st Value:  
2nd Value:  
Value Percent: **5.000**  
Continuous Index: **F01**  
Within 8" of Joint: **NO**  
Remarks:

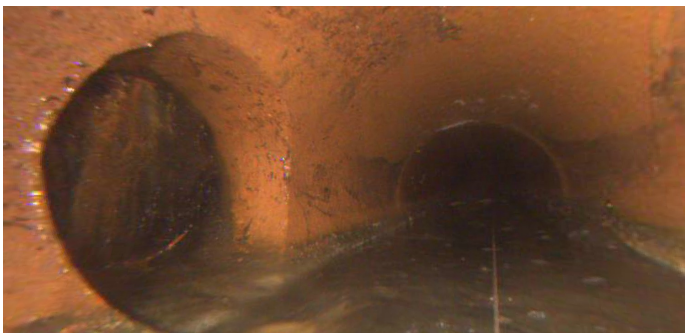
Code: **TFC**  
Description: **Tap Factory Capped**

Distance (ft): **88.7**  
Structural Grade: **0**  
O&M Grade: **0**  
Clock Start/From: **3**  
Clock To:  
1st Value: **4.000**  
2nd Value:  
Value Percent:  
Continuous Index:  
Within 8" of Joint:  
Remarks:

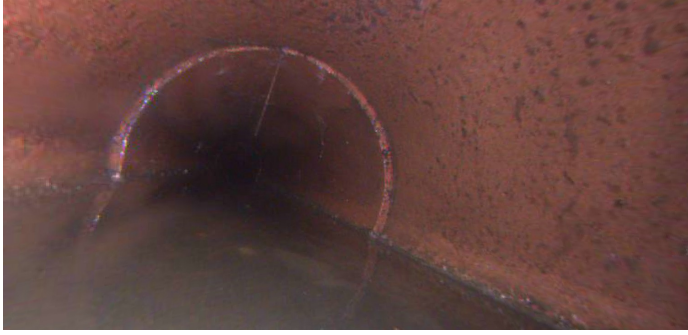
Code:	<b>MSA</b>
Description:	<b>Abandoned Survey</b>
Distance (ft):	<b>93.0</b>
Structural Grade:	<b>0</b>
O&M Grade:	<b>0</b>
Clock Start/From:	
Clock To:	
1st Value:	
2nd Value:	
Value Percent:	
Continuous Index:	
Within 8" of Joint:	<b>NO</b>
Remarks:	<b>DEBRIS UNDER WATER</b>
