Profile/Photo Observation Report

Street:	FOXCROFT STREET	Flow Control:	Not Controlled
City:	Hobart, IN	Year Renewed:	
Location:	Yard	Tape/Media #:	
Purpose:	Routine Assessment	Dia/Height:	8"
Use:	Sanitary	Material:	VCP
Drain Area:	NA	Lining:	
Category:	NA		
Comment:	P_C at 91 ft debris. Flow direction wrong		
Location Details:		Direction of Survey:	Downstream
US MH:	M-507-036	DS MH:	M-507-031
		Total Length Surveyed (ft):	93.0

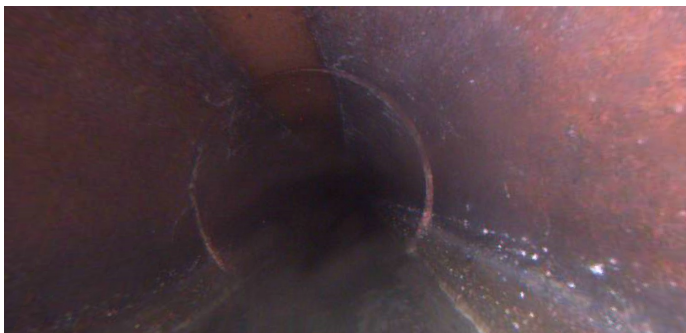
Code: **AMH**
Description: **Manhole**

Distance (ft): **.0**
Structural Grade: **0**
O&M Grade: **0**
Clock Start/From:
Clock To:
1st Value:
2nd Value:
Value Percent:
Continuous Index:
Within 8" of Joint: **NO**
Remarks: **M-507-036**

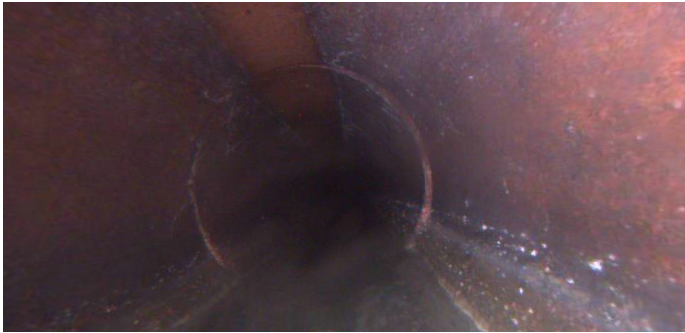
Code:	MWL
Description:	Water Level

Distance (ft):	.0
Structural Grade:	0
O&M Grade:	0
Clock Start/From:	
Clock To:	
1st Value:	
2nd Value:	
Value Percent:	10.000
Continuous Index:	
Within 8" of Joint:	NO
Remarks:

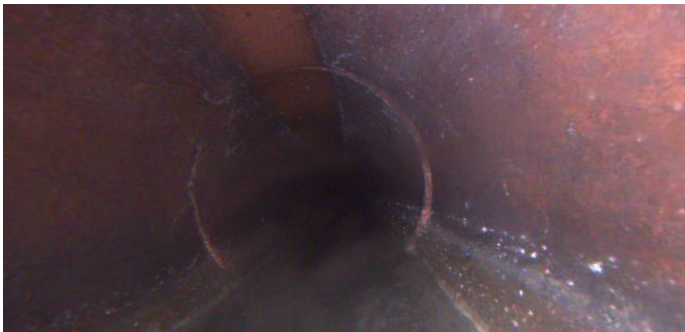
Code:	DAGS
Description:	Deposits Attached Grease

Distance (ft):	.0
Structural Grade:	0
O&M Grade:	2
Clock Start/From:	8
Clock To:	4
1st Value:	
2nd Value:	
Value Percent:	5.000
Continuous Index:	S01
Within 8" of Joint:	NO
Remarks:

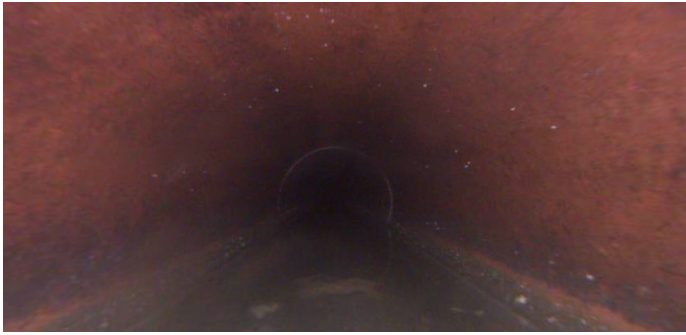
Code: **DAGS**
Description: **Deposits Attached Grease**

Distance (ft): **19.9**
Structural Grade: **0**
O&M Grade: **2**
Clock Start/From: **8**
Clock To: **4**
1st Value:
2nd Value:
Value Percent: **5.000**
Continuous Index: **F01**
Within 8" of Joint: **NO**
Remarks:

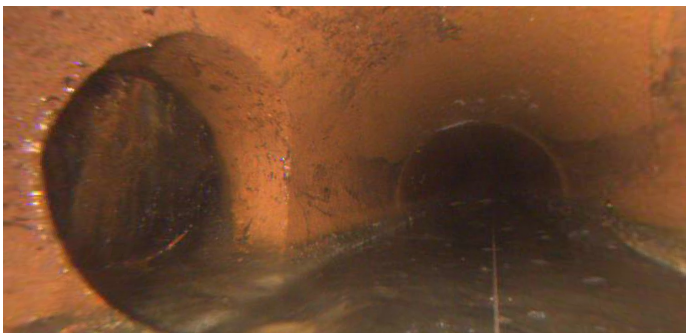
Code: **TFC**
Description: **Tap Factory Capped**

Distance (ft): **88.7**
Structural Grade: **0**
O&M Grade: **0**
Clock Start/From: **3**
Clock To:
1st Value: **4.000**
2nd Value:
Value Percent:
Continuous Index:
Within 8" of Joint:
Remarks:

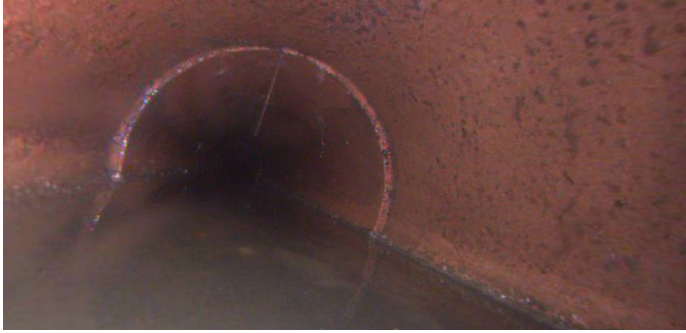
Code:	MSA
Description:	Abandoned Survey
Distance (ft):	93.0
Structural Grade:	0
O&M Grade:	0
Clock Start/From:	
Clock To:	
1st Value:	
2nd Value:	
Value Percent:	
Continuous Index:	
Within 8" of Joint:	NO
Remarks:	DEBRIS UNDER WATER
