## Profile/Photo Observation Report

Date:	<b>03/29/2018</b>	Weather:		Coding:	<b>PACP 6.0</b>
Pipe Length (ft):	<b>167.7</b>	Owner:	<b>NA</b>	Pre Clean:	<b>No Pre-Cleaning</b>
P.O.#:		Surveyor:	<b>Jen Costello</b>	PSR:	<b>P-507-031-036</b>
Customer:		Clean Date:	<b>01/01/1900</b>	Shape:	<b>C</b>

Street:	<b>CSOKASY LN &amp; S DEKALB ST</b>	Flow Control:	<b>Not Controlled</b>
City:	<b>Hobart, IN</b>	Year Renewed:	
Location:	<b>Yard</b>	Tape/Media #:	
Purpose:	<b>Routine Assessment</b>	Dia/Height:	<b>10"</b>
Use:	<b>Sanitary</b>	Material:	<b>VCP</b>
Drain Area:	<b>NA</b>	Lining:	
Category:	<b>NA</b>		
Comment:	<b>Flow direction wrong</b>		
Location Details:		Direction of Survey:	<b>Upstream</b>
US MH:	<b>M-507-036</b>	DS MH:	<b>M-507-031</b>
		Total Length Surveyed (ft):	<b>164.7</b>

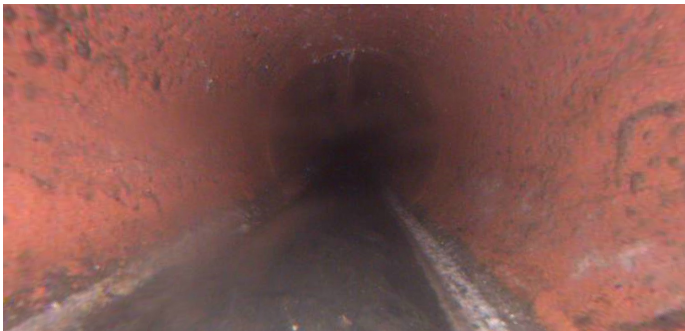
Code: **AMH**  
Description: **Manhole**

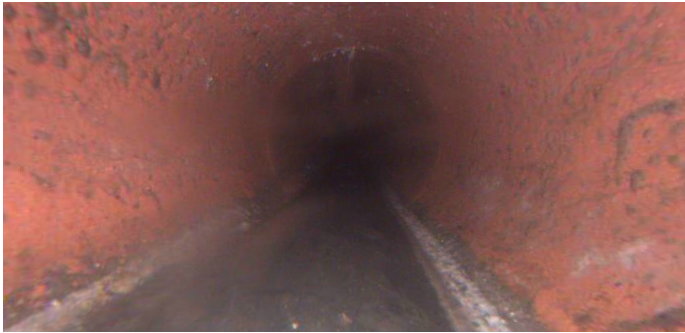
Code:	<b>MWL</b>
Description:	<b>Water Level</b>

Distance (ft):	<b>.0</b>
Structural Grade:	<b>0</b>
O&M Grade:	<b>0</b>
Clock Start/From:	
Clock To:	
1st Value:	
2nd Value:	
Value Percent:	<b>5.000</b>
Continuous Index:	
Within 8" of Joint:	<b>NO</b>
Remarks:

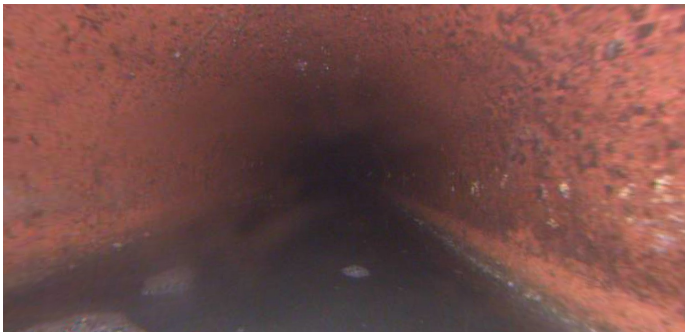
Code:	<b>MWL</b>
Description:	<b>Water Level</b>

Distance (ft):	<b>60.2</b>
Structural Grade:	<b>0</b>
O&M Grade:	<b>0</b>
Clock Start/From:	
Clock To:	
1st Value:	
2nd Value:	
Value Percent:	<b>20.000</b>
Continuous Index:	
Within 8" of Joint:	<b>NO</b>
Remarks:

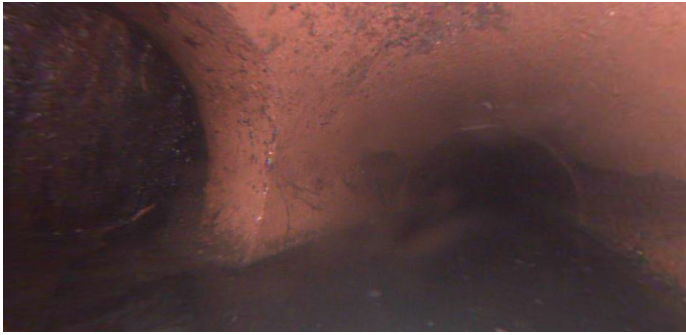
Code: **TFC**  
Description: **Tap Factory Capped**

Distance (ft): **72.8**  
Structural Grade: **0**  
O&M Grade: **0**  
Clock Start/From: **9**  
Clock To:  
1st Value: **4.000**  
2nd Value:  
Value Percent:  
Continuous Index:  
Within 8" of Joint:  
Remarks:

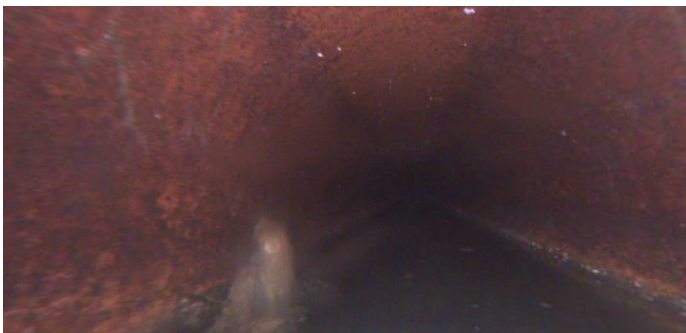
Code: **OBR**  
Description: **Obstacle Rocks**

Distance (ft): **91.7**  
Structural Grade: **0**  
O&M Grade: **2**  
Clock Start/From: **7**  
Clock To: **8**  
1st Value:  
2nd Value:  
Value Percent: **5.000**  
Continuous Index:  
Within 8" of Joint: **NO**  
Remarks:

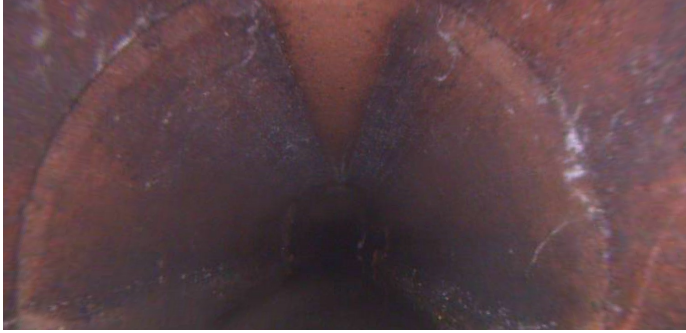
Code: **RFJ**  
Description: **Roots Fine Joint**

Distance (ft): **158.7**  
Structural Grade: **0**  
O&M Grade: **1**  
Clock Start/From: **8**  
Clock To: **4**  
1st Value:  
2nd Value:  
Value Percent:  
Continuous Index:  
Within 8" of Joint: **YES**  
Remarks:

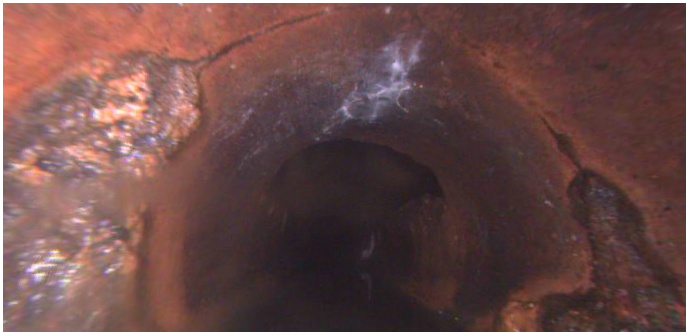
Code: **FC**  
Description: **Fracture Circumferential**

Distance (ft): **160.6**  
Structural Grade: **2**  
O&M Grade: **0**  
Clock Start/From: **8**  
Clock To: **4**  
1st Value:  
2nd Value:  
Value Percent:  
Continuous Index:  
Within 8" of Joint:  
Remarks:

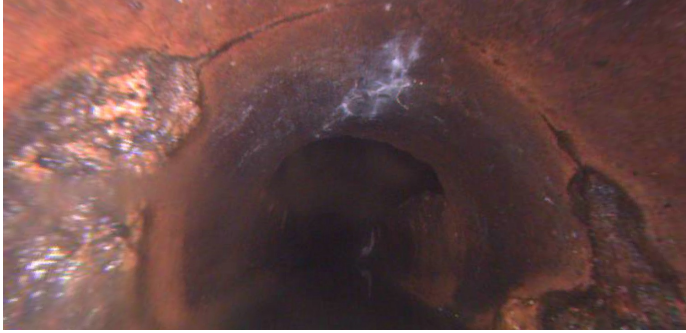
Code: **DAE**  
Description: **Deposits Attached Encrustation**

Distance (ft): **160.6**  
Structural Grade: **0**  
O&M Grade: **2**  
Clock Start/From: **8**  
Clock To: **4**  
1st Value:  
2nd Value:  
Value Percent: **10.000**  
Continuous Index:  
Within 8" of Joint: **NO**  
Remarks:

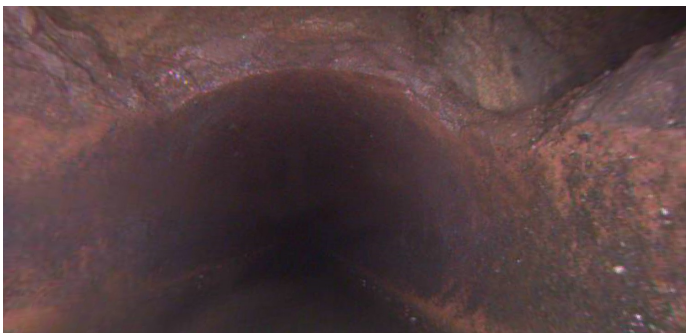
Code: **AMH**  
Description: **Manhole**

Distance (ft): **164.7**  
Structural Grade: **0**  
O&M Grade: **0**  
Clock Start/From:  
Clock To:  
1st Value:  
2nd Value:  
Value Percent:  
Continuous Index:  
Within 8" of Joint: **NO**  
Remarks: **M-507-036**
