## Profile/Photo Observation Report

Street:	<b>W 10TH ST</b>	Flow Control:	<b>Not Controlled</b>
City:	<b>Hobart, IN</b>	Year Renewed:	
Location:	<b>Yard</b>	Tape/Media #:	
Purpose:	<b>Routine Assessment</b>	Dia/Height:	<b>8"</b>
Use:	<b>Sanitary</b>	Material:	<b>PVC</b>
Drain Area:	<b>NA</b>	Lining:	
Category:	<b>NA</b>		
Comment:	<b>Flow direction is marked wrong.</b>

Location Details:		Direction of Survey:	<b>Downstream</b>
US MH:	<b>M-507-036.1</b>	DS MH:	<b>M-507-096</b>
		Total Length Surveyed (ft):	<b>119.1</b>

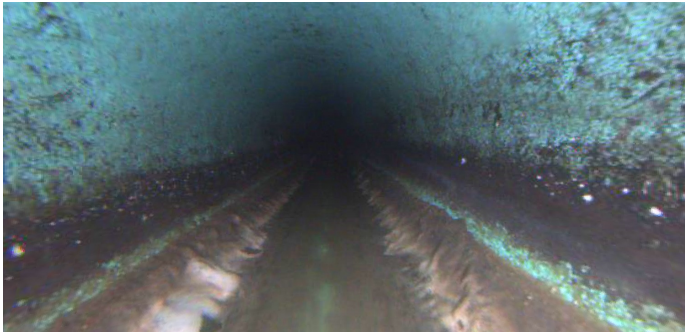
Code:	<b>MWL</b>
Description:	<b>Water Level</b>

Distance (ft):	<b>.0</b>
Structural Grade:	<b>0</b>
O&M Grade:	<b>0</b>
Clock Start/From:	
Clock To:	
1st Value:	
2nd Value:	
Value Percent:	<b>5.000</b>
Continuous Index:	
Within 8" of Joint:	<b>NO</b>
Remarks:

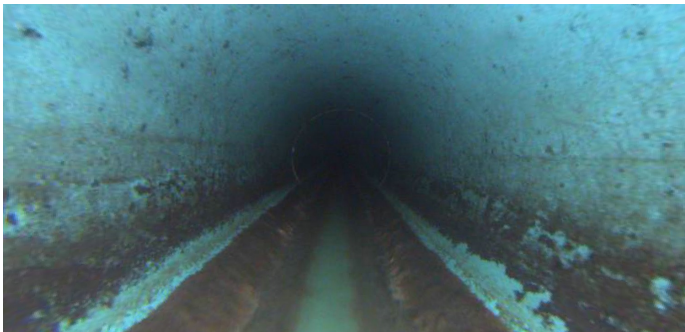
Code:	<b>DAGS</b>
Description:	<b>Deposits Attached Grease</b>

Distance (ft):	<b>10.5</b>
Structural Grade:	<b>0</b>
O&M Grade:	<b>2</b>
Clock Start/From:	<b>4</b>
Clock To:	<b>8</b>
1st Value:	
2nd Value:	
Value Percent:	<b>5.000</b>
Continuous Index:	<b>S01</b>
Within 8" of Joint:	<b>NO</b>
Remarks:

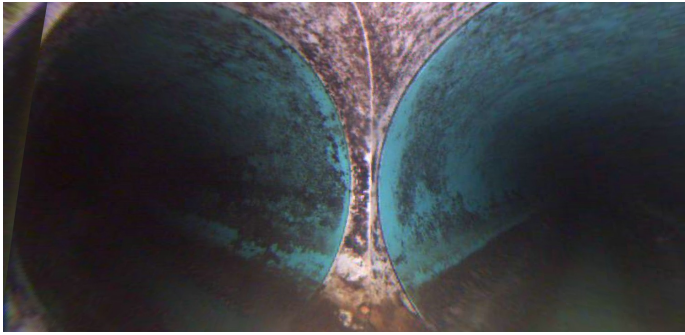
Code: **TFA**  
Description: **Tap Factory Active**

Distance (ft): **63.4**  
Structural Grade: **0**  
O&M Grade: **0**  
Clock Start/From: **9**  
Clock To:  
1st Value: **4.000**  
2nd Value:  
Value Percent:  
Continuous Index:  
Within 8" of Joint:  
Remarks:

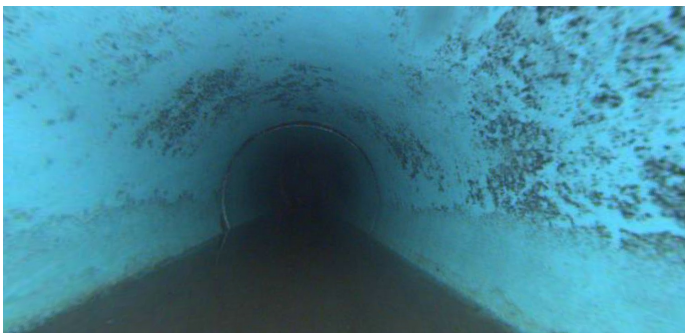
Code: **DAGS**  
Description: **Deposits Attached Grease**

Distance (ft): **113.6**  
Structural Grade: **0**  
O&M Grade: **2**  
Clock Start/From: **4**  
Clock To: **8**  
1st Value:  
2nd Value:  
Value Percent: **5.000**  
Continuous Index: **F01**  
Within 8" of Joint: **NO**  
Remarks:

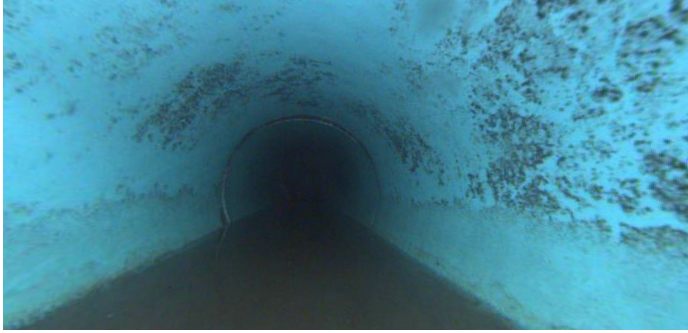
Code:	<b>MWL</b>
Description:	<b>Water Level</b>
Distance (ft):	<b>113.6</b>
Structural Grade:	<b>0</b>
O&M Grade:	<b>0</b>
Clock Start/From:	
Clock To:	
1st Value:	
2nd Value:	
Value Percent:	<b>20.000</b>
Continuous Index:	
Within 8" of Joint:	<b>NO</b>
Remarks:

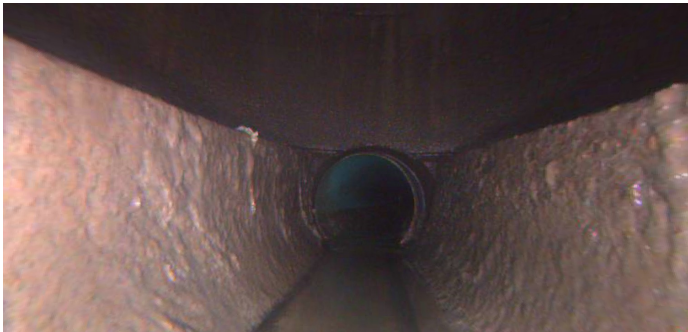
Code:	<b>AMH</b>
Description:	<b>Manhole</b>
Distance (ft):	<b>119.1</b>
Structural Grade:	<b>0</b>
O&M Grade:	<b>0</b>
Clock Start/From:	
Clock To:	
1st Value:	
2nd Value:	
Value Percent:	
Continuous Index:	
Within 8" of Joint:	<b>NO</b>
Remarks:	<b>M-507-096</b>
