Profile/Photo Observation Report

| Street: | FOXCROFT STREET | Flow Control: | Not Controlled |
| City: | Hobart, IN | Year Renewed: | |

| US MH: | M-507-036.1 | DS MH: | M-507-096 |

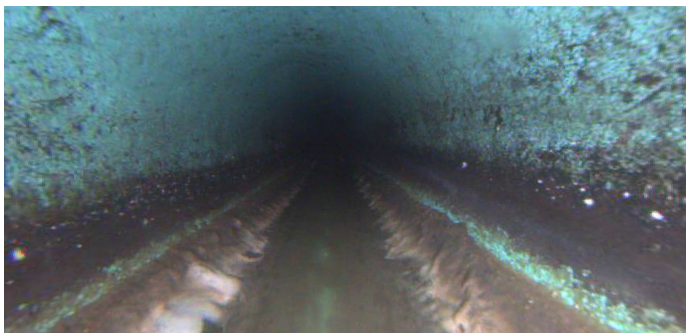
Code: **AMH**
Description: **Manhole**

Distance (ft): **.0**
Structural Grade: **0**
O&M Grade: **0**
Clock Start/From:
Clock To:
1st Value:
2nd Value:
Value Percent:
Continuous Index:
Within 8" of Joint: **NO**
Remarks: **M-507-036.1**

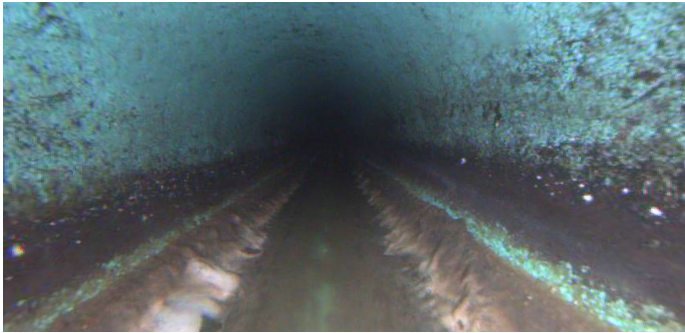
| Code: | MWL |
| Description: | Water Level |

| Distance (ft): | .0 |
| Value Percent: | 5.000 |

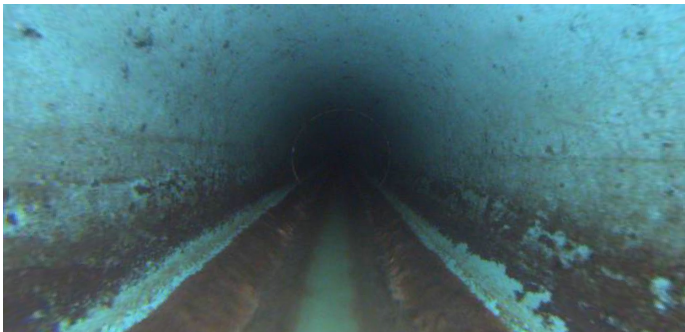
| Code: | DAGS |
| Description: | Deposits Attached Grease |

| Distance (ft): | 10.5 |
| O&M Grade: | 2 |
| Clock Start/From: | 4 |
| Clock To: | 8 |
| Value Percent: | 5.000 |
| Continuous Index: | S01 |

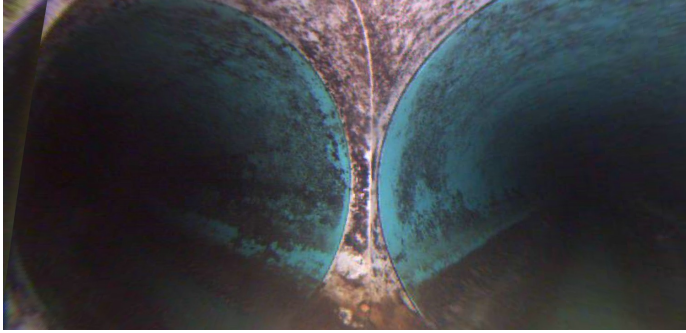
Code: **TFA**
Description: **Tap Factory Active**

Distance (ft): **63.4**
Structural Grade: **0**
O&M Grade: **0**
Clock Start/From: **9**
Clock To:
1st Value: **4.000**
2nd Value:
Value Percent:
Continuous Index:
Within 8" of Joint:
Remarks:

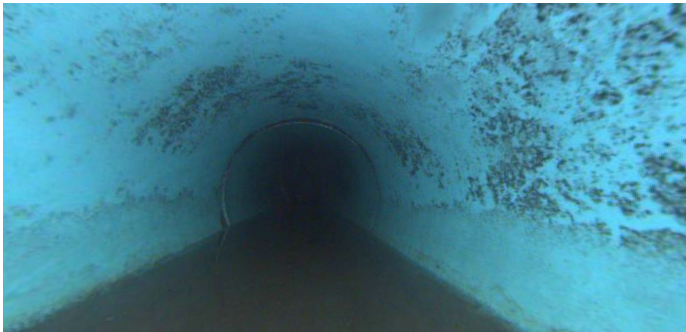
Code: **DAGS**
Description: **Deposits Attached Grease**

Distance (ft): **113.6**
Structural Grade: **0**
O&M Grade: **2**
Clock Start/From: **4**
Clock To: **8**
1st Value:
2nd Value:
Value Percent: **5.000**
Continuous Index: **F01**
Within 8" of Joint: **NO**
Remarks:

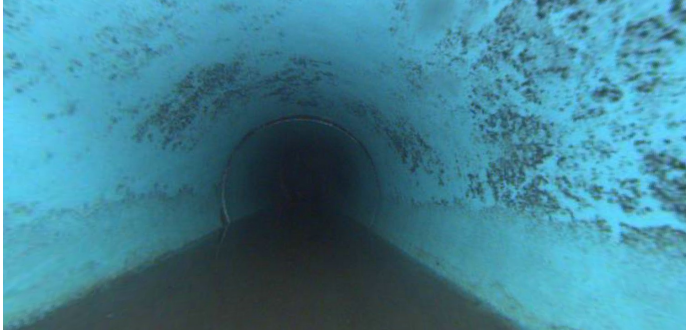
Code: **MWL**
Description: **Water Level**

Distance (ft): **113.6**
Structural Grade: **0**
O&M Grade: **0**
Clock Start/From:
Clock To:
1st Value:
2nd Value:
Value Percent: **20.000**
Continuous Index:
Within 8" of Joint: **NO**
Remarks:

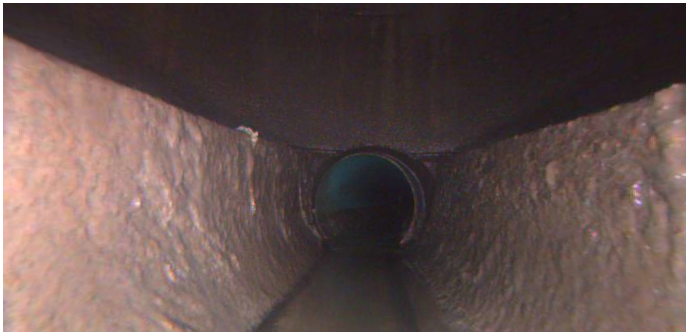
Code: **AMH**
Description: **Manhole**

Distance (ft): **119.1**
Structural Grade: **0**
O&M Grade: **0**
Clock Start/From:
Clock To:
1st Value:
2nd Value:
Value Percent:
Continuous Index:
Within 8" of Joint: **NO**
Remarks: **M-507-096**
