## Profile/Photo Observation Report

| P.O.#: | | Surveyor: | <b>Jen Costello</b> | PSR: | <b>P-507-039.3-039.2</b> |

| Street: | <b>FOXCROFT STREET</b> | Flow Control: | <b>Not Controlled</b> |
| City: | <b>Hobart, IN</b> | Year Renewed: | |

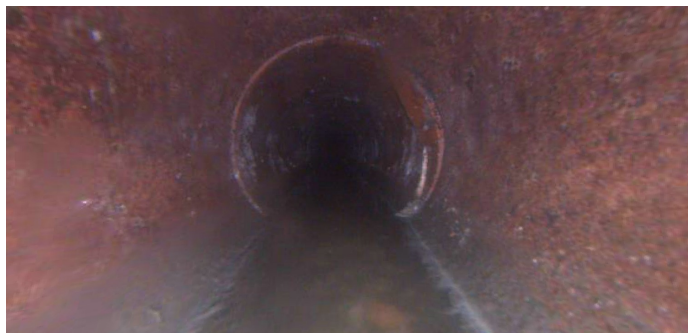
Code: **AMH**  
 Description: **Manhole**  
 Distance (ft): **.0**  
 Structural Grade: **0**  
 O&M Grade: **0**  
 Clock Start/From:  
 Clock To:  
 1st Value:  
 2nd Value:  
 Value Percent:  
 Continuous Index:  
 Within 8" of Joint: **NO**  
 Remarks: **M-507-039.2**

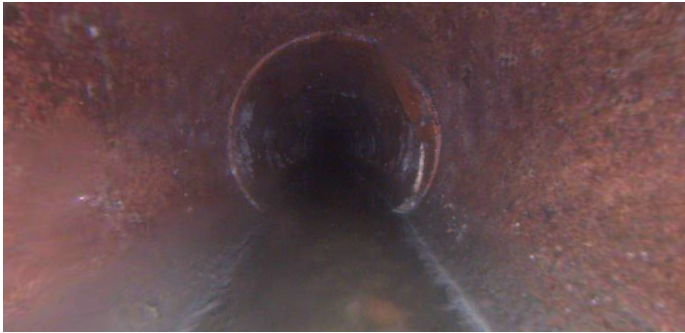
| Code: | <b>MWL</b> |
| Description: | <b>Water Level</b> |

| Value Percent: | <b>5.000</b> |

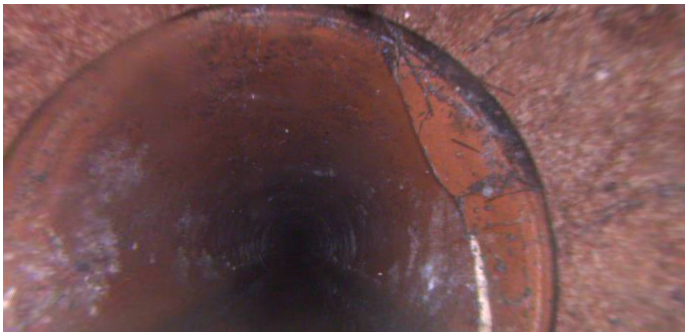
| Code: | <b>B</b> |
| Description: | <b>Broken</b> |

| Distance (ft): | <b>1.4</b> |
| Structural Grade: | <b>5</b> |
| Clock Start/From: | <b>1</b> |
| Clock To: | <b>3</b> |

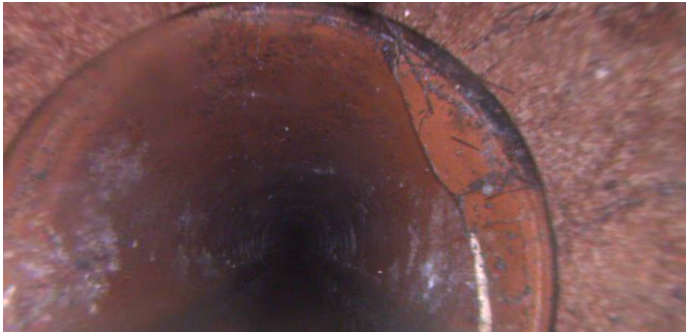
Code: **RFJ**  
Description: **Roots Fine Joint**

Distance (ft): **1.4**  
Structural Grade: **0**  
O&M Grade: **1**  
Clock Start/From: **1**  
Clock To: **3**  
1st Value:  
2nd Value:  
Value Percent:  
Continuous Index:  
Within 8" of Joint: **YES**  
Remarks:

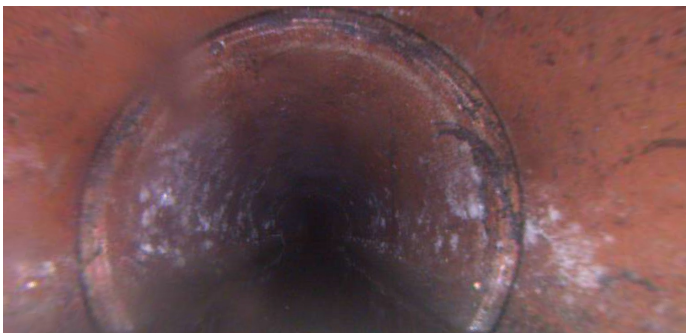
Code: **RFJ**  
Description: **Roots Fine Joint**

Distance (ft): **4.4**  
Structural Grade: **0**  
O&M Grade: **1**  
Clock Start/From: **8**  
Clock To: **4**  
1st Value:  
2nd Value:  
Value Percent:  
Continuous Index: **S01**  
Within 8" of Joint: **YES**  
Remarks:

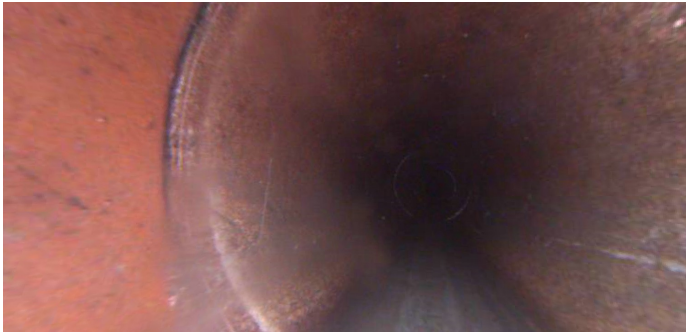
Code: **FM**  
Description: **Fracture Multiple**

Distance (ft): **22.4**  
Structural Grade: **4**  
O&M Grade: **0**  
Clock Start/From: **8**  
Clock To: **10**  
1st Value:  
2nd Value:  
Value Percent:  
Continuous Index:  
Within 8" of Joint: **YES**  
Remarks:

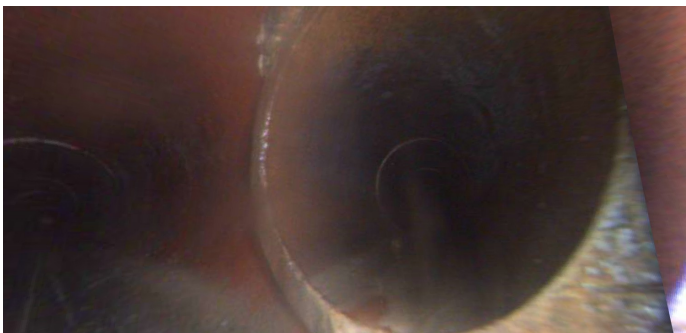
Code: **TBI**  
Description: **Tap Break-in Intruding**

Distance (ft): **34.3**  
Structural Grade: **0**  
O&M Grade: **2**  
Clock Start/From: **9**  
Clock To:  
1st Value: **4.000**  
2nd Value: **1.000**  
Value Percent:  
Continuous Index:  
Within 8" of Joint:  
Remarks:

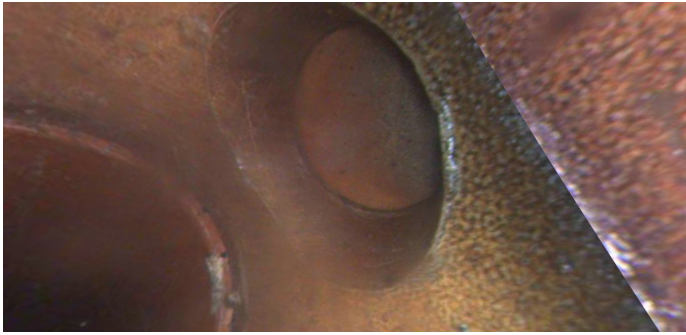
Code: **TFC**  
Description: **Tap Factory Capped**

Distance (ft): **40.4**  
Structural Grade: **0**  
O&M Grade: **0**  
Clock Start/From: **10**  
Clock To:  
1st Value: **4.000**  
2nd Value:  
Value Percent:  
Continuous Index:  
Within 8" of Joint:  
Remarks:

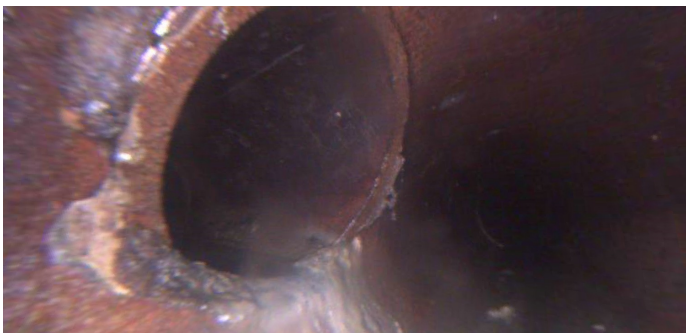
Code: **TBI**  
Description: **Tap Break-in Intruding**

Distance (ft): **73.9**  
Structural Grade: **0**  
O&M Grade: **2**  
Clock Start/From: **9**  
Clock To:  
1st Value: **4.000**  
2nd Value: **1.000**  
Value Percent:  
Continuous Index:  
Within 8" of Joint:  
Remarks:

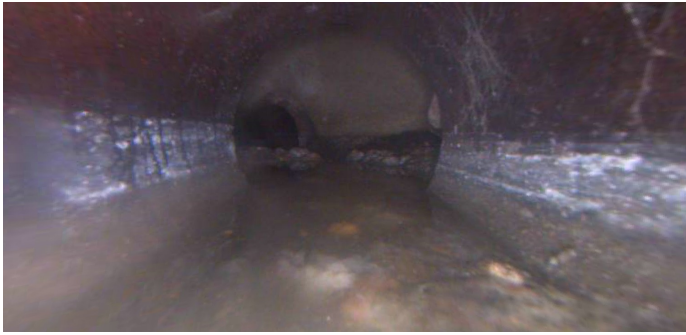
Code: **RFJ**  
Description: **Roots Fine Joint**

Distance (ft): **110.7**  
Structural Grade: **0**  
O&M Grade: **1**  
Clock Start/From: **8**  
Clock To: **4**  
1st Value:  
2nd Value:  
Value Percent:  
Continuous Index: **F01**  
Within 8" of Joint: **YES**  
Remarks:

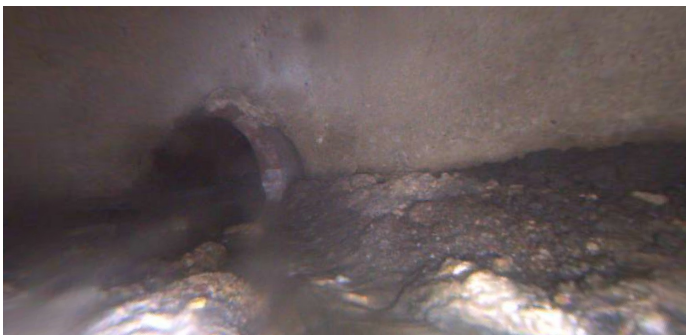
Code: **AMH**  
Description: **Manhole**

Distance (ft): **112.7**  
Structural Grade: **0**  
O&M Grade: **0**  
Clock Start/From:  
Clock To:  
1st Value:  
2nd Value:  
Value Percent:  
Continuous Index:  
Within 8" of Joint: **NO**  
Remarks: **M-507-039.3**
