## Profile/Photo Observation Report

Street:	<b>FOXCROFT STREET</b>	Flow Control:	<b>Not Controlled</b>
City:	<b>Hobart, IN</b>	Year Renewed:	
Location:	<b>Yard</b>	Tape/Media #:	
Purpose:	<b>Routine Assessment</b>	Dia/Height:	<b>12"</b>
Use:	<b>Sanitary</b>	Material:	<b>VCP</b>
Drain Area:	<b>NA</b>	Lining:	
Category:	<b>NA</b>		
Comment:

Location Details:		Direction of Survey:	<b>Upstream</b>
US MH:	<b>M-507-039.5</b>	DS MH:	<b>M-507-083</b>
		Total Length Surveyed (ft):	<b>19.5</b>

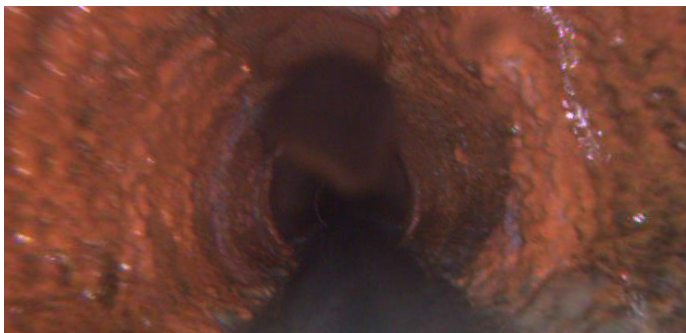
Code: **AMH**  
Description: **Manhole**

Distance (ft): **.0**  
Structural Grade: **0**  
O&M Grade: **0**  
Clock Start/From:  
Clock To:  
1st Value:  
2nd Value:  
Value Percent:  
Continuous Index:  
Within 8" of Joint: **NO**  
Remarks: **M-507-083**

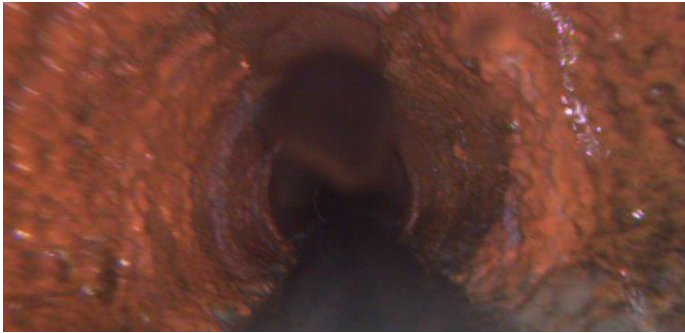
Code:	<b>MWL</b>
Description:	<b>Water Level</b>

Distance (ft):	<b>.0</b>
Structural Grade:	<b>0</b>
O&M Grade:	<b>0</b>
Clock Start/From:	
Clock To:	
1st Value:	
2nd Value:	
Value Percent:	<b>5.000</b>
Continuous Index:	
Within 8" of Joint:	<b>NO</b>
Remarks:

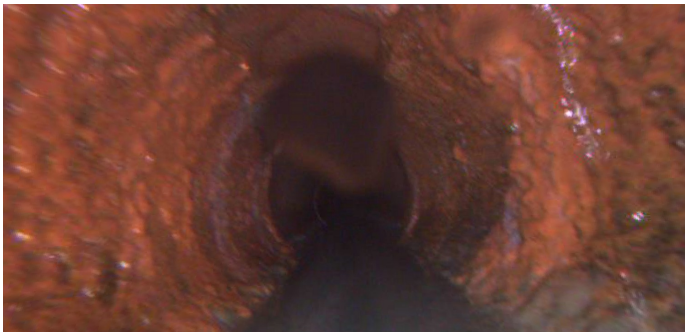
Code:	<b>DAE</b>
Description:	<b>Deposits Attached Encrustation</b>

Distance (ft):	<b>.0</b>
Structural Grade:	<b>0</b>
O&M Grade:	<b>2</b>
Clock Start/From:	<b>7</b>
Clock To:	<b>5</b>
1st Value:	
2nd Value:	
Value Percent:	<b>10.000</b>
Continuous Index:	
Within 8" of Joint:	<b>NO</b>
Remarks:

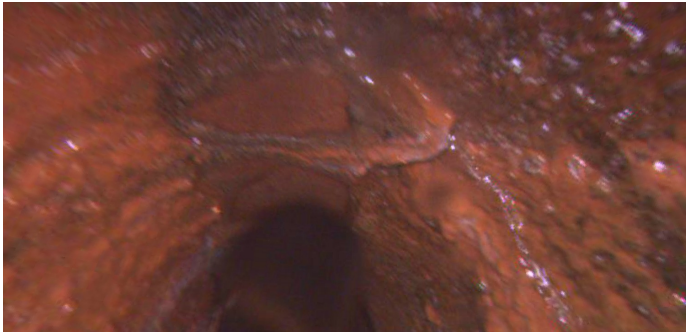
Code: **FM**  
Description: **Fracture Multiple**

Distance (ft): **.0**  
Structural Grade: **4**  
O&M Grade: **0**  
Clock Start/From: **10**  
Clock To: **2**  
1st Value:  
2nd Value:  
Value Percent:  
Continuous Index:  
Within 8" of Joint:  
Remarks:

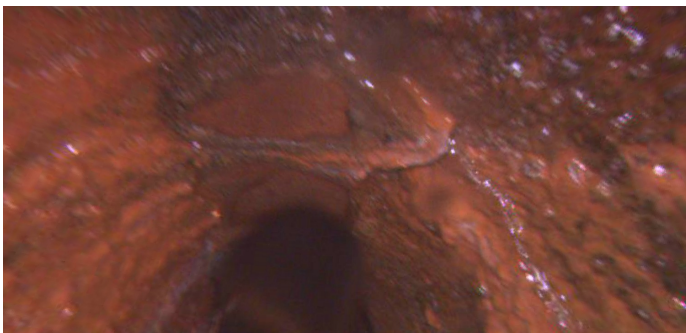
Code: **IR**  
Description: **Infil Runner**

Distance (ft): **.0**  
Structural Grade: **0**  
O&M Grade: **4**  
Clock Start/From: **1**  
Clock To:  
1st Value:  
2nd Value:  
Value Percent:  
Continuous Index:  
Within 8" of Joint:  
Remarks:

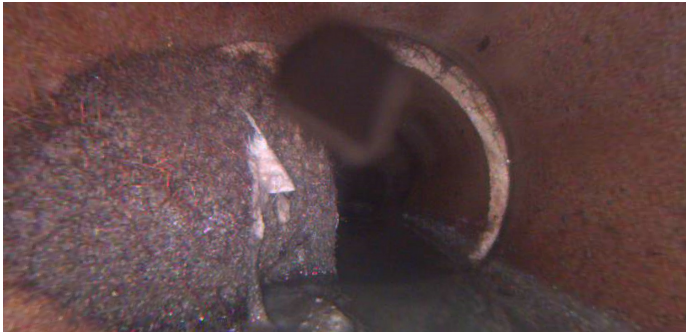
Code: **RMJ**  
Description: **Roots Medium Joint**

Distance (ft): **16.1**  
Structural Grade: **0**  
O&M Grade: **3**  
Clock Start/From: **6**  
Clock To: **12**  
1st Value:  
2nd Value:  
Value Percent: **40.000**  
Continuous Index:  
Within 8" of Joint: **YES**  
Remarks:

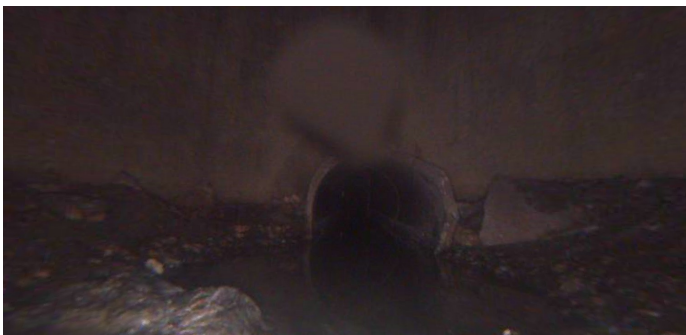
Code: **AMH**  
Description: **Manhole**

Distance (ft): **19.5**  
Structural Grade: **0**  
O&M Grade: **0**  
Clock Start/From:  
Clock To:  
1st Value:  
2nd Value:  
Value Percent:  
Continuous Index:  
Within 8" of Joint: **NO**  
Remarks: **M-507-039.5**
