## Profile/Photo Observation Report

Date:	<b>04/12/2018</b>	Weather:		Coding:	<b>PACP 6.0</b>
Pipe Length (ft):	<b>130.8</b>	Owner:	<b>NA</b>	Pre Clean:	<b>No Pre-Cleaning</b>
P.O.#:		Surveyor:	<b>Jen Costello</b>	PSR:	<b>P-507-039.6-039.5</b>
Customer:		Clean Date:	<b>01/01/1900</b>	Shape:	<b>C</b>

Street:	<b>W 10TH PL</b>	Flow Control:	<b>Not Controlled</b>
City:	<b>Hobart, IN</b>	Year Renewed:	
Location:	<b>Yard</b>	Tape/Media #:	
Purpose:	<b>Routine Assessment</b>	Dia/Height:	<b>12"</b>
Use:	<b>Sanitary</b>	Material:	<b>VCP</b>
Drain Area:	<b>NA</b>	Lining:	
Category:	<b>NA</b>		
Comment:

Location Details:		Direction of Survey:	<b>Downstream</b>
US MH:	<b>M-507-039.6</b>	DS MH:	<b>M-507-039.5</b>
		Total Length Surveyed (ft):	<b>26.9</b>

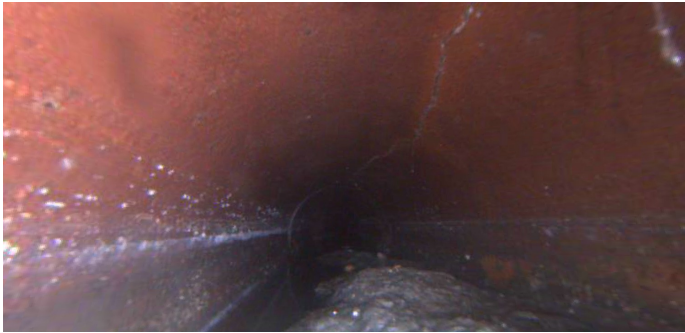
Code:	<b>MWL</b>
Description:	<b>Water Level</b>

Distance (ft):	<b>.0</b>
Structural Grade:	<b>0</b>
O&M Grade:	<b>0</b>
Clock Start/From:	
Clock To:	
1st Value:	
2nd Value:	
Value Percent:	<b>10.000</b>
Continuous Index:	
Within 8" of Joint:	<b>NO</b>
Remarks:

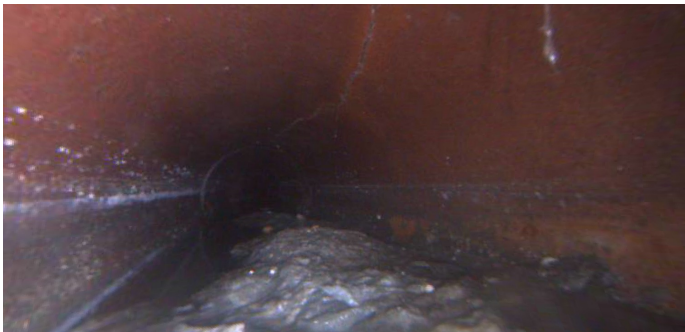
Code:	<b>DSZ</b>
Description:	<b>Deposits Settled Other</b>

Distance (ft):	<b>.0</b>
Structural Grade:	<b>0</b>
O&M Grade:	<b>2</b>
Clock Start/From:	<b>5</b>
Clock To:	<b>7</b>
1st Value:	
2nd Value:	
Value Percent:	<b>10.000</b>
Continuous Index:	
Within 8" of Joint:	<b>NO</b>
Remarks:	<b>misc</b>

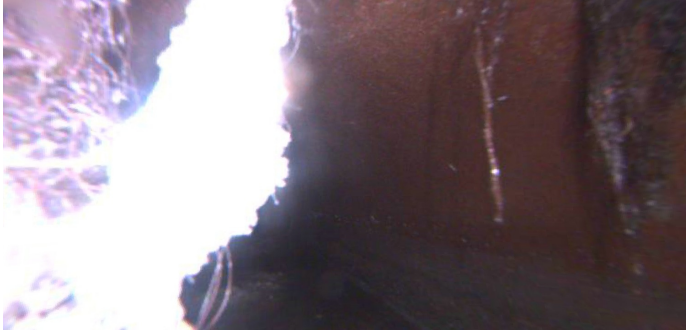
Code: **RMJ**  
Description: **Roots Medium Joint**

Distance (ft): **6.8**  
Structural Grade: **0**  
O&M Grade: **3**  
Clock Start/From: **8**  
Clock To: **4**  
1st Value:  
2nd Value:  
Value Percent: **20.000**  
Continuous Index:  
Within 8" of Joint: **YES**  
Remarks:

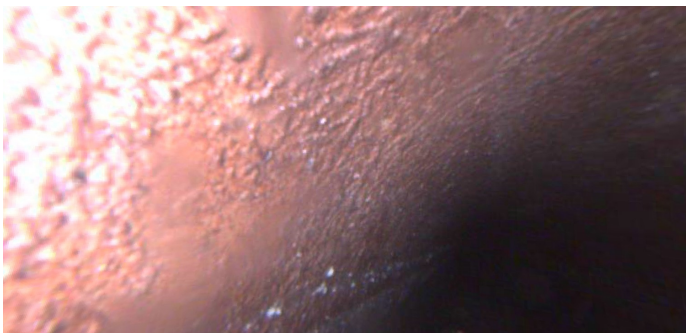
Code: **MSA**  
Description: **Abandoned Survey**

Distance (ft): **26.9**  
Structural Grade: **0**  
O&M Grade: **0**  
Clock Start/From:  
Clock To:  
1st Value:  
2nd Value:  
Value Percent:  
Continuous Index:  
Within 8" of Joint: **NO**  
Remarks: **debris under water**
