Profile/Photo Observation Report

Date:	04/12/2018	Weather:		Coding:	PACP 6.0
Pipe Length (ft):	130.8	Owner:	NA	Pre Clean:	No Pre-Cleaning
P.O.#:		Surveyor:	Jen Costello	PSR:	P-507-039.6-039.5
Customer:		Clean Date:	01/01/1900	Shape:	C

Street:	FOXCROFT STREET	Flow Control:	Not Controlled
City:	Hobart, IN	Year Renewed:	
Location:	Yard	Tape/Media #:	
Purpose:	Routine Assessment	Dia/Height:	12"
Use:	Sanitary	Material:	VCP
Drain Area:	NA	Lining:	
Category:	NA		
Comment:

Location Details:		Direction of Survey:	Downstream
US MH:	M-507-039.6	DS MH:	M-507-039.5
		Total Length Surveyed (ft):	26.9

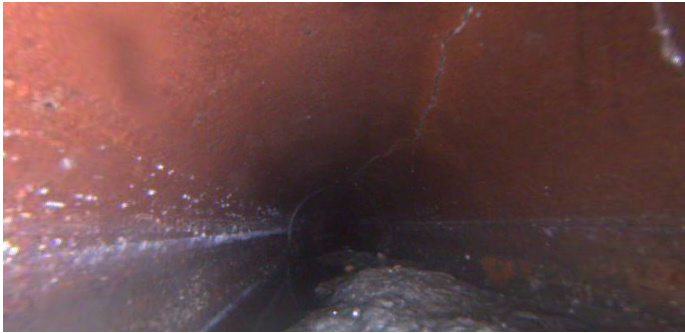
Code:	MWL
Description:	Water Level

Distance (ft):	.0
Structural Grade:	0
O&M Grade:	0
Clock Start/From:	
Clock To:	
1st Value:	
2nd Value:	
Value Percent:	10.000
Continuous Index:	
Within 8" of Joint:	NO
Remarks:

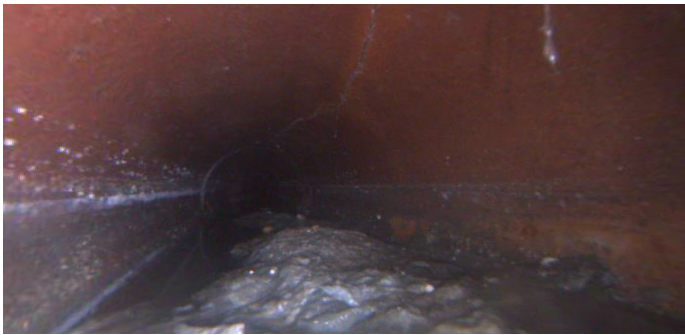
Code:	DSZ
Description:	Deposits Settled Other

Distance (ft):	.0
Structural Grade:	0
O&M Grade:	2
Clock Start/From:	5
Clock To:	7
1st Value:	
2nd Value:	
Value Percent:	10.000
Continuous Index:	
Within 8" of Joint:	NO
Remarks:	misc

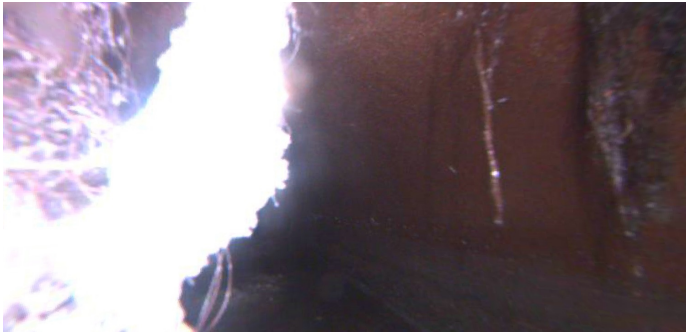
Code: **RMJ**
Description: **Roots Medium Joint**

Distance (ft): **6.8**
Structural Grade: **0**
O&M Grade: **3**
Clock Start/From: **8**
Clock To: **4**
1st Value:
2nd Value:
Value Percent: **20.000**
Continuous Index:
Within 8" of Joint: **YES**
Remarks:

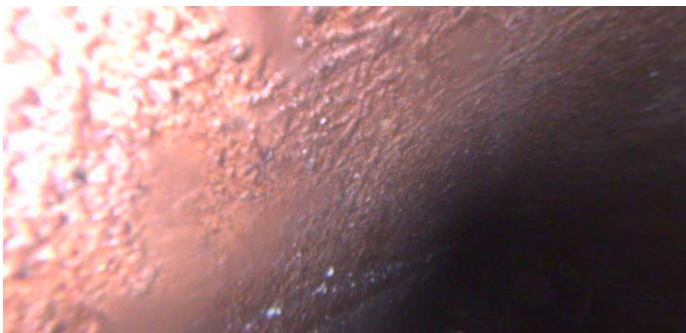
Code: **MSA**
Description: **Abandoned Survey**

Distance (ft): **26.9**
Structural Grade: **0**
O&M Grade: **0**
Clock Start/From:
Clock To:
1st Value:
2nd Value:
Value Percent:
Continuous Index:
Within 8" of Joint: **NO**
Remarks: **debris under water**
