## Profile/Photo Observation Report

Date:	<b>04/13/2018</b>	Weather:		Coding:	<b>PACP 6.0</b>
Pipe Length (ft):	<b>60.2</b>	Owner:	<b>NA</b>	Pre Clean:	<b>No Pre-Cleaning</b>
P.O.#:		Surveyor:	<b>Jen Costello</b>	PSR:	<b>P-507-054-041</b>
Customer:		Clean Date:	<b>01/01/1900</b>	Shape:	<b>C</b>

Street:	<b>S VIRGINIA ST</b>	Flow Control:	<b>Not Controlled</b>
City:	<b>Hobart, IN</b>	Year Renewed:	
Location:	<b>Yard</b>	Tape/Media #:	
Purpose:	<b>Routine Assessment</b>	Dia/Height:	<b>8"</b>
Use:	<b>Sanitary</b>	Material:	<b>PVC</b>
Drain Area:	<b>NA</b>	Lining:	
Category:	<b>NA</b>		
Comment:	<b>Flow direction is marked wrong.</b>		
Location Details:		Direction of Survey:	<b>Upstream</b>
US MH:	<b>M-507-041</b>	DS MH:	<b>M-507-054</b>
		Total Length Surveyed (ft):	<b>57.0</b>

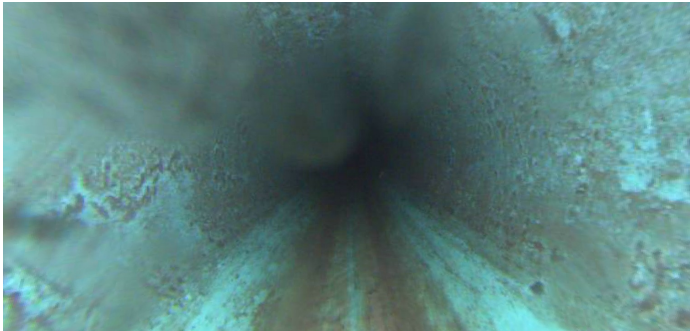
Code: AMH

Description: Manhole

Remarks: M-507-054

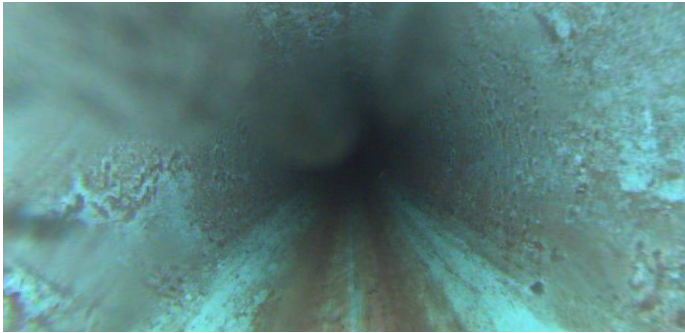
Code:	<b>MWL</b>
Description:	<b>Water Level</b>

Distance (ft):	<b>.0</b>
Structural Grade:	<b>0</b>
O&M Grade:	<b>0</b>
Clock Start/From:	
Clock To:	
1st Value:	
2nd Value:	
Value Percent:	<b>5.000</b>
Continuous Index:	
Within 8" of Joint:	<b>NO</b>
Remarks:

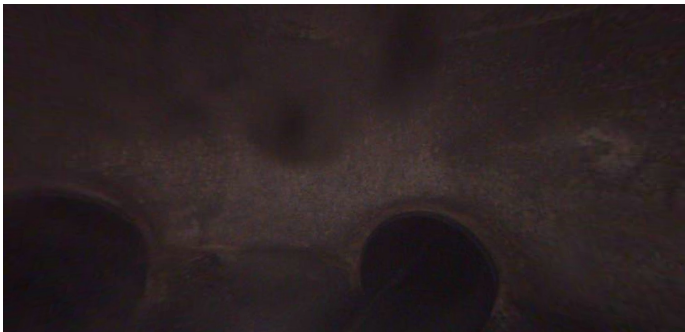
Code:	<b>AMH</b>
Description:	<b>Manhole</b>

Distance (ft):	<b>57.0</b>
Structural Grade:	<b>0</b>
O&M Grade:	<b>0</b>
Clock Start/From:	
Clock To:	
1st Value:	
2nd Value:	
Value Percent:	
Continuous Index:	
Within 8" of Joint:	<b>NO</b>
Remarks:	<b>M-507-041</b>
