## Profile/Photo Observation Report

Date:	<b>04/13/2018</b>	Weather:		Coding:	<b>PACP 6.0</b>
Pipe Length (ft):	<b>60.2</b>	Owner:	<b>NA</b>	Pre Clean:	<b>No Pre-Cleaning</b>
P.O.#:		Surveyor:	<b>Jen Costello</b>	PSR:	<b>P-507-054-041</b>
Customer:		Clean Date:	<b>01/01/1900</b>	Shape:	<b>C</b>

Street:	<b>FOXCROFT STREET</b>	Flow Control:	<b>Not Controlled</b>
City:	<b>Hobart, IN</b>	Year Renewed:	
Location:	<b>Yard</b>	Tape/Media #:	
Purpose:	<b>Routine Assessment</b>	Dia/Height:	<b>8"</b>
Use:	<b>Sanitary</b>	Material:	<b>PVC</b>
Drain Area:	<b>NA</b>	Lining:	
Category:	<b>NA</b>		
Comment:	<b>Flow direction is marked wrong.</b>		
Location Details:		Direction of Survey:	<b>Upstream</b>
US MH:	<b>M-507-041</b>	DS MH:	<b>M-507-054</b>
		Total Length Surveyed (ft):	<b>57.0</b>

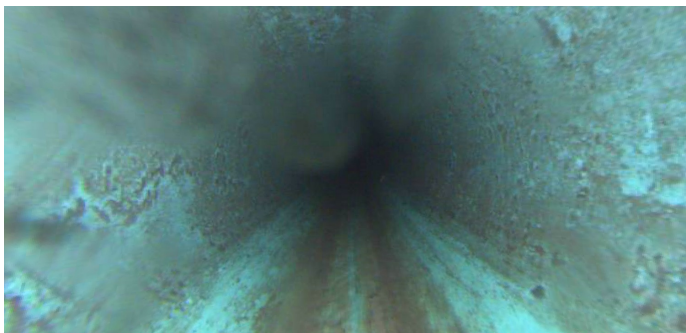
Code: **AMH**  
Description: **Manhole**

Distance (ft): **.0**  
Structural Grade: **0**  
O&M Grade: **0**  
Clock Start/From:  
Clock To:  
1st Value:  
2nd Value:  
Value Percent:  
Continuous Index:  
Within 8" of Joint: **NO**  
Remarks: **M-507-054**

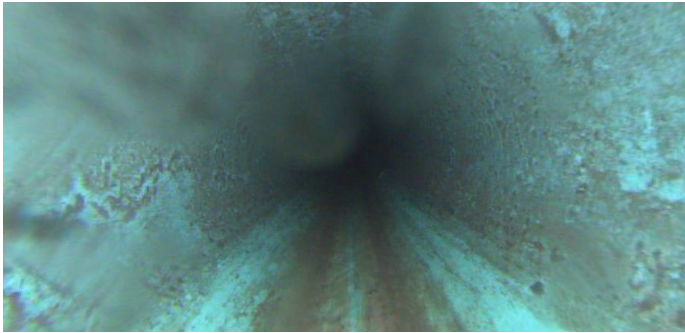
Code:	<b>MWL</b>
Description:	<b>Water Level</b>

Distance (ft):	<b>.0</b>
Structural Grade:	<b>0</b>
O&M Grade:	<b>0</b>
Clock Start/From:	
Clock To:	
1st Value:	
2nd Value:	
Value Percent:	<b>5.000</b>
Continuous Index:	
Within 8" of Joint:	<b>NO</b>
Remarks:

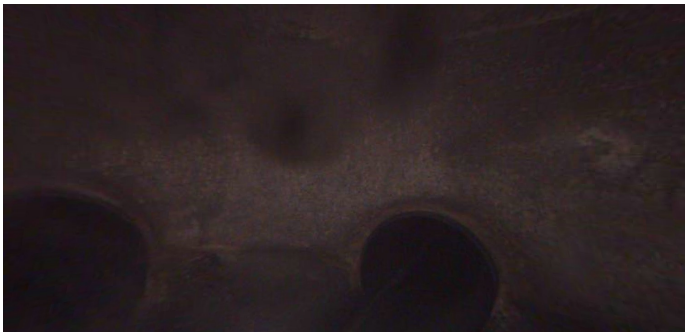
Code:	<b>AMH</b>
Description:	<b>Manhole</b>

Distance (ft):	<b>57.0</b>
Structural Grade:	<b>0</b>
O&M Grade:	<b>0</b>
Clock Start/From:	
Clock To:	
1st Value:	
2nd Value:	
Value Percent:	
Continuous Index:	
Within 8" of Joint:	<b>NO</b>
Remarks:	<b>M-507-041</b>
