Profile/Photo Observation Report

Date:	04/07/2018	Weather:		Coding:	PACP 6.0
Pipe Length (ft):		Owner:	City of Hobart	Pre Clean:	Not Known
P.O.#:	200	Surveyor:	B. Helbling	PSR:	P-507-044-043
Customer:	City of Hobart	Clean Date:		Shape:	C

Street:	South Delaware Street	Flow Control:	Not Controlled
City:	Hobart, IN	Year Renewed:	
Location:	Light Highway	Tape/Media #:	DEP200
Purpose:	Routine Assessment	Dia/Height:	15"
Use:	Sanitary	Material:	PVC
Drain Area:		Lining:	
Category:	NA		
Comment:	YES501824 Submittal 2		
Location Details:		Direction of Survey:	Upstream
US MH:	M-507-044	DS MH:	M-507-043
		Total Length Surveyed (ft):	249.3

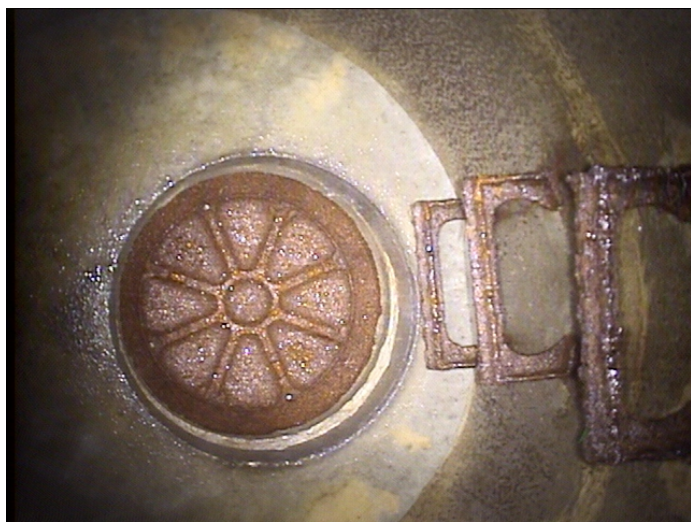
Code: **AMH**
 Description: **Manhole**

Distance (ft): **.0**
 Structural Grade: **0**
 O&M Grade: **0**
 Clock Start/From:
 Clock To:
 1st Value:
 2nd Value:
 Value Percent:
 Continuous Index:
 Within 8" of Joint: **NO**
 Remarks: **M-507-043**

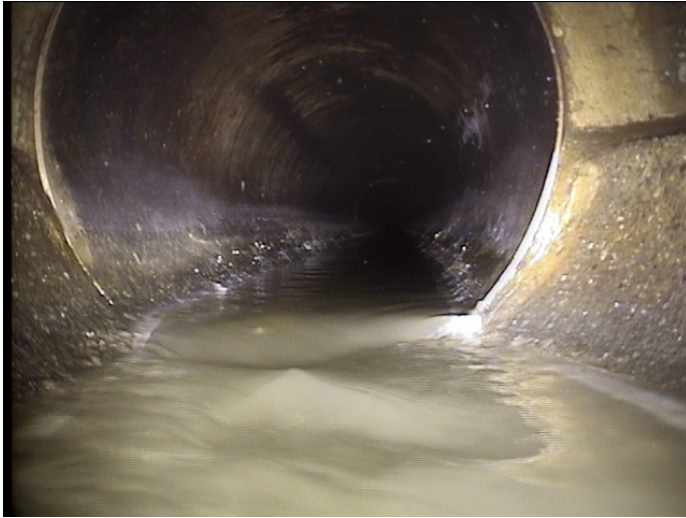
Code: **MWL**
Description: **Water Level**

Distance (ft): **.0**
Structural Grade: **0**
O&M Grade: **0**
Clock Start/From:
Clock To:
1st Value:
2nd Value:
Value Percent: **5.000**
Continuous Index:
Within 8" of Joint: **NO**
Remarks:

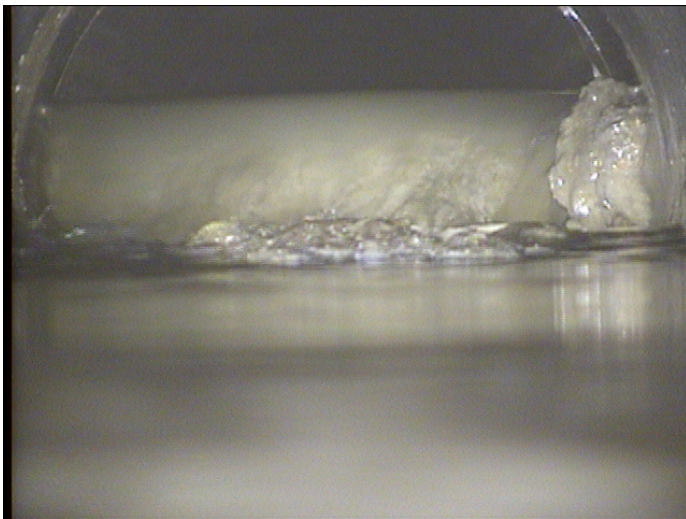
Code: **MSA**
Description: **Abandoned Survey**

Distance (ft): **249.3**
Structural Grade: **0**
O&M Grade: **0**
Clock Start/From:
Clock To:
1st Value:
2nd Value:
Value Percent:
Continuous Index:
Within 8" of Joint: **NO**
Remarks: **Cannot pass sediment. Unknown obstacle ahead.**
