Profile/Photo Observation Report

Date:	01/16/2025	Weather:		Coding:	PACP 7.0
Pipe Length (ft):	420.0	Owner:	City of Hobart	Pre Clean:	Heavy Cleaning
P.O.#:	YES502259	Surveyor:	S. Bucklin	PSR:	P-507-044-043
Customer:	City of Hobart	Clean Date:	12/05/2024	Shape:	C

Street:	South Delaware Street	Flow Control:	Not Controlled
City:	Hobart, IN	Year Renewed:	
Location:	Local rural streets with light traffic, t	Tape/Media #:	
Purpose:	Sewer System Evaluation Survey (SS	Dia/Height:	15"
Use:	Sanitary Sewage Pipe	Material:	PVC
Drain Area:		Lining:	None
Category:	NA		
Comment:			
Location Details:		Direction of Survey:	Upstream
US MH:	M-507-044	DS MH:	M-507-043
		Total Length Surveyed (ft):	267.3

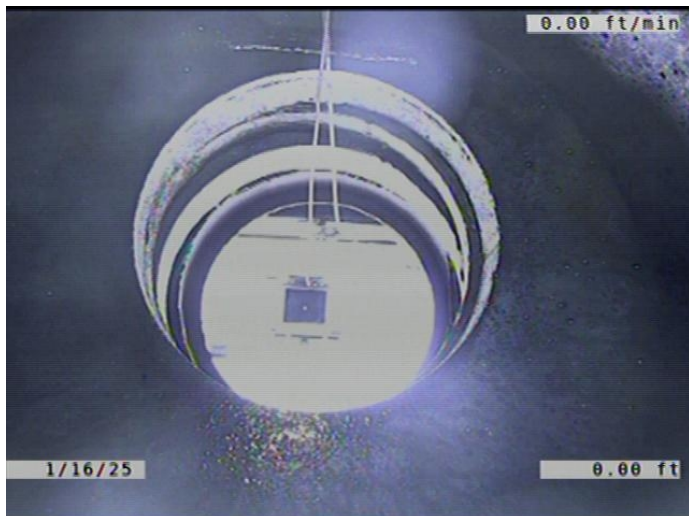
Code: **AMH**
Description: **Manhole**

Distance (ft): **.0**
Structural Grade: **0**
O&M Grade: **0**
Clock Start/From:
Clock To:
1st Value:
2nd Value:
Value Percent:
Continuous Index:
Within 8" of Joint: **NO**
Remarks: **M-507-043**

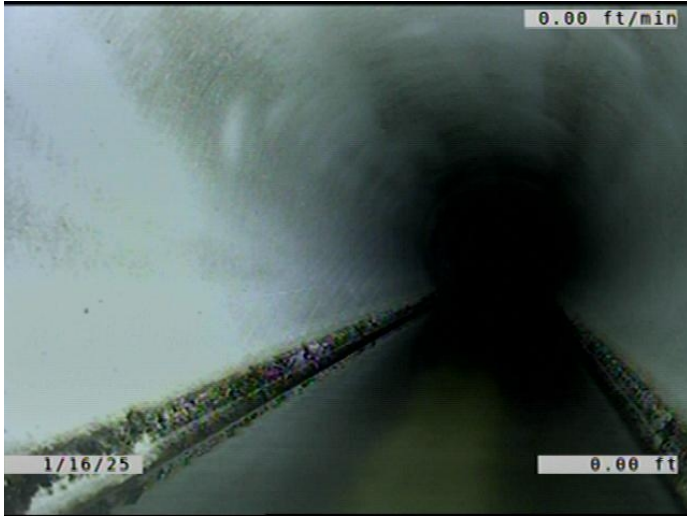
Code:	MWL
Description:	Miscellaneous Water Level
Distance (ft):	.0
Structural Grade:	0
O&M Grade:	0
Clock Start/From:	
Clock To:	
1st Value:	
2nd Value:	
Value Percent:	15.000
Continuous Index:	
Within 8" of Joint:	NO
Remarks:

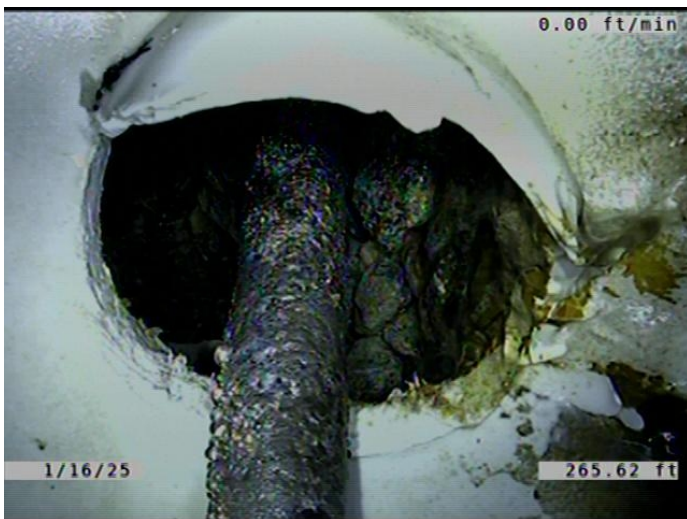
Code:	HVV
Description:	Hole Void Visible
Distance (ft):	265.6
Structural Grade:	5
O&M Grade:	0
Clock Start/From:	3
Clock To:	
1st Value:	
2nd Value:	
Value Percent:	
Continuous Index:	
Within 8" of Joint:	YES
Remarks:

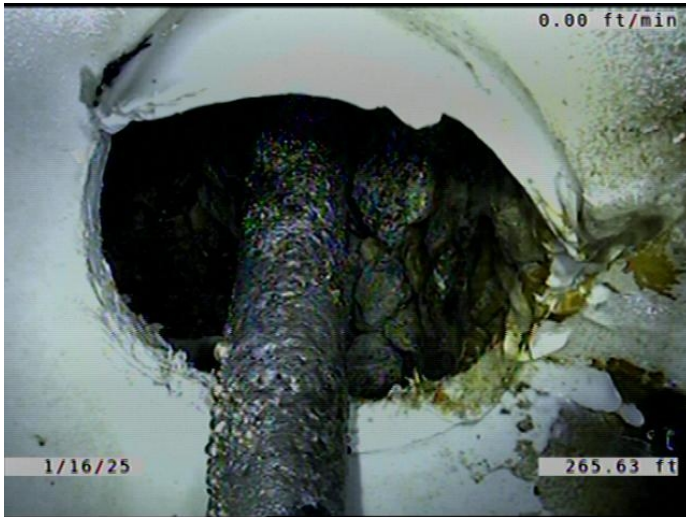
Code: **IRB**
 Description: **Infiltration Runner Barrel**

Distance (ft): **265.6**
 Structural Grade: **0**
 O&M Grade: **4**
 Clock Start/From: **3**
 Clock To:
 1st Value:
 2nd Value:
 Value Percent:
 Continuous Index:
 Within 8" of Joint: **YES**
 Remarks:

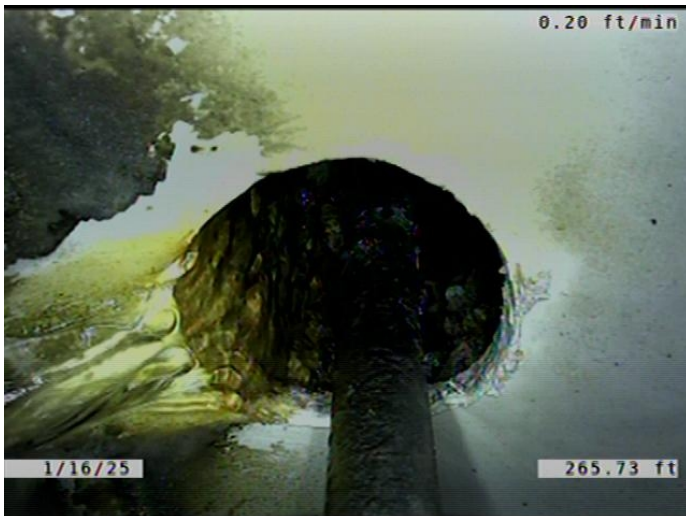
Code: **HVV**
 Description: **Hole Void Visible**

Distance (ft): **265.7**
 Structural Grade: **5**
 O&M Grade: **0**
 Clock Start/From: **9**
 Clock To:
 1st Value:
 2nd Value:
 Value Percent:
 Continuous Index:
 Within 8" of Joint: **YES**
 Remarks:

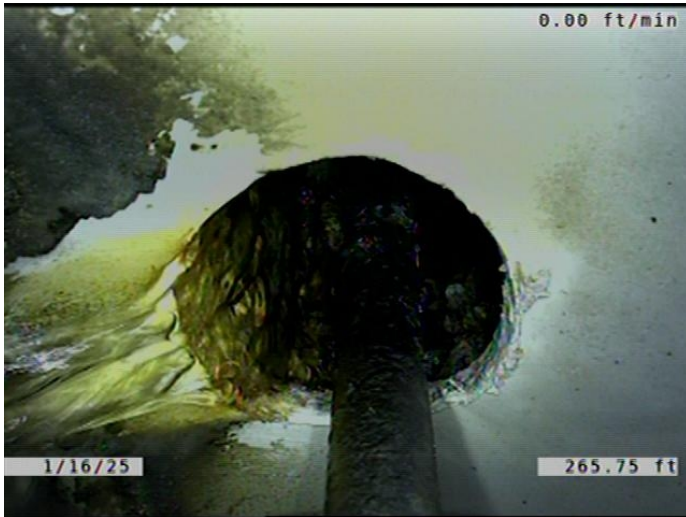
Code: **IRB**
 Description: **Infiltration Runner Barrel**

Distance (ft): **265.8**
 Structural Grade: **0**
 O&M Grade: **4**
 Clock Start/From: **9**
 Clock To:
 1st Value:
 2nd Value:
 Value Percent:
 Continuous Index:
 Within 8" of Joint: **YES**
 Remarks:

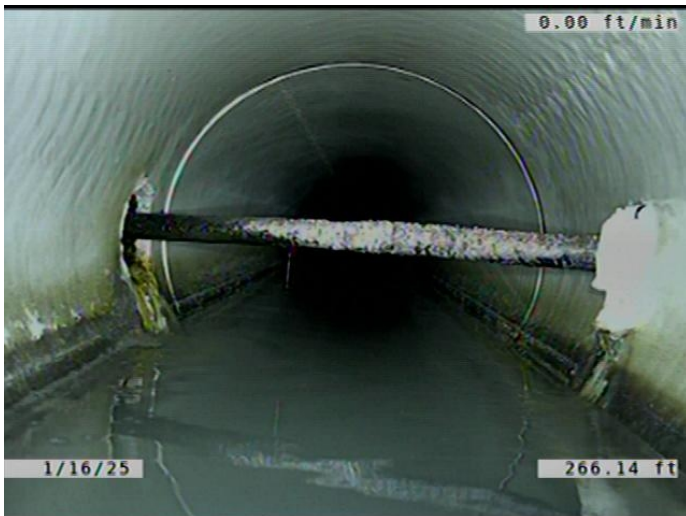
Code: **OBP**
 Description: **Obstruction External Pipe or Cable**

Distance (ft): **266.1**
 Structural Grade: **0**
 O&M Grade: **2**
 Clock Start/From: **3**
 Clock To: **9**
 1st Value:
 2nd Value:
 Value Percent: **5.000**
 Continuous Index:
 Within 8" of Joint: **YES**
 Remarks:

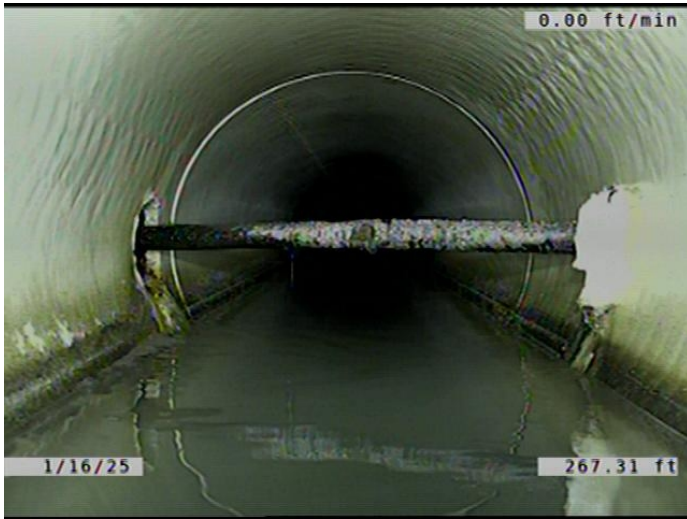
Code:	MSA
Description:	Miscellaneous Survey Abandoned
Distance (ft):	267.3
Structural Grade:	0
O&M Grade:	0
Clock Start/From:	
Clock To:	
1st Value:	
2nd Value:	
Value Percent:	
Continuous Index:	
Within 8" of Joint:	NO
Remarks:	CAMERA CANT MAKE IT PAST THE CROSS BORE. MADE IT TO THE POIN
