Profile/Photo Observation Report

Date:	01/16/2025	Weather:		Coding:	PACP 7.0
Pipe Length (ft):	420.0	Owner:	City of Hobart	Pre Clean:	Heavy Cleaning
P.O.#:	YES502259	Surveyor:	S. Bucklin	PSR:	P-507-044-043
Customer:	City of Hobart	Clean Date:	12/05/2024	Shape:	C

Street:	South Delaware Street	Flow Control:	Not Controlled
City:	Hobart, IN	Year Renewed:	
Location:	Local rural streets with light traffic, t	Tape/Media #:	
Purpose:	Sewer System Evaluation Survey (SS	Dia/Height:	15"
Use:	Sanitary Sewage Pipe	Material:	PVC
Drain Area:		Lining:	None
Category:	NA		
Comment:			
Location Details:		Direction of Survey:	Downstream
US MH:	M-507-044	DS MH:	M-507-043
		Total Length Surveyed (ft):	135.2

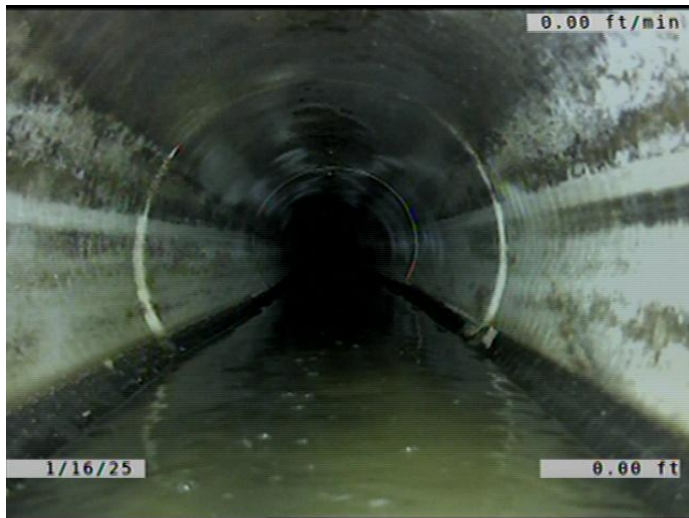
Code: **MWL**
 Description: **Miscellaneous Water Level**

Distance (ft): **.0**
 Structural Grade: **0**
 O&M Grade: **0**
 Clock Start/From:
 Clock To:
 1st Value:
 2nd Value:
 Value Percent: **15.000**
 Continuous Index:
 Within 8" of Joint: **NO**
 Remarks:

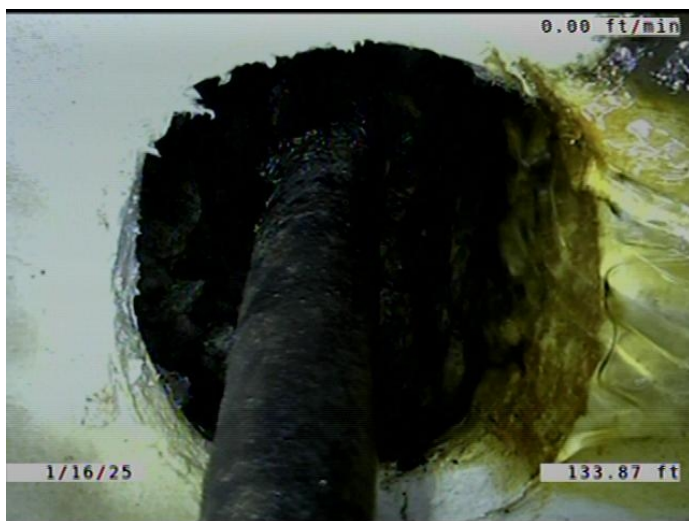
Code: **HVV**
 Description: **Hole Void Visible**

Distance (ft): **133.9**
 Structural Grade: **5**
 O&M Grade: **0**
 Clock Start/From: **3**
 Clock To:
 1st Value:
 2nd Value:
 Value Percent:
 Continuous Index:
 Within 8" of Joint: **YES**
 Remarks:

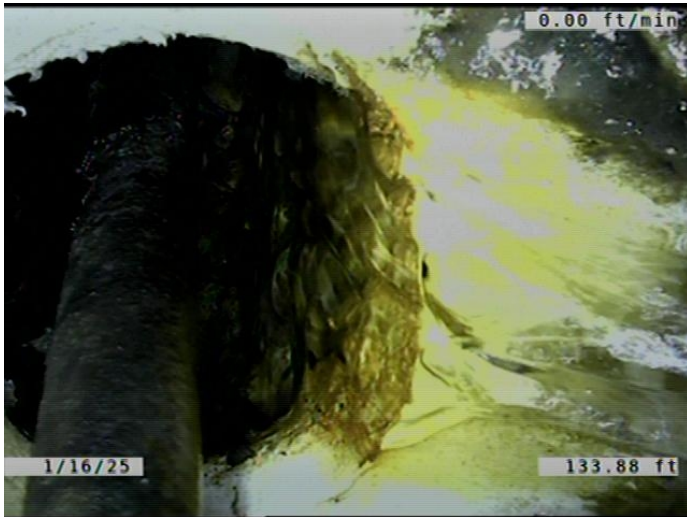
Code: **IRB**
Description: **Infiltration Runner Barrel**

Distance (ft): **133.9**
Structural Grade: **0**
O&M Grade: **4**
Clock Start/From: **3**
Clock To:
1st Value:
2nd Value:
Value Percent:
Continuous Index:
Within 8" of Joint: **YES**
Remarks:

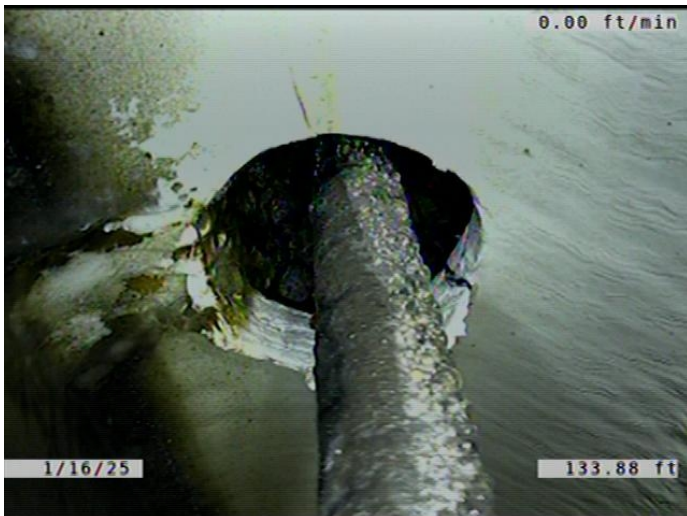
Code: **HVV**
Description: **Hole Void Visible**

Distance (ft): **133.9**
Structural Grade: **5**
O&M Grade: **0**
Clock Start/From: **9**
Clock To:
1st Value:
2nd Value:
Value Percent:
Continuous Index:
Within 8" of Joint: **YES**
Remarks:

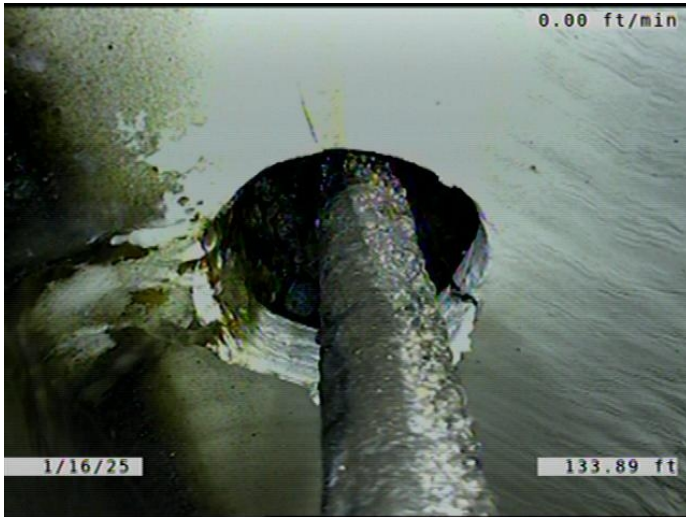
Code: **IRB**
Description: **Infiltration Runner Barrel**

Distance (ft): **133.9**
Structural Grade: **0**
O&M Grade: **4**
Clock Start/From: **9**
Clock To:
1st Value:
2nd Value:
Value Percent:
Continuous Index:
Within 8" of Joint: **YES**
Remarks:

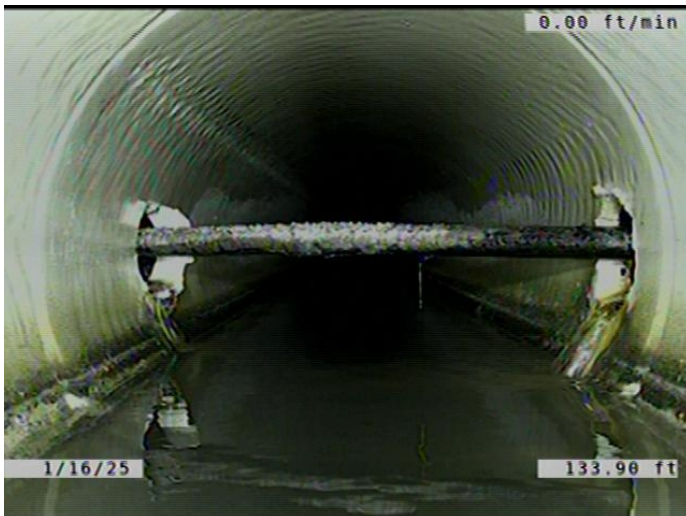
Code: **OBP**
Description: **Obstruction External Pipe or Cable**

Distance (ft): **133.9**
Structural Grade: **0**
O&M Grade: **2**
Clock Start/From: **3**
Clock To: **9**
1st Value:
2nd Value:
Value Percent: **5.000**
Continuous Index:
Within 8" of Joint: **YES**
Remarks:

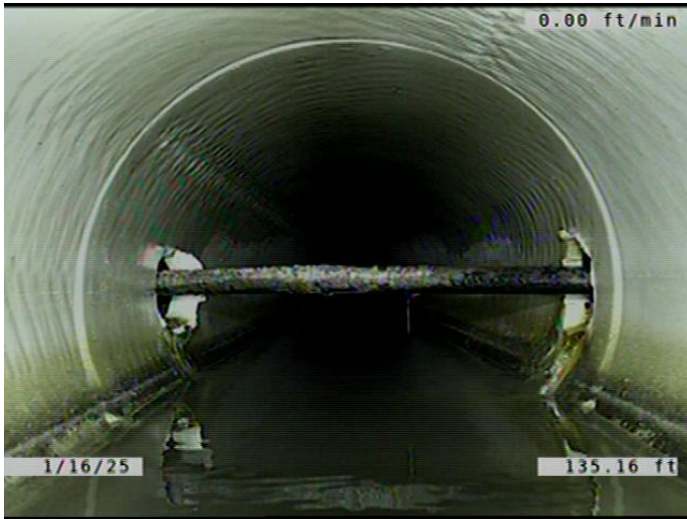
Code:	MSA
Description:	Miscellaneous Survey Abandoned
Distance (ft):	135.2
Structural Grade:	0
O&M Grade:	0
Clock Start/From:	
Clock To:	
1st Value:	
2nd Value:	
Value Percent:	
Continuous Index:	
Within 8" of Joint:	NO
Remarks:	CAMERA CANT MAKE IT PAST CROSS BORE.
