## Profile/Photo Observation Report

Date:	<b>03/26/2018</b>	Weather:		Coding:	<b>PACP 6.0</b>
Pipe Length (ft):	<b>318.8</b>	Owner:	<b>NA</b>	Pre Clean:	<b>No Pre-Cleaning</b>
P.O.#:		Surveyor:	<b>Justin Gonzales</b>	PSR:	<b>P-507-048-049</b>
Customer:		Clean Date:	<b>01/01/1900</b>	Shape:	<b>C</b>

Street:	<b>S VIRGINIA ST &amp; CSOKASY LN</b>	Flow Control:	<b>Not Controlled</b>
City:	<b>Hobart, IN</b>	Year Renewed:	
Location:	<b>Light Highway</b>	Tape/Media #:	
Purpose:	<b>Routine Assessment</b>	Dia/Height:	<b>8"</b>
Use:	<b>Sanitary</b>	Material:	<b>PVC</b>
Drain Area:	<b>NA</b>	Lining:	
Category:	<b>NA</b>		
Comment:

Location Details:		Direction of Survey:	<b>Downstream</b>
US MH:	<b>M-507-048</b>	DS MH:	<b>M-507-049</b>
		Total Length Surveyed (ft):	<b>319.1</b>

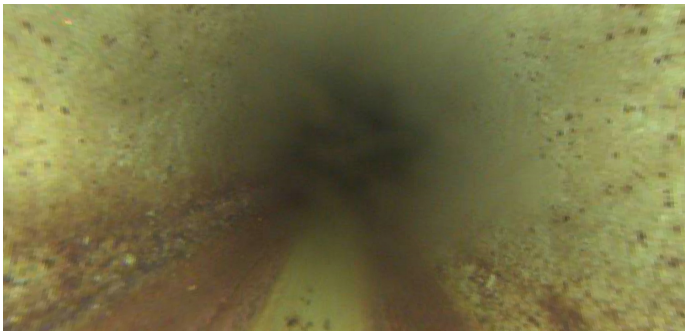
Code: **AMH**  
Description: **Manhole**

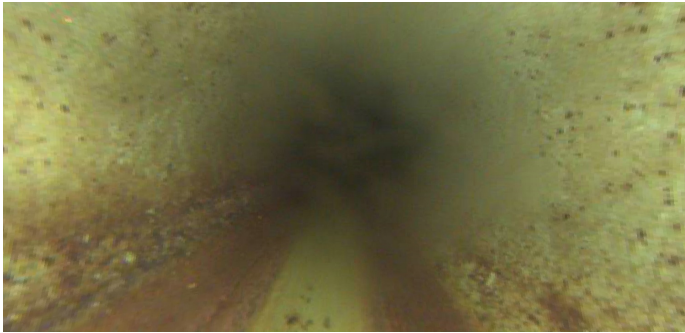
Code:	<b>MWL</b>
Description:	<b>Water Level</b>

Distance (ft):	<b>.0</b>
Structural Grade:	<b>0</b>
O&M Grade:	<b>0</b>
Clock Start/From:	
Clock To:	
1st Value:	
2nd Value:	
Value Percent:	<b>5.000</b>
Continuous Index:	
Within 8" of Joint:	<b>NO</b>
Remarks:

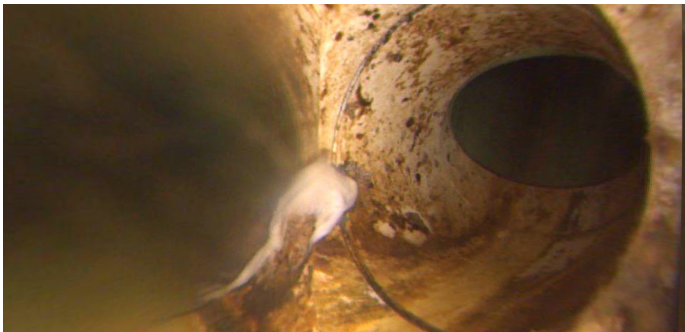
Code:	<b>TFD</b>
Description:	<b>Tap Factory Defective</b>

Distance (ft):	<b>127.3</b>
Structural Grade:	<b>0</b>
O&M Grade:	<b>2</b>
Clock Start/From:	<b>3</b>
Clock To:	
1st Value:	<b>4.000</b>
2nd Value:	
Value Percent:	
Continuous Index:	
Within 8" of Joint:	
Remarks:	<b>dags</b>

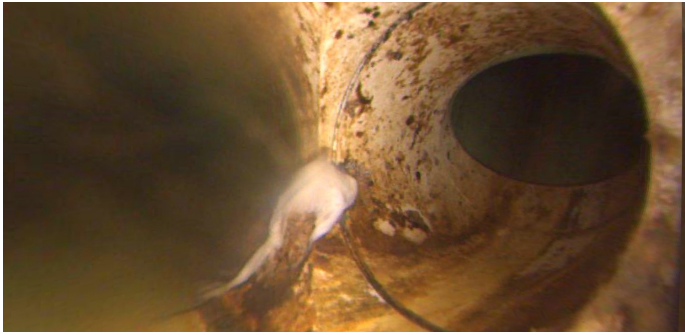
Code: **DAGS**  
Description: **Deposits Attached Grease**

Distance (ft): **127.3**  
Structural Grade: **0**  
O&M Grade: **2**  
Clock Start/From: **3**  
Clock To: **4**  
1st Value:  
2nd Value:  
Value Percent: **5.000**  
Continuous Index:  
Within 8" of Joint: **NO**  
Remarks:

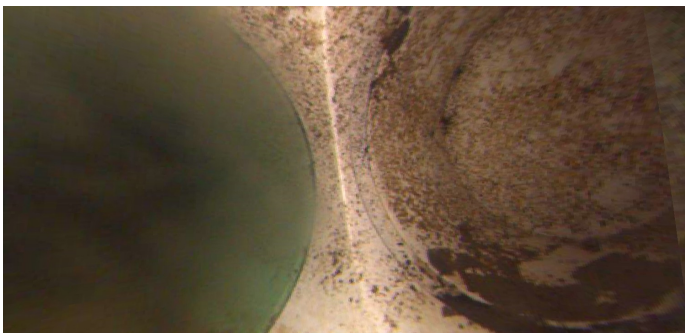
Code: **TFC**  
Description: **Tap Factory Capped**

Distance (ft): **205.8**  
Structural Grade: **0**  
O&M Grade: **0**  
Clock Start/From: **3**  
Clock To:  
1st Value: **4.000**  
2nd Value:  
Value Percent:  
Continuous Index:  
Within 8" of Joint:  
Remarks:

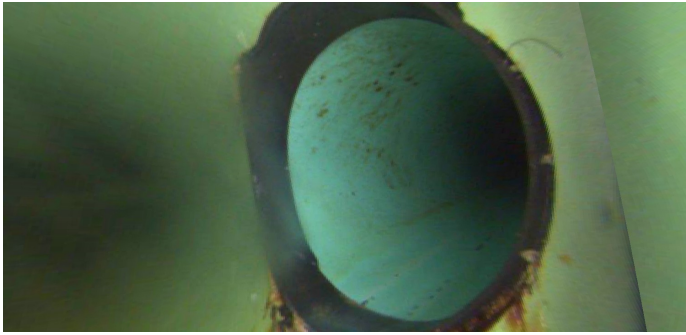
Code: **TF**  
Description: **Tap Factory**

Distance (ft): **218.6**  
Structural Grade: **0**  
O&M Grade: **0**  
Clock Start/From: **3**  
Clock To:  
1st Value: **4.000**  
2nd Value:  
Value Percent:  
Continuous Index:  
Within 8" of Joint:  
Remarks:

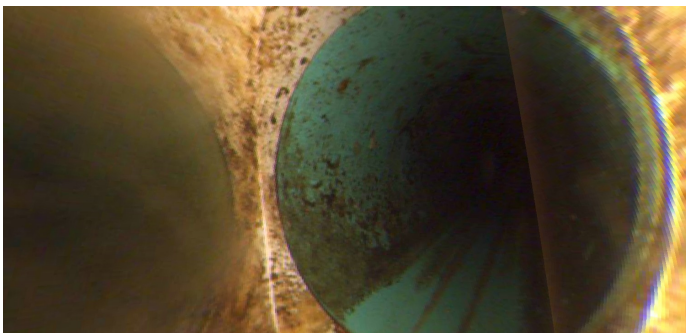
Code: **TF**  
Description: **Tap Factory**

Distance (ft): **281.9**  
Structural Grade: **0**  
O&M Grade: **0**  
Clock Start/From: **3**  
Clock To:  
1st Value: **4.000**  
2nd Value:  
Value Percent:  
Continuous Index:  
Within 8" of Joint:  
Remarks:

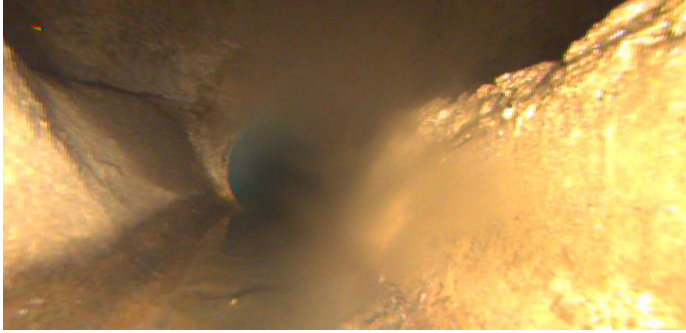
Code:	<b>AMH</b>
Description:	<b>Manhole</b>
Distance (ft):	<b>319.1</b>
Structural Grade:	<b>0</b>
O&M Grade:	<b>0</b>
Clock Start/From:	
Clock To:	
1st Value:	
2nd Value:	
Value Percent:	
Continuous Index:	
Within 8" of Joint:	<b>NO</b>
Remarks:	<b>M-507-049</b>
