Profile/Photo Observation Report

Street:	S VIRGINIA ST	Flow Control:	Not Controlled
City:	Hobart, IN	Year Renewed:	
Location:	Light Highway	Tape/Media #:	
Purpose:	Routine Assessment	Dia/Height:	8"
Use:	Sanitary	Material:	PVC
Drain Area:	NA	Lining:	
Category:	NA		
Comment:	P_C at 29 ft debris

Location Details:		Direction of Survey:	Upstream
US MH:	M-507-049	DS MH:	M-507-050
		Total Length Surveyed (ft):	30.7

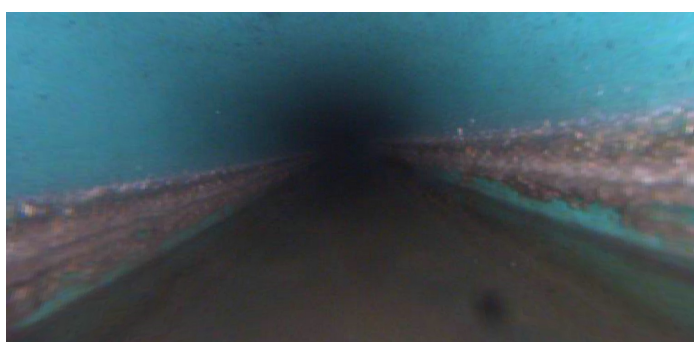
Code: **AMH**
Description: **Manhole**

Distance (ft): **.0**
Structural Grade: **0**
O&M Grade: **0**
Clock Start/From:
Clock To:
1st Value:
2nd Value:
Value Percent:
Continuous Index:
Within 8" of Joint: **NO**
Remarks: **M-507-050**

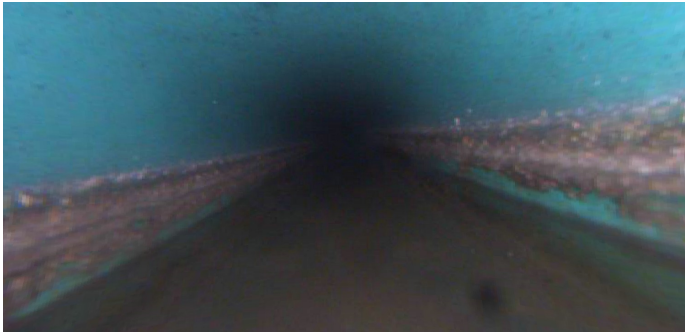
Code:	MWL
Description:	Water Level

Distance (ft):	.0
Structural Grade:	0
O&M Grade:	0
Clock Start/From:	
Clock To:	
1st Value:	
2nd Value:	
Value Percent:	5.000
Continuous Index:	
Within 8" of Joint:	NO
Remarks:

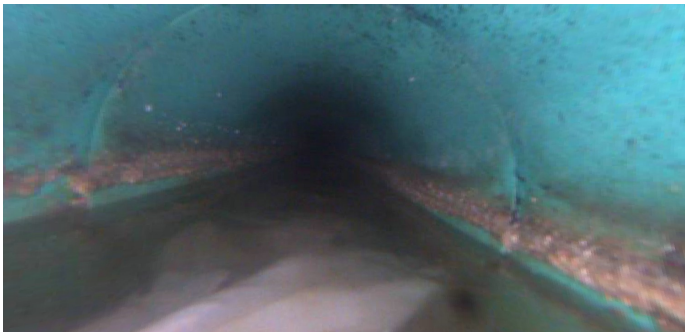
Code:	DSZ
Description:	Deposits Settled Other

Distance (ft):	12.1
Structural Grade:	0
O&M Grade:	2
Clock Start/From:	6
Clock To:	
1st Value:	
2nd Value:	
Value Percent:	5.000
Continuous Index:	
Within 8" of Joint:	NO
Remarks:	tissue

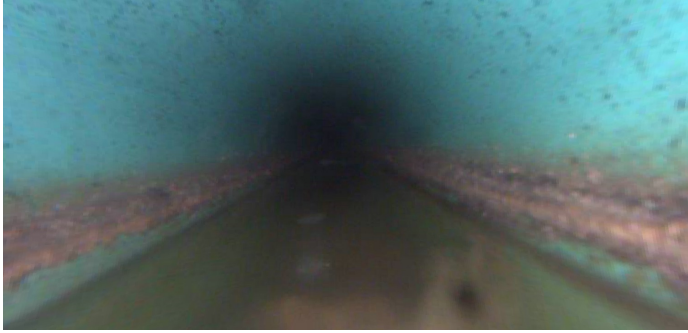
Code:	MSA
Description:	Abandoned Survey
Distance (ft):	30.7
Structural Grade:	0
O&M Grade:	0
Clock Start/From:	
Clock To:	
1st Value:	
2nd Value:	
Value Percent:	
Continuous Index:	
Within 8" of Joint:	NO
Remarks:	stopped/no blockage
