Profile/Photo Observation Report

Street:	FOXCROFT STREET	Flow Control:	Not Controlled
City:	Hobart, IN	Year Renewed:	
Location:	Light Highway	Tape/Media #:	
Purpose:	Routine Assessment	Dia/Height:	8"
Use:	Sanitary	Material:	PVC
Drain Area:	NA	Lining:	
Category:	NA		
Comment:	P_C at 29 ft debris

Location Details:		Direction of Survey:	Upstream
US MH:	M-507-049	DS MH:	M-507-050
		Total Length Surveyed (ft):	30.7

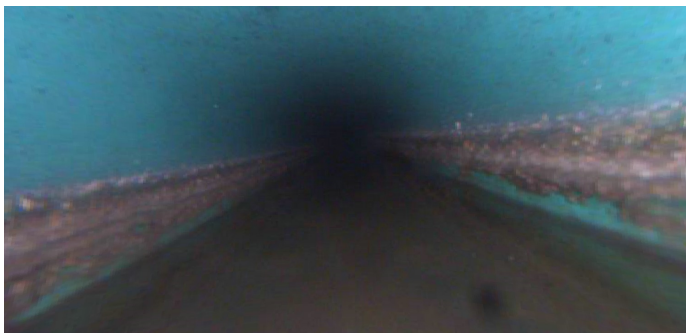
Code: **AMH**
Description: **Manhole**

Distance (ft): **.0**
Structural Grade: **0**
O&M Grade: **0**
Clock Start/From:
Clock To:
1st Value:
2nd Value:
Value Percent:
Continuous Index:
Within 8" of Joint: **NO**
Remarks: **M-507-050**

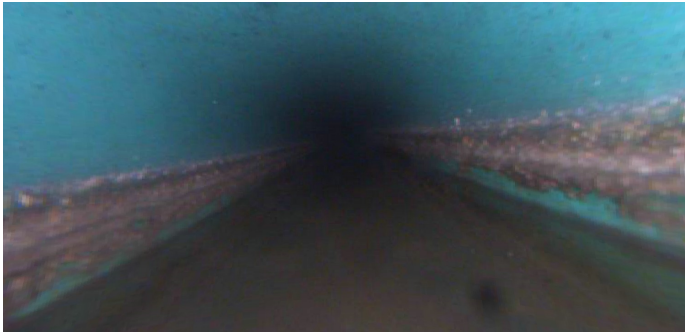
Code:	MWL
Description:	Water Level

Distance (ft):	.0
Structural Grade:	0
O&M Grade:	0
Clock Start/From:	
Clock To:	
1st Value:	
2nd Value:	
Value Percent:	5.000
Continuous Index:	
Within 8" of Joint:	NO
Remarks:

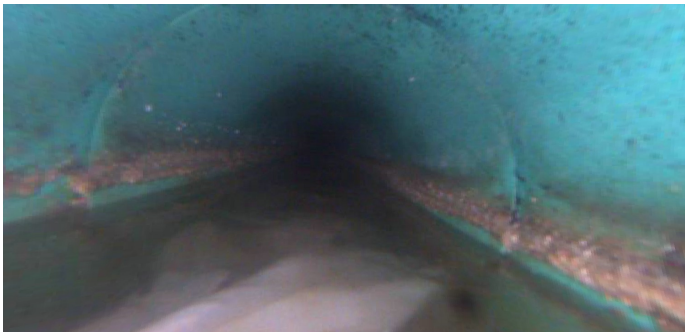
Code:	DSZ
Description:	Deposits Settled Other

Distance (ft):	12.1
Structural Grade:	0
O&M Grade:	2
Clock Start/From:	6
Clock To:	
1st Value:	
2nd Value:	
Value Percent:	5.000
Continuous Index:	
Within 8" of Joint:	NO
Remarks:	tissue

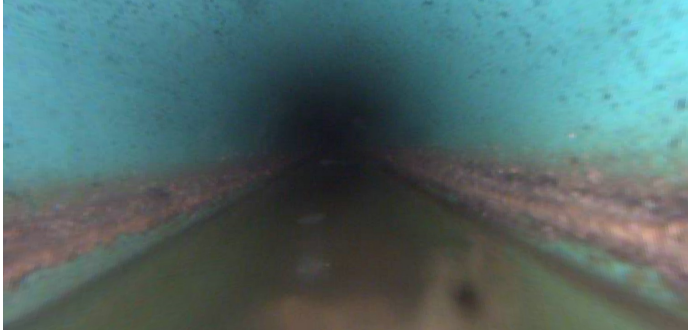
Code:	MSA
Description:	Abandoned Survey
Distance (ft):	30.7
Structural Grade:	0
O&M Grade:	0
Clock Start/From:	
Clock To:	
1st Value:	
2nd Value:	
Value Percent:	
Continuous Index:	
Within 8" of Joint:	NO
Remarks:	stopped/no blockage
