## Profile/Photo Observation Report

Street:	<b>S VIRGINIA ST</b>	Flow Control:	<b>Not Controlled</b>
City:	<b>Hobart, IN</b>	Year Renewed:	
Location:	<b>Light Highway</b>	Tape/Media #:	
Purpose:	<b>Routine Assessment</b>	Dia/Height:	<b>8"</b>
Use:	<b>Sanitary</b>	Material:	<b>PVC</b>
Drain Area:	<b>NA</b>	Lining:	
Category:	<b>NA</b>		
Comment:

Location Details:		Direction of Survey:	<b>Downstream</b>
US MH:	<b>M-507-052</b>	DS MH:	<b>M-507-053</b>
		Total Length Surveyed (ft):	<b>197.7</b>

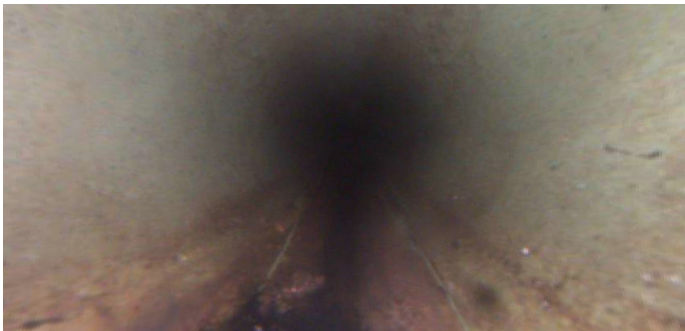
Code: **AMH**  
Description: **Manhole**

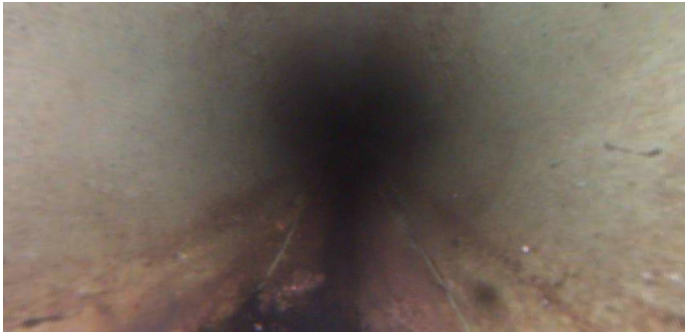
Code:	<b>MWL</b>
Description:	<b>Water Level</b>

Distance (ft):	<b>.0</b>
Structural Grade:	<b>0</b>
O&M Grade:	<b>0</b>
Clock Start/From:	
Clock To:	
1st Value:	
2nd Value:	
Value Percent:	<b>5.000</b>
Continuous Index:	
Within 8" of Joint:	<b>NO</b>
Remarks:

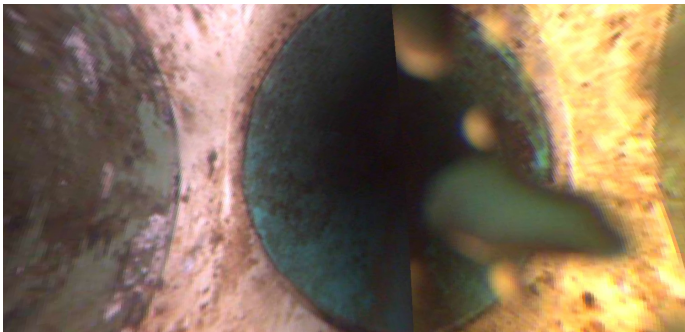
Code:	<b>TF</b>
Description:	<b>Tap Factory</b>

Distance (ft):	<b>47.4</b>
Structural Grade:	<b>0</b>
O&M Grade:	<b>0</b>
Clock Start/From:	<b>2</b>
Clock To:	
1st Value:	<b>4.000</b>
2nd Value:	
Value Percent:	
Continuous Index:	
Within 8" of Joint:	
Remarks:

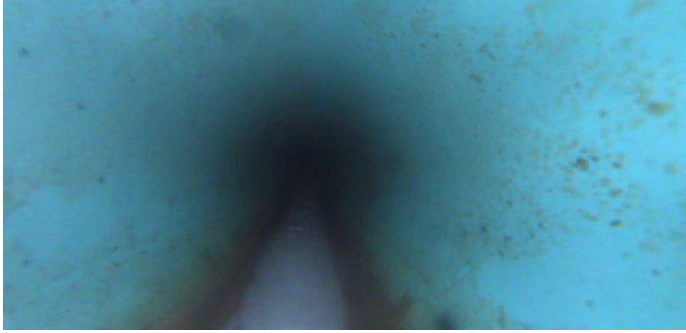
Code: **MGO**  
Description: **General Observation**

Distance (ft): **97.9**  
Structural Grade: **0**  
O&M Grade: **0**  
Clock Start/From:  
Clock To:  
1st Value:  
2nd Value:  
Value Percent:  
Continuous Index:  
Within 8" of Joint: **NO**  
Remarks: **SOAP SUDS**

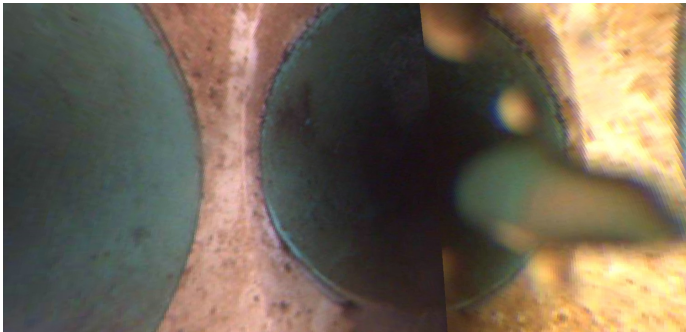
Code: **TF**  
Description: **Tap Factory**

Distance (ft): **112.7**  
Structural Grade: **0**  
O&M Grade: **0**  
Clock Start/From: **3**  
Clock To:  
1st Value: **4.000**  
2nd Value:  
Value Percent:  
Continuous Index:  
Within 8" of Joint:  
Remarks:

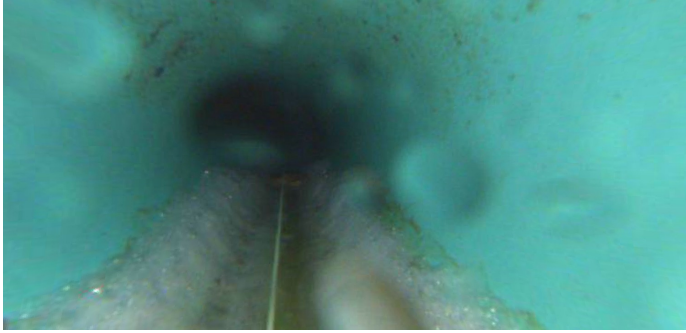
Code: **MGO**  
Description: **General Observation**

Distance (ft): **130.0**  
Structural Grade: **0**  
O&M Grade: **0**  
Clock Start/From:  
Clock To:  
1st Value:  
2nd Value:  
Value Percent:  
Continuous Index:  
Within 8" of Joint: **NO**  
Remarks: **REAR CAMERA**

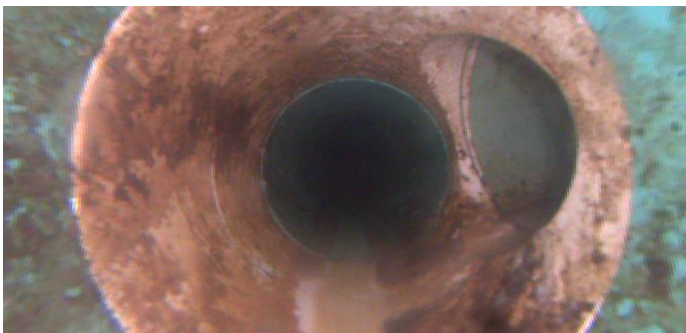
Code: **TF**  
Description: **Tap Factory**

Distance (ft): **178.0**  
Structural Grade: **0**  
O&M Grade: **0**  
Clock Start/From: **3**  
Clock To:  
1st Value: **4.000**  
2nd Value:  
Value Percent:  
Continuous Index:  
Within 8" of Joint:  
Remarks:

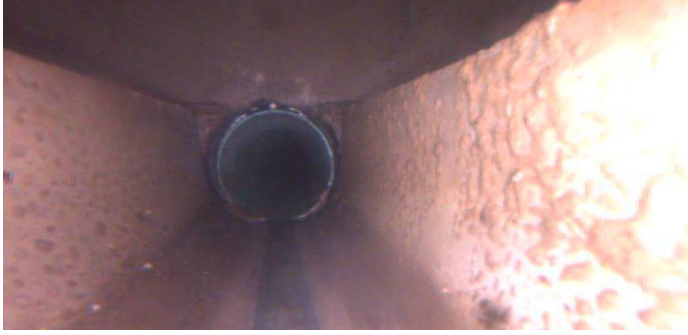
Code:	<b>AMH</b>
Description:	<b>Manhole</b>
Distance (ft):	<b>197.7</b>
Structural Grade:	<b>0</b>
O&M Grade:	<b>0</b>
Clock Start/From:	
Clock To:	
1st Value:	
2nd Value:	
Value Percent:	
Continuous Index:	
Within 8" of Joint:	<b>NO</b>
Remarks:	<b>M-507-053</b>
