## Profile/Photo Observation Report

Street:	<b>S VIRGINIA ST</b>	Flow Control:	<b>Not Controlled</b>
City:	<b>Hobart, IN</b>	Year Renewed:	
Location:	<b>Light Highway</b>	Tape/Media #:	
Purpose:	<b>Routine Assessment</b>	Dia/Height:	<b>8"</b>
Use:	<b>Sanitary</b>	Material:	<b>PVC</b>
Drain Area:	<b>NA</b>	Lining:	
Category:	<b>NA</b>		
Comment:			
Location Details:		Direction of Survey:	<b>Upstream</b>
US MH:	<b>M-507-053</b>	DS MH:	<b>M-507-054</b>
		Total Length Surveyed (ft):	<b>229.2</b>

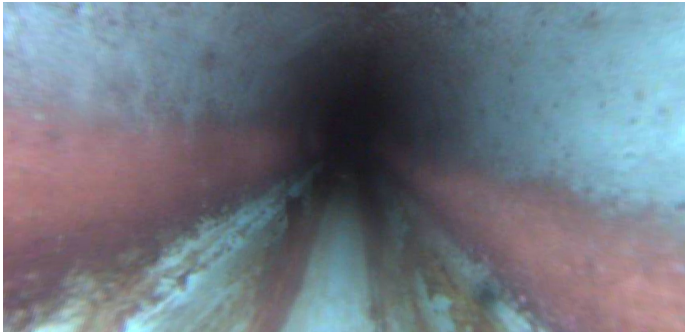
Code:	<b>MWL</b>
Description:	<b>Water Level</b>

Distance (ft):	<b>.0</b>
Structural Grade:	<b>0</b>
O&M Grade:	<b>0</b>
Clock Start/From:	
Clock To:	
1st Value:	
2nd Value:	
Value Percent:	<b>5.000</b>
Continuous Index:	
Within 8" of Joint:	<b>NO</b>
Remarks:

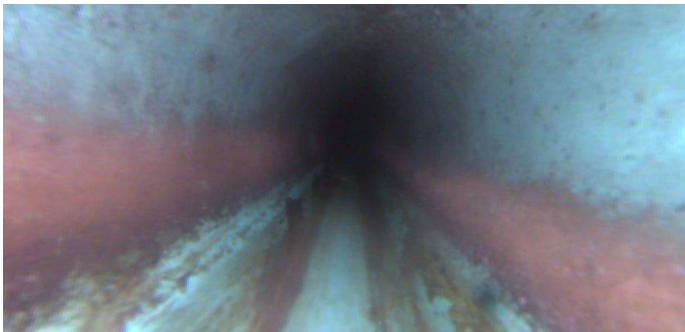
Code:	<b>DAZ</b>
Description:	<b>Deposits Attached Other</b>

Distance (ft):	<b>.0</b>
Structural Grade:	<b>0</b>
O&M Grade:	<b>2</b>
Clock Start/From:	<b>7</b>
Clock To:	<b>5</b>
1st Value:	
2nd Value:	
Value Percent:	<b>5.000</b>
Continuous Index:	<b>S01</b>
Within 8" of Joint:	<b>YES</b>
Remarks:	<b>WANDER</b>

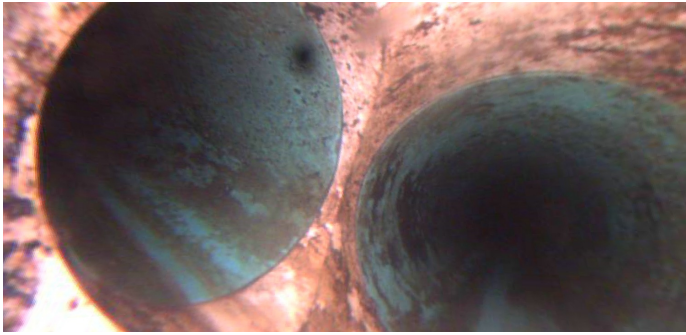
Code: **TF**  
Description: **Tap Factory**

Distance (ft): **16.9**  
Structural Grade: **0**  
O&M Grade: **0**  
Clock Start/From: **9**  
Clock To:  
1st Value: **4.000**  
2nd Value:  
Value Percent:  
Continuous Index:  
Within 8" of Joint:  
Remarks:

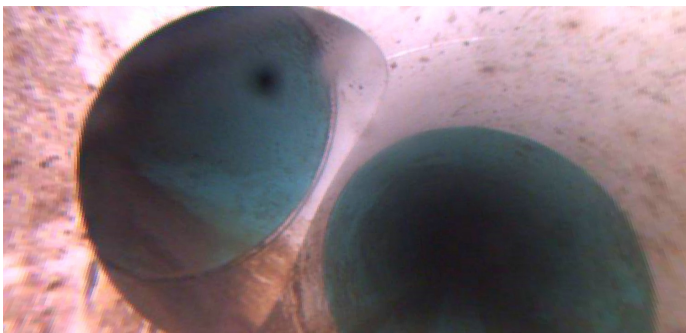
Code: **TF**  
Description: **Tap Factory**

Distance (ft): **86.4**  
Structural Grade: **0**  
O&M Grade: **0**  
Clock Start/From: **10**  
Clock To:  
1st Value: **4.000**  
2nd Value:  
Value Percent:  
Continuous Index:  
Within 8" of Joint:  
Remarks:

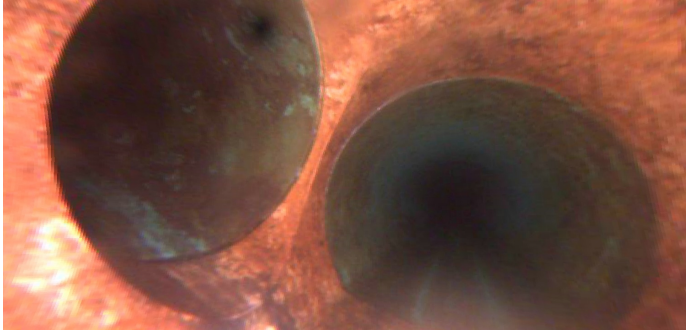
Code: **TF**  
Description: **Tap Factory**

Distance (ft): **165.3**  
Structural Grade: **0**  
O&M Grade: **0**  
Clock Start/From: **10**  
Clock To:  
1st Value: **4.000**  
2nd Value:  
Value Percent:  
Continuous Index:  
Within 8" of Joint:  
Remarks:

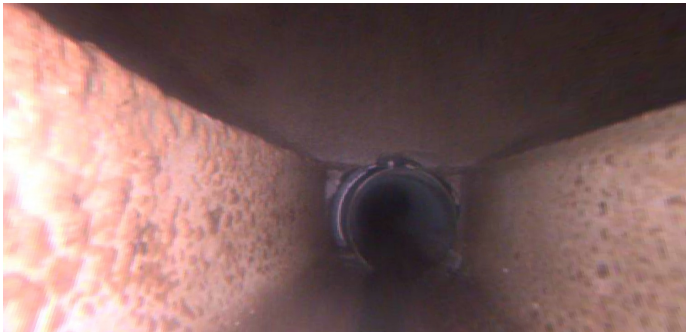
Code: **AMH**  
Description: **Manhole**

Distance (ft): **229.2**  
Structural Grade: **0**  
O&M Grade: **0**  
Clock Start/From:  
Clock To:  
1st Value:  
2nd Value:  
Value Percent:  
Continuous Index:  
Within 8" of Joint: **NO**  
Remarks: **M-507-053**

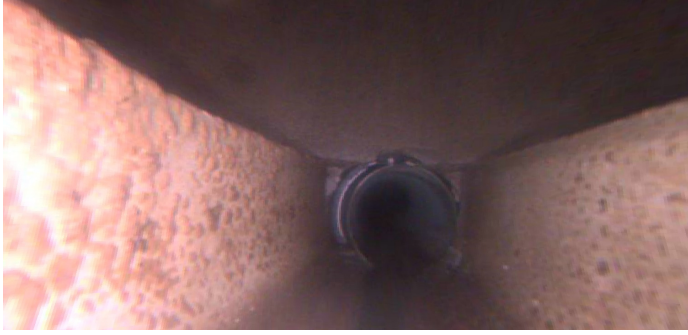
Code:	<b>DAZ</b>
Description:	<b>Deposits Attached Other</b>
Distance (ft):	<b>229.2</b>
Structural Grade:	<b>0</b>
O&M Grade:	<b>2</b>
Clock Start/From:	<b>7</b>
Clock To:	<b>5</b>
1st Value:	
2nd Value:	
Value Percent:	<b>5.000</b>
Continuous Index:	<b>F01</b>
Within 8" of Joint:	<b>YES</b>
Remarks:	<b>WANDER</b>
