Profile/Photo Observation Report

Date:	04/13/2018	Weather:		Coding:	PACP 6.0
Pipe Length (ft):	217.8	Owner:	NA	Pre Clean:	No Pre-Cleaning
P.O.#:		Surveyor:	John Kuglmaier	PSR:	P-507-056-055
Customer:		Clean Date:	01/01/1900	Shape:	C

Street:	FOXCROFT STREET	Flow Control:	Not Controlled
City:	Hobart, IN	Year Renewed:	
Location:	Yard	Tape/Media #:	
Purpose:	Routine Assessment	Dia/Height:	8"
Use:	Sanitary	Material:	PVC
Drain Area:	NA	Lining:	
Category:	NA		
Comment:	Flow direction is marked wrong.		
Location Details:		Direction of Survey:	Downstream
US MH:	M-507-055	DS MH:	M-507-056
		Total Length Surveyed (ft):	210.7

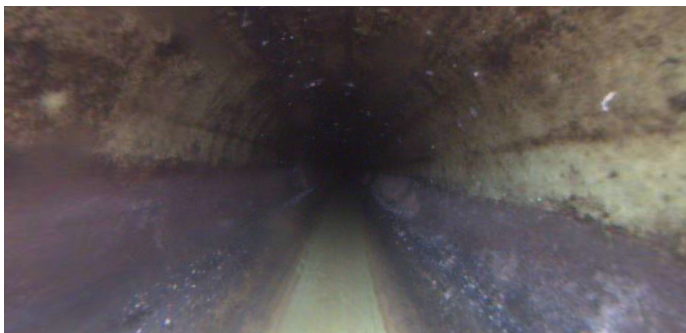
Code: **AMH**
Description: **Manhole**

Distance (ft): **.0**
Structural Grade: **0**
O&M Grade: **0**
Clock Start/From:
Clock To:
1st Value:
2nd Value:
Value Percent:
Continuous Index:
Within 8" of Joint: **NO**
Remarks: **M-507-055**

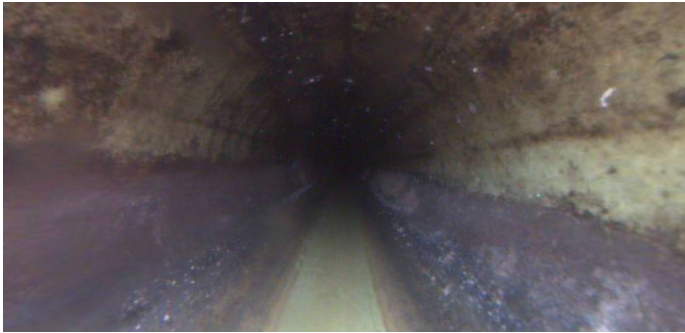
Code:	MWL
Description:	Water Level

Distance (ft):	.0
Structural Grade:	0
O&M Grade:	0
Clock Start/From:	
Clock To:	
1st Value:	
2nd Value:	
Value Percent:	5.000
Continuous Index:	
Within 8" of Joint:	NO
Remarks:

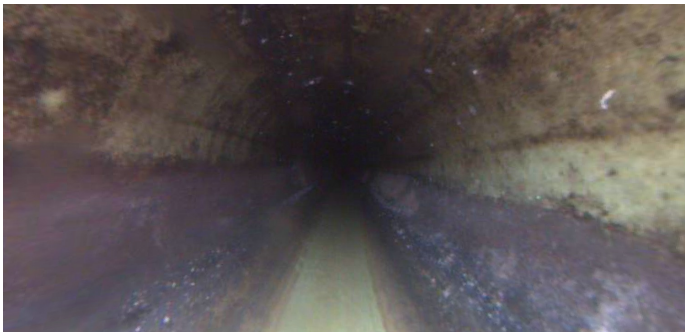
Code:	DAGS
Description:	Deposits Attached Grease

Distance (ft):	.0
Structural Grade:	0
O&M Grade:	2
Clock Start/From:	7
Clock To:	5
1st Value:	
2nd Value:	
Value Percent:	5.000
Continuous Index:	S01
Within 8" of Joint:	NO
Remarks:

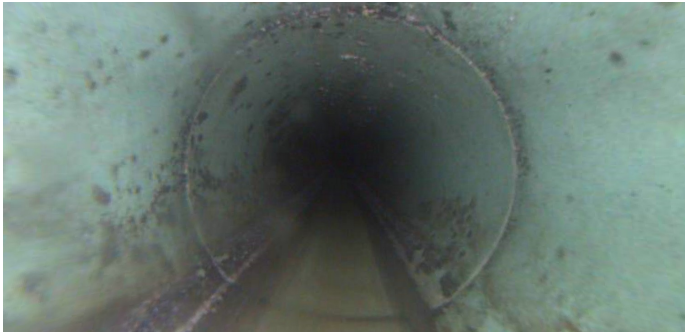
Code: **DAGS**
Description: **Deposits Attached Grease**

Distance (ft): **49.7**
Structural Grade: **0**
O&M Grade: **2**
Clock Start/From: **7**
Clock To: **5**
1st Value:
2nd Value:
Value Percent: **5.000**
Continuous Index: **F01**
Within 8" of Joint: **NO**
Remarks:

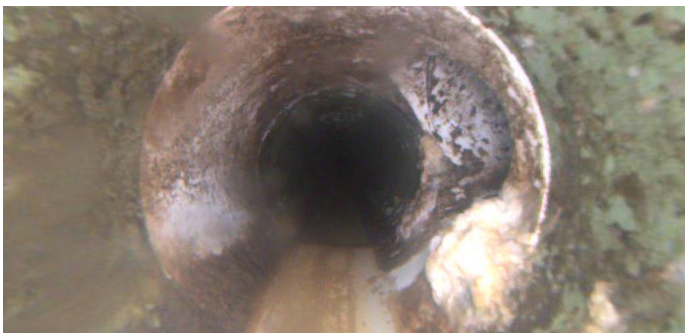
Code: **DAGS**
Description: **Deposits Attached Grease**

Distance (ft): **69.3**
Structural Grade: **0**
O&M Grade: **2**
Clock Start/From: **3**
Clock To: **4**
1st Value:
2nd Value:
Value Percent: **5.000**
Continuous Index:
Within 8" of Joint: **NO**
Remarks:

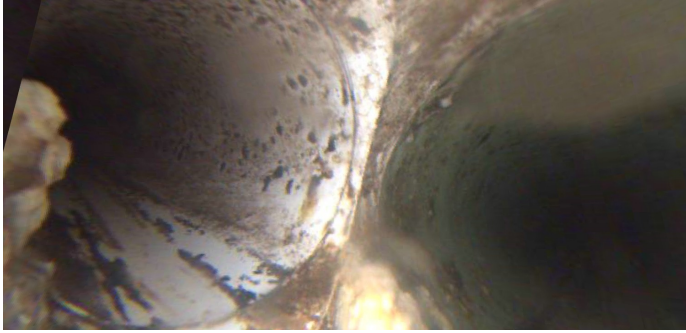
Code: **TF**
Description: **Tap Factory**

Distance (ft): **70.2**
Structural Grade: **0**
O&M Grade: **0**
Clock Start/From: **3**
Clock To:
1st Value: **4.000**
2nd Value:
Value Percent:
Continuous Index:
Within 8" of Joint:
Remarks:

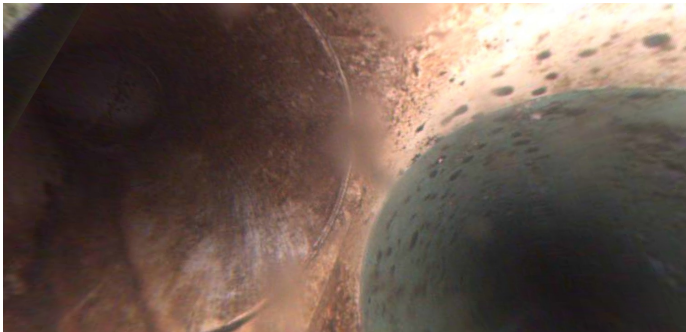
Code: **TF**
Description: **Tap Factory**

Distance (ft): **78.0**
Structural Grade: **0**
O&M Grade: **0**
Clock Start/From: **10**
Clock To:
1st Value: **4.000**
2nd Value:
Value Percent:
Continuous Index:
Within 8" of Joint:
Remarks:

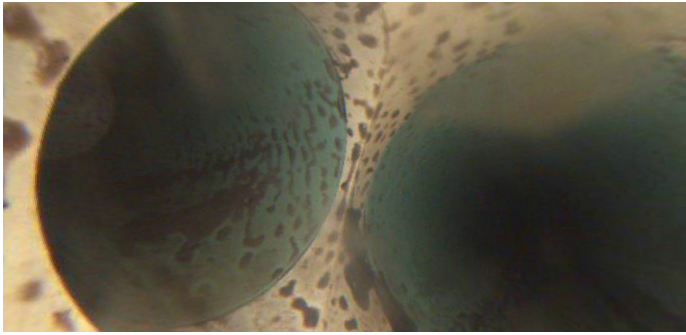
Code: **TFC**
Description: **Tap Factory Capped**

Distance (ft): **161.3**
Structural Grade: **0**
O&M Grade: **0**
Clock Start/From: **3**
Clock To:
1st Value: **4.000**
2nd Value:
Value Percent:
Continuous Index:
Within 8" of Joint:
Remarks:

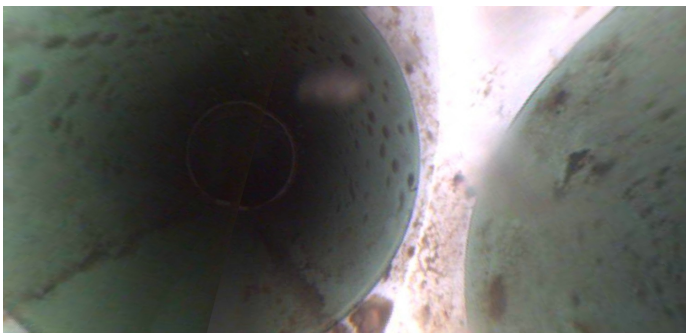
Code: **TF**
Description: **Tap Factory**

Distance (ft): **168.0**
Structural Grade: **0**
O&M Grade: **0**
Clock Start/From: **10**
Clock To:
1st Value: **4.000**
2nd Value:
Value Percent:
Continuous Index:
Within 8" of Joint:
Remarks:

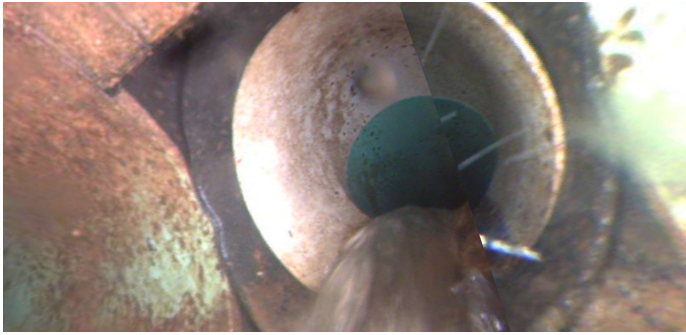
Code: **TBA**
Description: **Tap Break-in Active**

Distance (ft): **177.9**
Structural Grade: **0**
O&M Grade: **0**
Clock Start/From: **2**
Clock To:
1st Value: **4.000**
2nd Value:
Value Percent:
Continuous Index:
Within 8" of Joint:
Remarks:

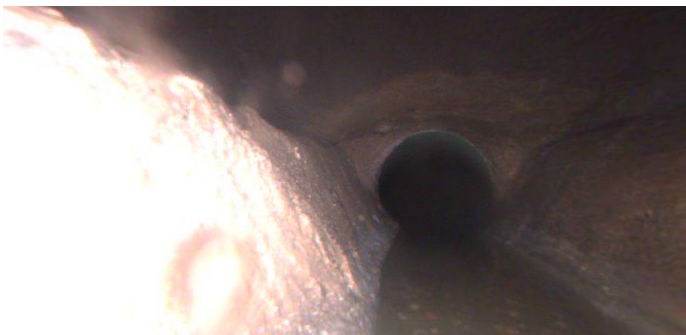
Code: **AMH**
Description: **Manhole**

Distance (ft): **210.7**
Structural Grade: **0**
O&M Grade: **0**
Clock Start/From:
Clock To:
1st Value:
2nd Value:
Value Percent:
Continuous Index:
Within 8" of Joint: **NO**
Remarks: **M-507-056**
