## Profile/Photo Observation Report

Date:	<b>03/26/2018</b>	Weather:		Coding:	<b>PACP 6.0</b>
Pipe Length (ft):	<b>134.1</b>	Owner:	<b>NA</b>	Pre Clean:	<b>No Pre-Cleaning</b>
P.O.#:		Surveyor:	<b>Jen Costello</b>	PSR:	<b>P-507-059-081</b>
Customer:		Clean Date:	<b>01/01/1900</b>	Shape:	<b>C</b>

Street:	<b>S VIRGINIA ST</b>	Flow Control:	<b>Not Controlled</b>
City:	<b>Hobart, IN</b>	Year Renewed:	
Location:	<b>Light Highway</b>	Tape/Media #:	
Purpose:	<b>Routine Assessment</b>	Dia/Height:	<b>8"</b>
Use:	<b>Sanitary</b>	Material:	<b>PVC</b>
Drain Area:	<b>NA</b>	Lining:	
Category:	<b>NA</b>		
Comment:			
Location Details:		Direction of Survey:	<b>Upstream</b>
US MH:	<b>M-507-059</b>	DS MH:	<b>M-507-081</b>
		Total Length Surveyed (ft):	<b>131.4</b>

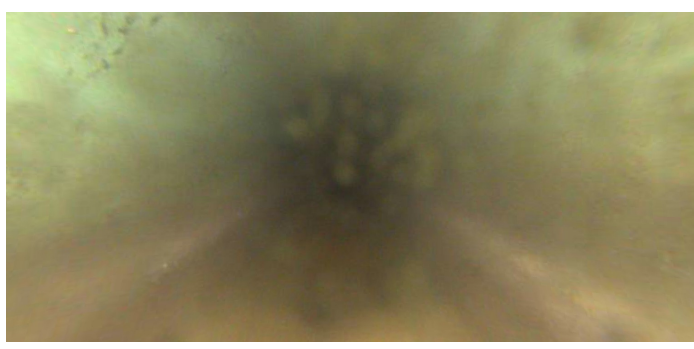
Code: **AMH**  
Description: **Manhole**

Distance (ft): **.0**  
Structural Grade: **0**  
O&M Grade: **0**  
Clock Start/From:  
Clock To:  
1st Value:  
2nd Value:  
Value Percent:  
Continuous Index:  
Within 8" of Joint: **NO**  
Remarks: **M-507-081**

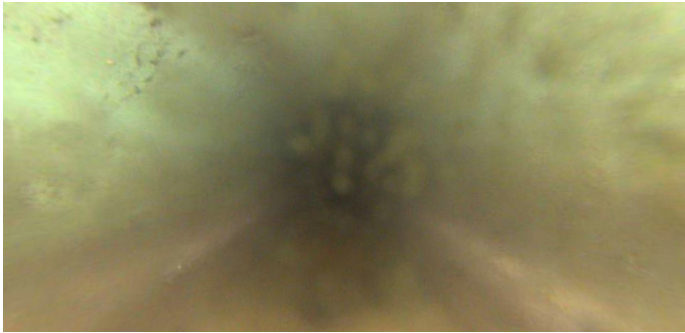
Code:	<b>MWL</b>
Description:	<b>Water Level</b>

Distance (ft):	<b>.0</b>
Structural Grade:	<b>0</b>
O&M Grade:	<b>0</b>
Clock Start/From:	
Clock To:	
1st Value:	
2nd Value:	
Value Percent:	<b>10.000</b>
Continuous Index:	
Within 8" of Joint:	<b>NO</b>
Remarks:

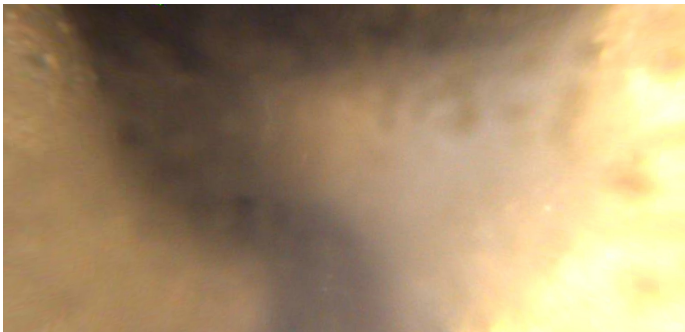
Code:	<b>AMH</b>
Description:	<b>Manhole</b>

Distance (ft):	<b>131.4</b>
Structural Grade:	<b>0</b>
O&M Grade:	<b>0</b>
Clock Start/From:	
Clock To:	
1st Value:	
2nd Value:	
Value Percent:	
Continuous Index:	
Within 8" of Joint:	<b>NO</b>
Remarks:	<b>M-507-059</b>
